Annual Inspection

Radford Semele Parish Council

Fenced Play Area

Inspection Ref: 1589724

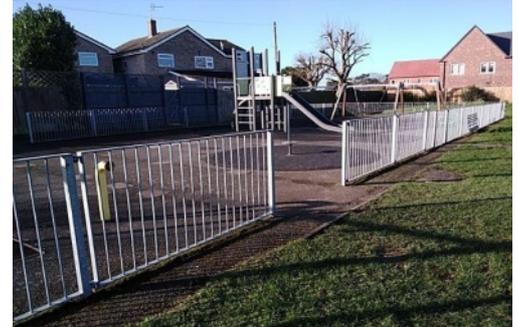
Item: Fencing - Flat Top
Manufacturer: Unknown
Surface Type: Tarmac
Item Quantity: 1
Equipment Compliance: N/A
Surface Area Compliance: N/A

This item is satisfactory - no work required -

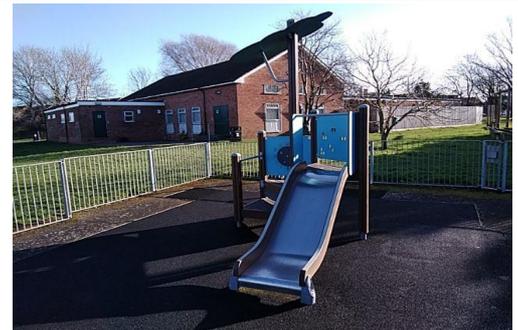
Item: Multi Play (Toddler)
Manufacturer: Lappset UK Ltd
Surface Type: Wet Pour
Item Quantity: 1
Equipment Compliance: Yes
Surface Area Compliance: Yes

There are gaps opening between the surfacing and the edging surround or between the joints in the surfacing - Monitor for any further deterioration and repair as required

There are areas or parts of the timber edging around the playing surface that have rotted - Replace all affected timbers

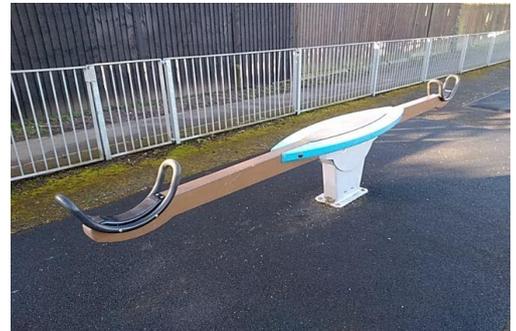
Item: See Saw
Manufacturer: Lappset UK Ltd
Surface Type: Wet Pour
Item Quantity: 1
Equipment Compliance: Yes
Surface Area Compliance: Yes

Finding 1
 The seesaw seat clearance is less than 230mm in contravention of BS EN 1176 Part 6 - Adjust to provide the correct seat clearance

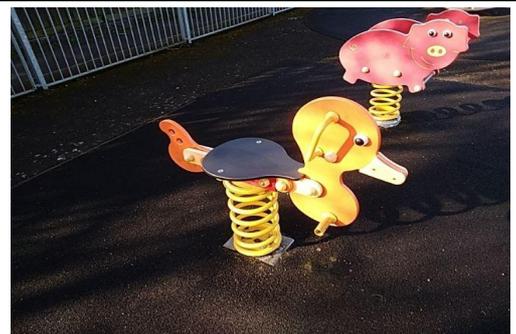
Item: Spring Bird
Manufacturer: Unknown
Surface Type: Wet Pour
Item Quantity: 1
Equipment Compliance: No
Surface Area Compliance: Yes

Finding 1
 There is/are bolt cap covers missing or damaged on the item - Replace missing or damaged bolt cap covers

Finding 3
 The end of handgrips and/or footrests have a cross section of less than 15cm² and fail to meet the requirements of BS EN 1176 Part 6 - Monitor - No remedial work recommended

Finding 2
 There are end caps missing from the item. These are no longer available - Monitor

Finding 4
 There is no identification label affixed to the equipment - Provide an identification label

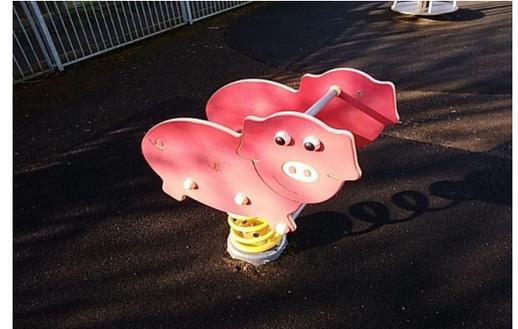
Item: Spring Pig
Manufacturer: Unknown
Surface Type: Wet Pour
Item Quantity: 1
Equipment Compliance: No
Surface Area Compliance: Yes

There is no identification label affixed to the equipment - Provide an identification label

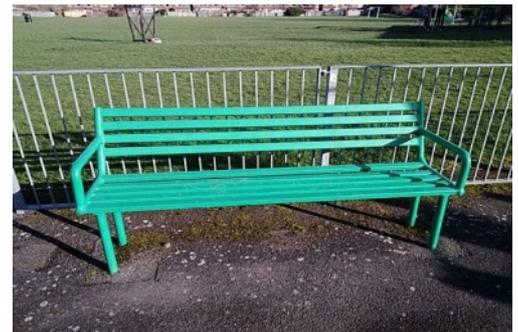
Item: Seat
Manufacturer: Unknown
Surface Type: Tarmac
Item Quantity: 2
Equipment Compliance: N/A
Surface Area Compliance: N/A

This item is satisfactory - no work required -

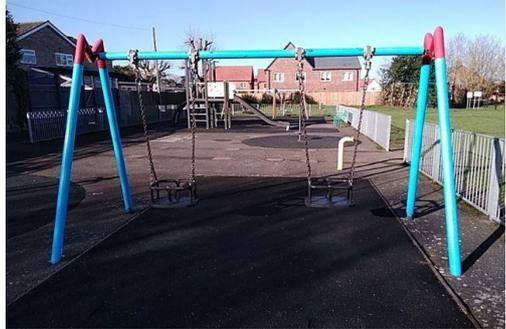
Item: 1 Bay 2 Seat (Cradle)
Manufacturer: Monster Play Systems
Surface Type: Wet Pour
Item Quantity: 1
Equipment Compliance: No
Surface Area Compliance: Yes

Finding 1
 Slight movement at the frame joints - Monitor

Finding 2
 There are gaps opening between the surfacing and the edging surround or between the joints in the surfacing - Monitor for any further deterioration and repair as required

Finding 3
 The surface has been repaired - Monitor

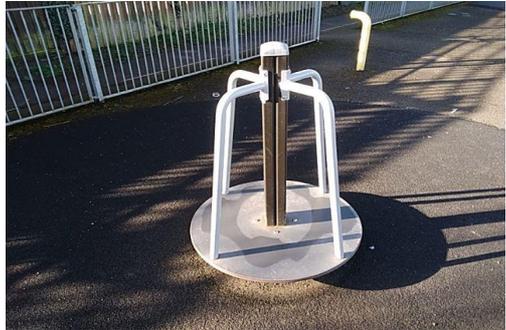
Item: Spinning Pole
Manufacturer: Lappset UK Ltd
Surface Type: Wet Pour
Item Quantity: 1
Equipment Compliance: No
Surface Area Compliance: Yes

Finding 1
 The distance between the underside of the roundabout platform and the playing surface is in excess of 110mm and contravenes the requirements of BS EN 1176 Part 5 which requires that the distance be maintained between 60mm-110mm - for the entire circumference of the roundabout - Monitor - No remedial work recommended

Finding 2
 There is no identification label affixed to the equipment - Provide an identification label

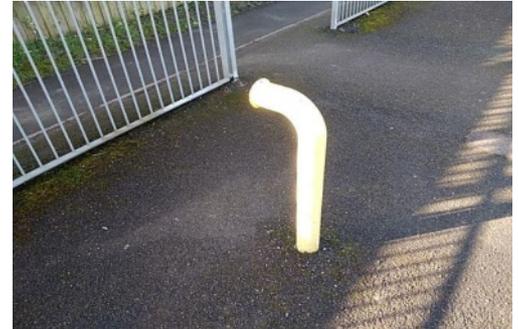
Item: Talk Tubes
Manufacturer: Unknown
Surface Type: Tarmac
Item Quantity: 2
Equipment Compliance: N/A
Surface Area Compliance: N/A

This item is satisfactory - no work required -

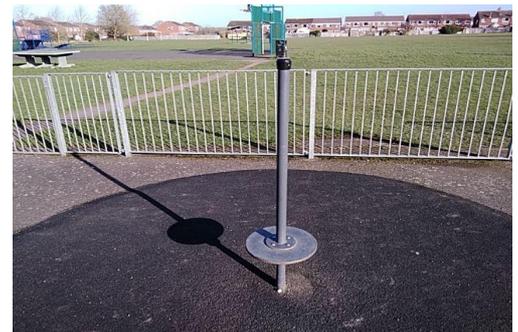
Item: Spinning Pole
Manufacturer: Unknown
Surface Type: Wet Pour
Item Quantity: 1
Equipment Compliance: No
Surface Area Compliance: Yes

There is no identification label affixed to the equipment - Provide an identification label

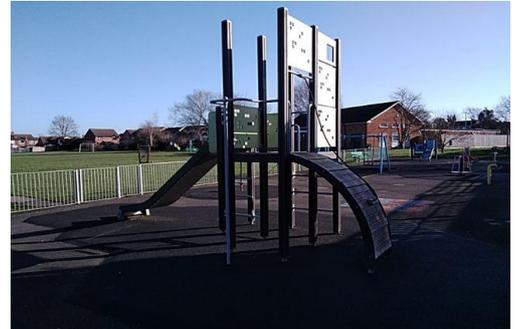
Item: Multi Play (Junior)
Manufacturer: Lappset UK Ltd
Surface Type: Wet Pour
Item Quantity: 1
Equipment Compliance: No
Surface Area Compliance: Yes

Finding 1
 The firemans pole is less than 350mm from the platform and does not meet with the recommendations of BS EN 1176 Part 1 - Monitor - No remedial work recommended

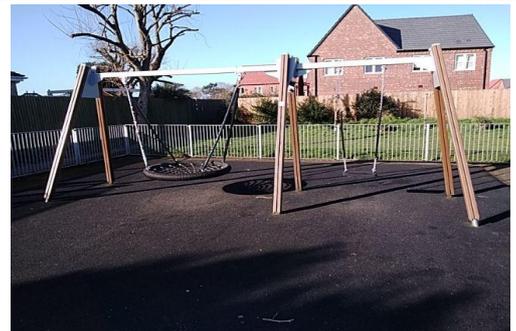
Item: 2 Bay 1 Flat 1 Basket
Manufacturer: Lappset UK Ltd
Surface Type: Wet Pour
Item Quantity: 1
Equipment Compliance: Yes
Surface Area Compliance: Yes

Finding 1
 The seat clearance from finished surface level to the underside of the seat is too low when measured in its most onerous position and does not meet the requirements of BS EN 1176 Part 2 - Install seats to a minimum height of 400mm for Group Swing Seats

Finding 3
 There are gaps opening between the surfacing and the edging surround or between the joints in the surfacing - Monitor for any further deterioration and repair as required

Finding 2
 The identification label affixed to the equipment cannot be read - Monitor

Finding 4
 The wetpour playing surface is damaged - Wicksteed are due to repair the surface shortly

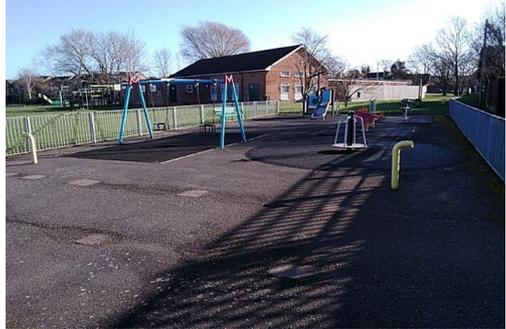
8 - Low Risk	
<p>Item: Site General Manufacturer: Unknown Surface Type: Mixed Surface Item Quantity: 1 Equipment Compliance: N/A Surface Area Compliance: N/A</p> <p>Total Findings: 2</p>

Finding 1	Finding 2
There is algae or moss growth on the surface resulting in slippery conditions - Clean and treat appropriately	It is recommended that signage, with information including the site address, contact information for maintenance issues and emergency contact details are provided for the facility - Provide in accordance with the recommendations

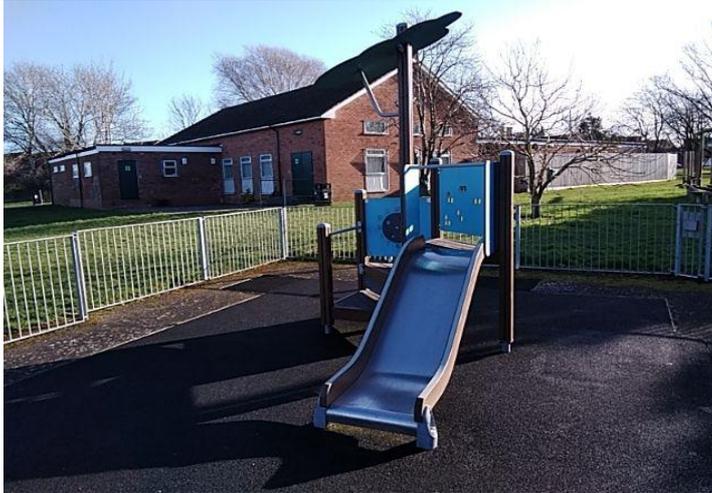
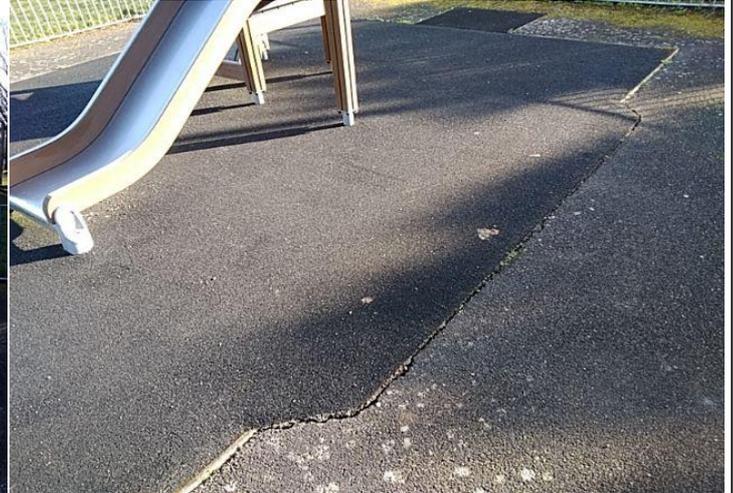
Item: Activity Equipment - Multi Play (Toddler)
Manufacturer: Lappset UK Ltd

Finding: There are gaps opening between the surfacing and the edging surround or between the joints in the surfacing
Action: Monitor for any further deterioration and repair as required

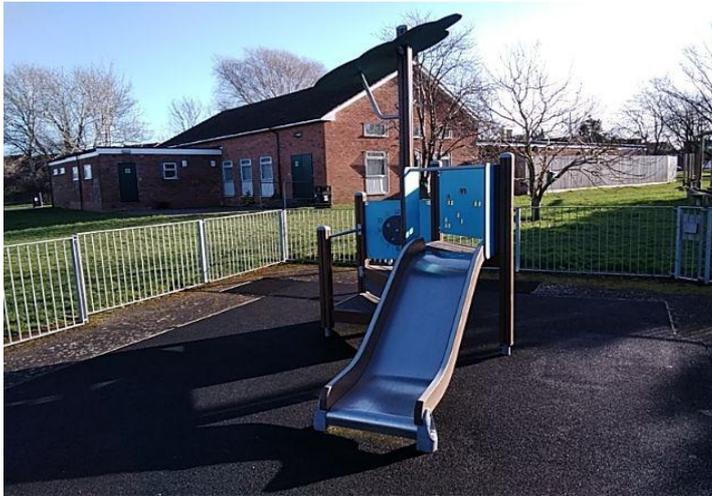
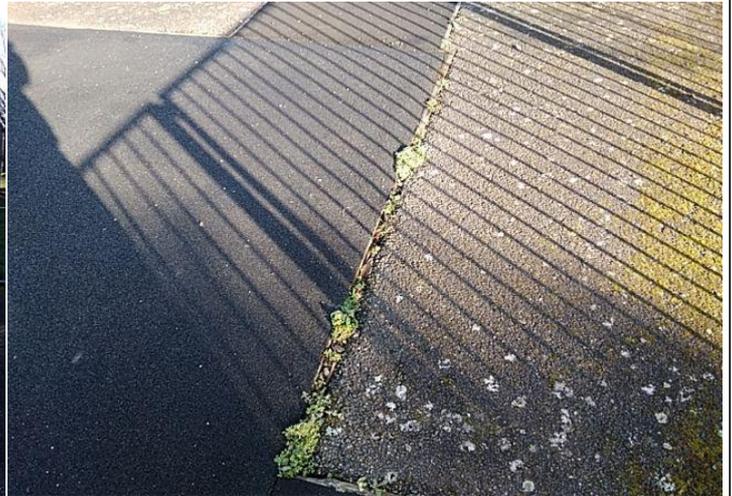
Item: Activity Equipment - Multi Play (Toddler)
Manufacturer: Lappset UK Ltd

Finding: There are areas or parts of the timber edging around the playing surface that have rotted

Action: Replace all affected timbers

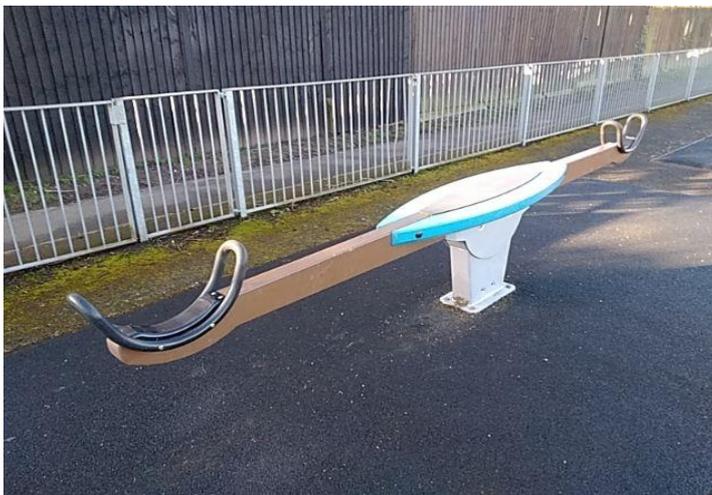
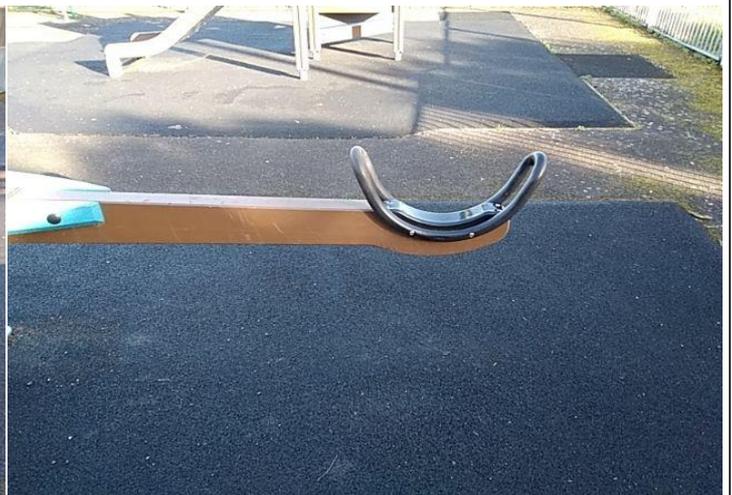
Item: Rocking Equipment - See Saw
Manufacturer: Lappset UK Ltd

Finding: The seesaw seat clearance is less than 230mm in contravention of BS EN 1176 Part 6

Action: Adjust to provide the correct seat clearance

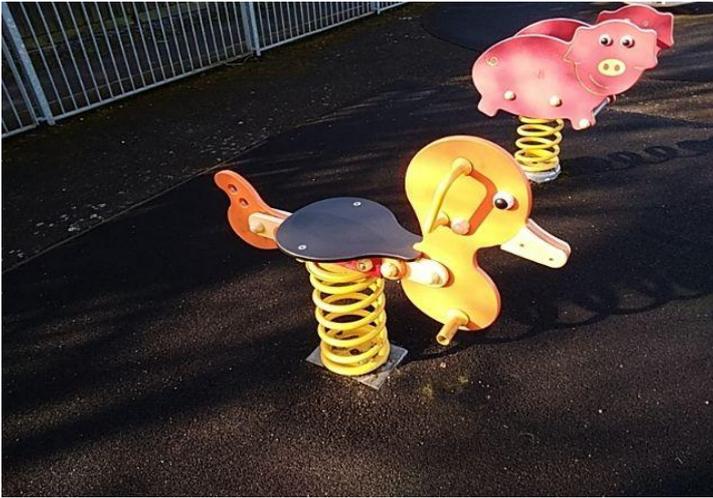
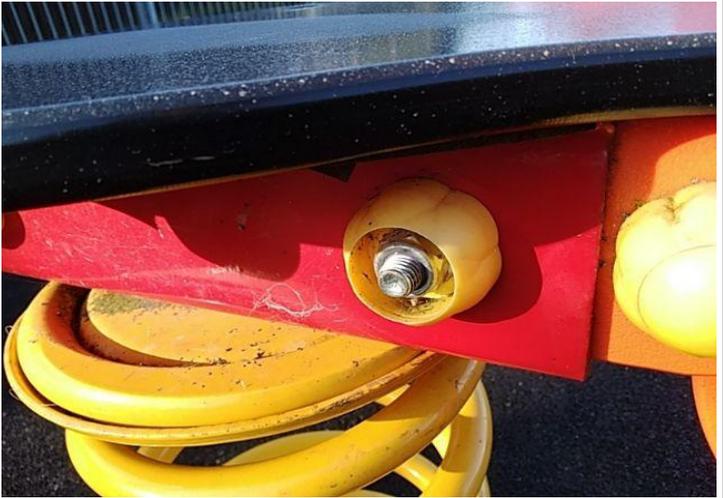
Item:	Rocking Equipment - Spring Bird	Risk Level:	V - Very Low Risk
Manufacturer:	Unknown	Surface:	Wet Pour

Finding: There is/are bolt cap covers missing or damaged on the item

Action: Replace missing or damaged bolt cap covers

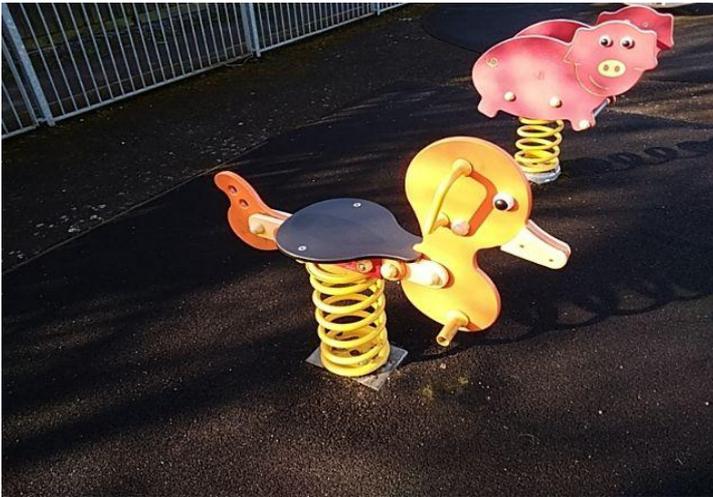
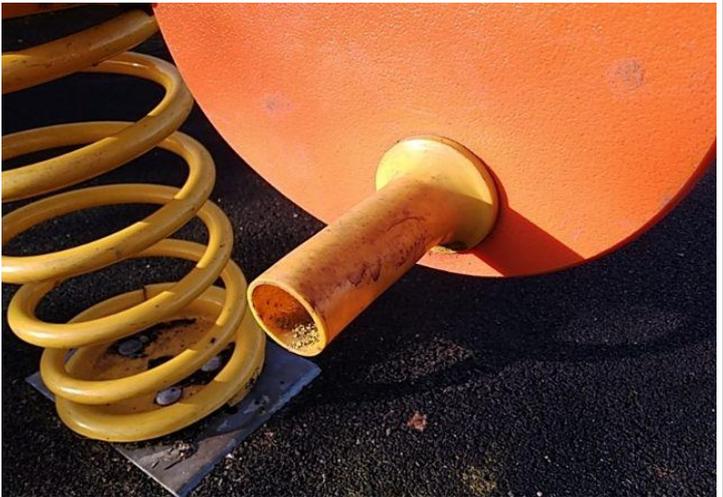
Item:	Rocking Equipment - Spring Bird	Risk Level:	L - Low Risk
Manufacturer:	Unknown	Surface:	Wet Pour

Finding: There are end caps missing from the item. These are no longer available

Action: Monitor

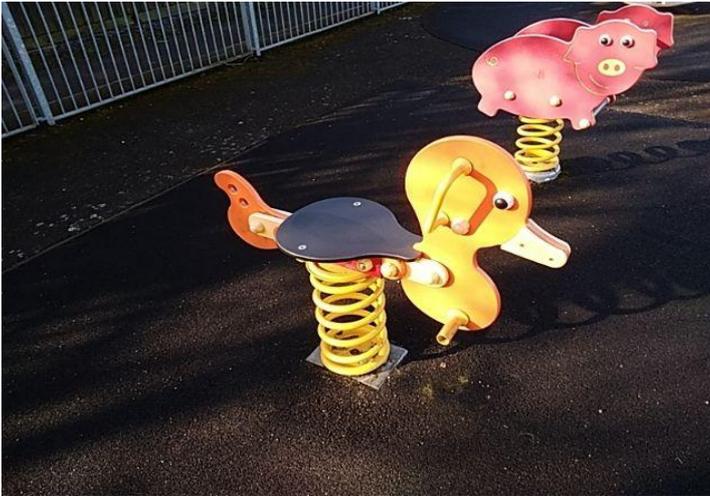
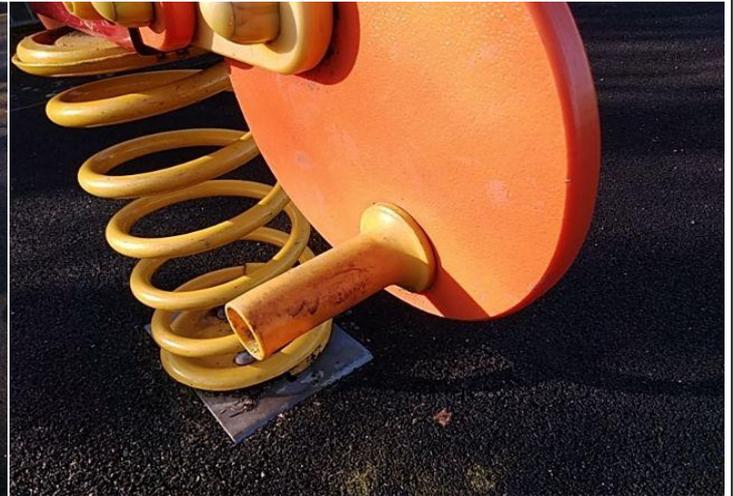
Item: Rocking Equipment - Spring Bird
Manufacturer: Unknown

Finding: The end of handgrips and/or footrests have a cross section of less than 15cm² and fail to meet the requirements of BS EN 1176 Part 6
Action: Monitor - No remedial work recommended

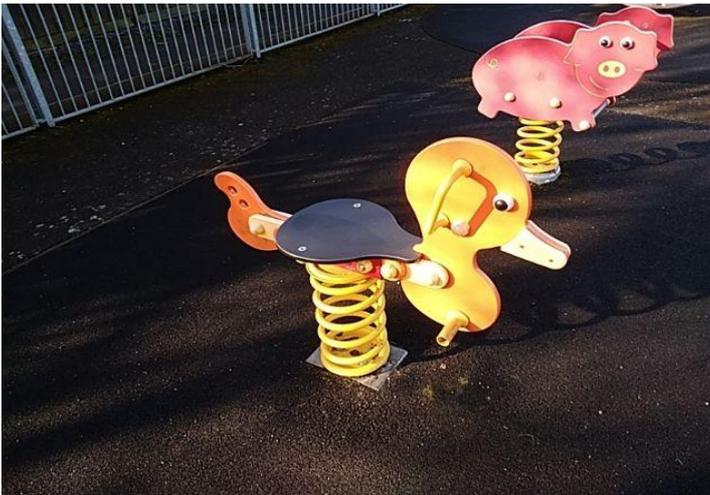
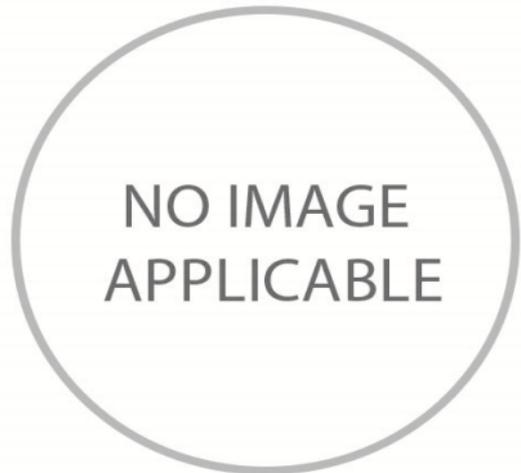
Item: Rocking Equipment - Spring Bird
Manufacturer: Unknown

Finding: There is no identification label affixed to the equipment

Action: Provide an identification label

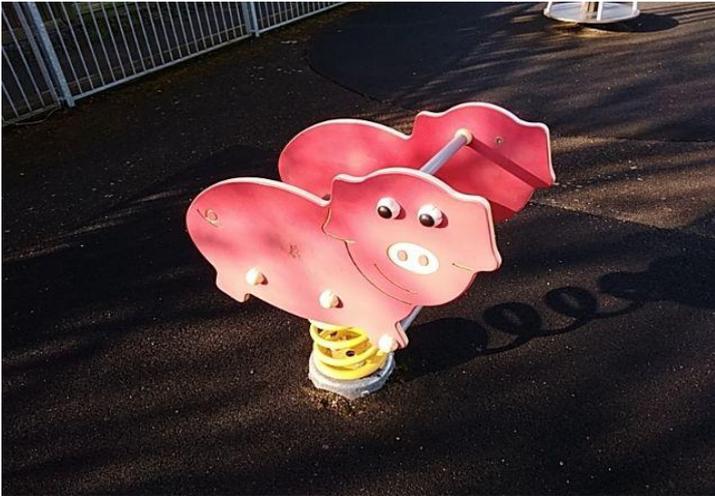
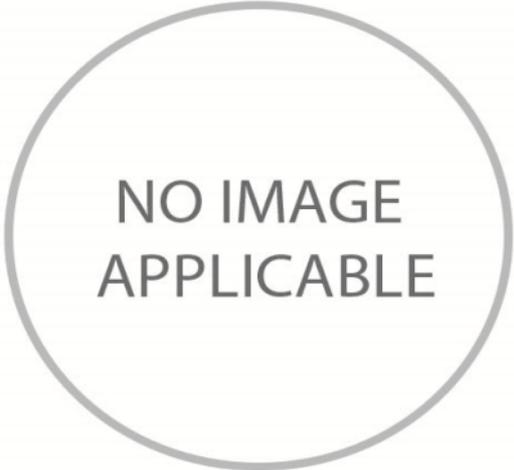
Item:	Rocking Equipment - Spring Pig	Risk Level:	N - Risk Assessment not Undertaken
Manufacturer:	Unknown	Surface:	Wet Pour

Finding: There is no identification label affixed to the equipment

Action: Provide an identification label

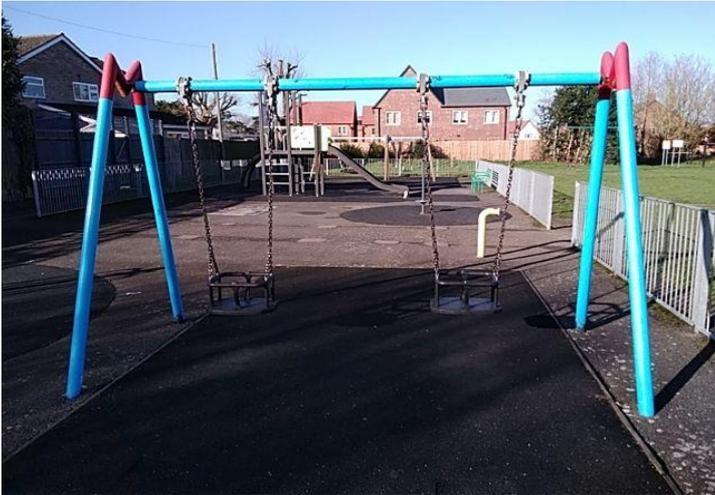
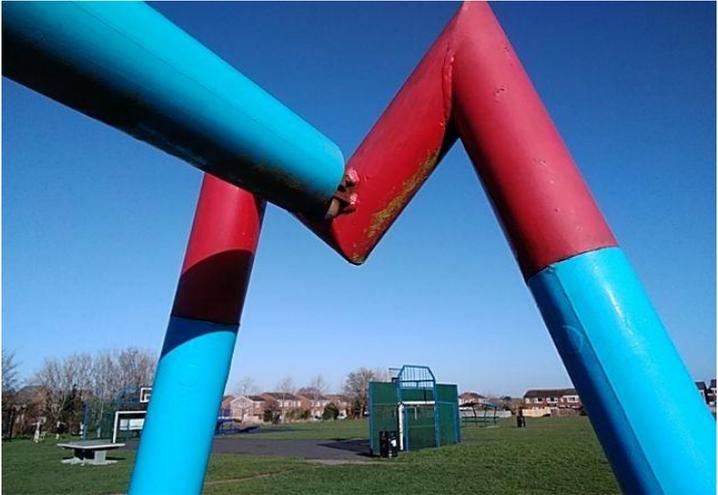
Item:	Swings - 1 Bay 2 Seat (Cradle)	Risk Level:	L - Low Risk
Manufacturer:	Monster Play Systems	Surface:	Wet Pour

Finding: Slight movement at the frame joints

Action: Monitor

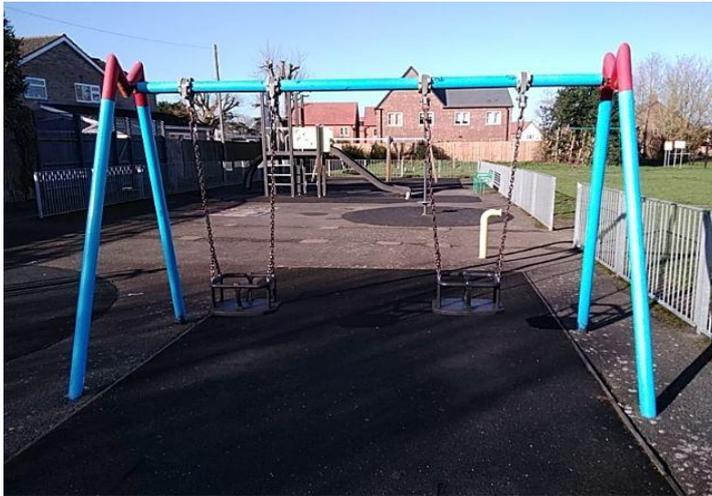
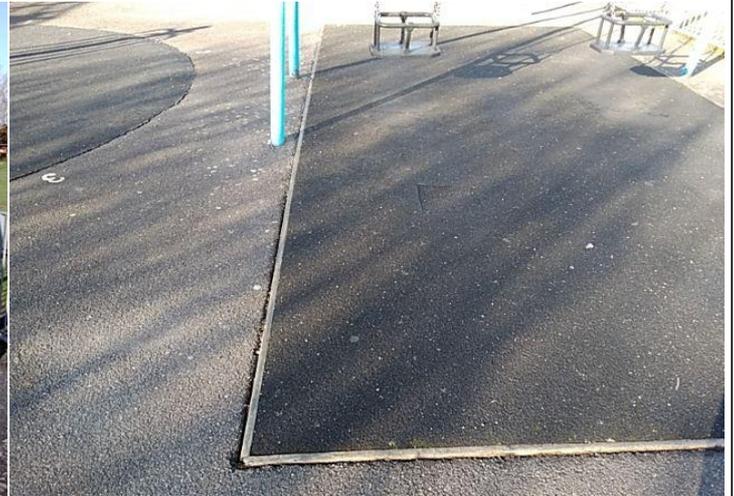
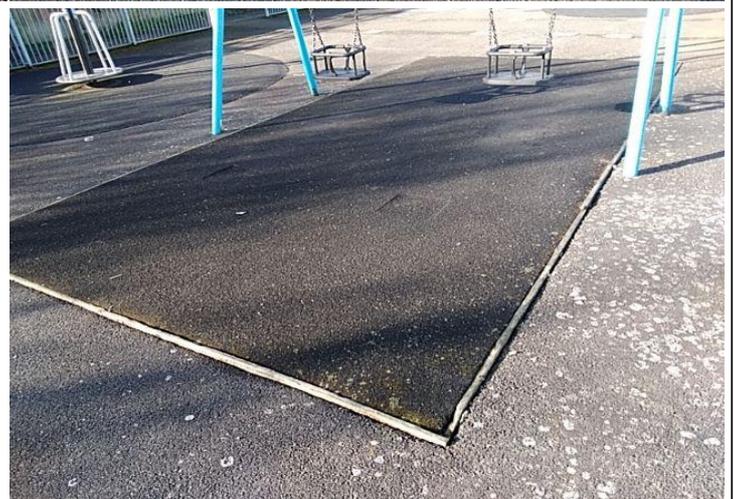
Item: Swings - 1 Bay 2 Seat (Cradle)
Manufacturer: Monster Play Systems

Finding: There are gaps opening between the surfacing and the edging surround or between the joints in the surfacing
Action: Monitor for any further deterioration and repair as required

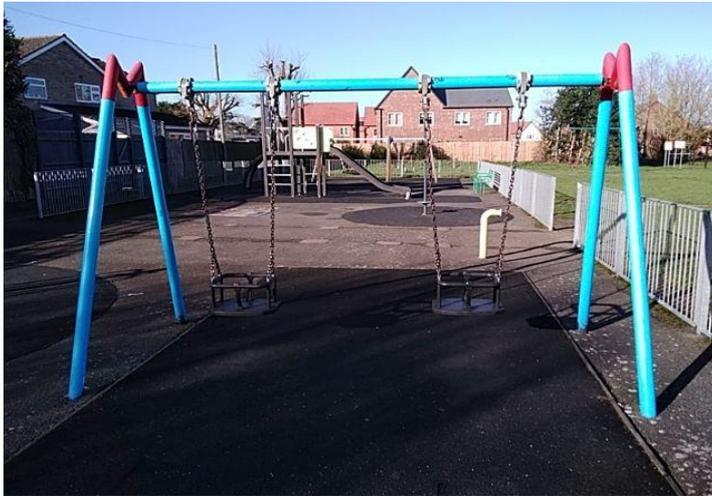
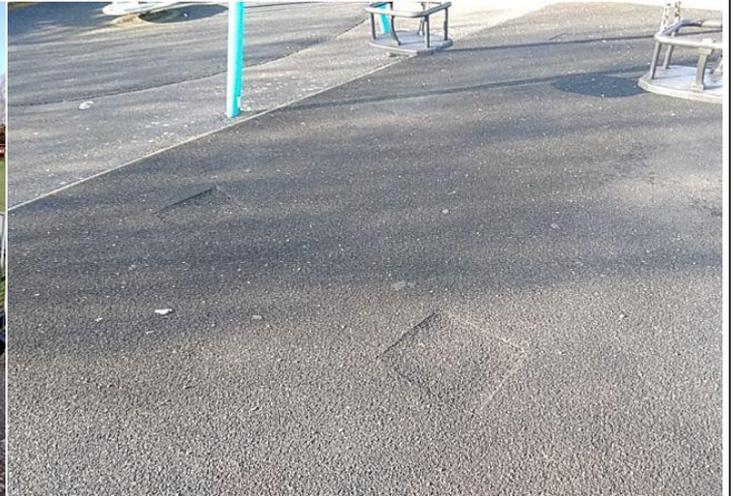
Item: Swings - 1 Bay 2 Seat (Cradle)
Manufacturer: Monster Play Systems

Finding: The surface has been repaired

Action: Monitor

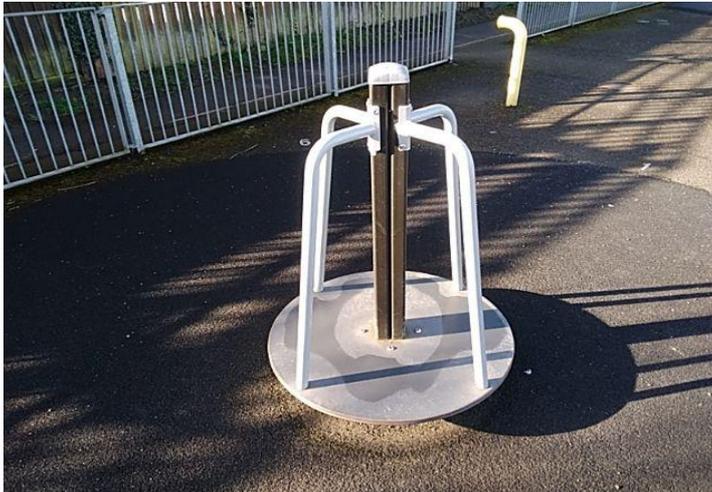
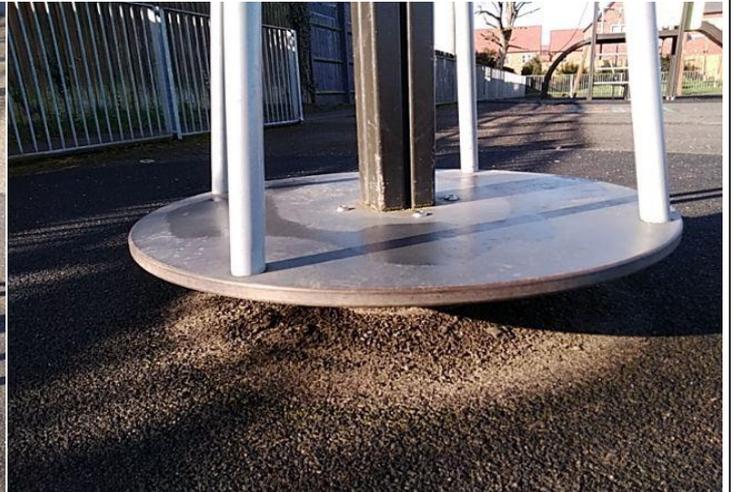
Item: Rotor Play - Spinning Pole
Manufacturer: Lappset UK Ltd

Finding: The distance between the underside of the roundabout platform and the playing surface is in excess of 110mm and contravenes the requirements of BS EN 1176 Part 5 which requires that the distance be maintained between 60mm-110mm - for the entire circumference of the roundabout

Action: Monitor - No remedial work recommended

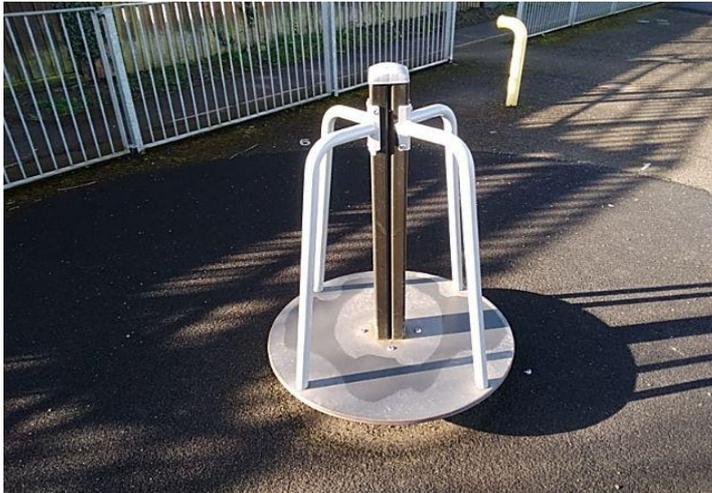
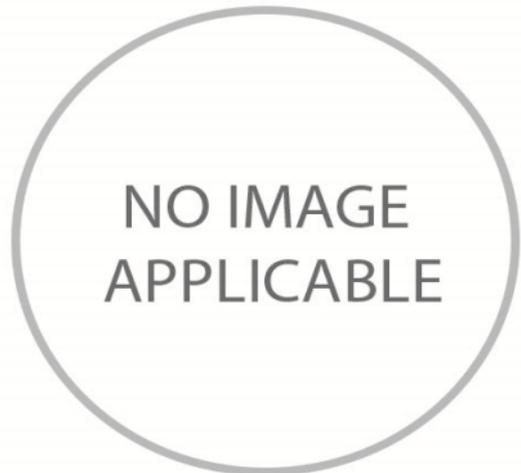
Item: Rotor Play - Spinning Pole
Manufacturer: Lappset UK Ltd

Finding: There is no identification label affixed to the equipment

Action: Provide an identification label

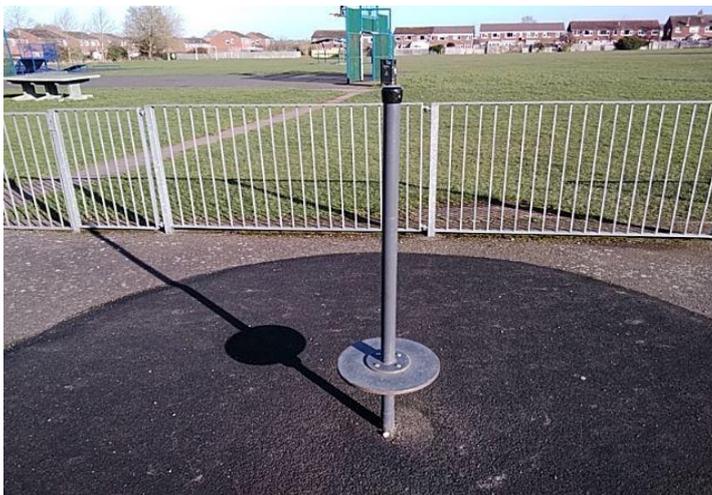
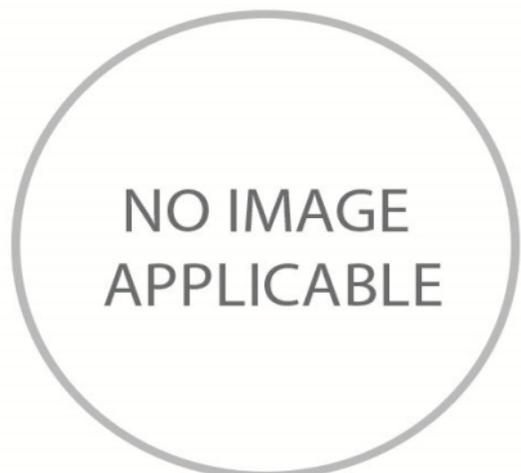
Item: Rotor Play - Spinning Pole
Manufacturer: Unknown

Finding: There is no identification label affixed to the equipment

Action: Provide an identification label

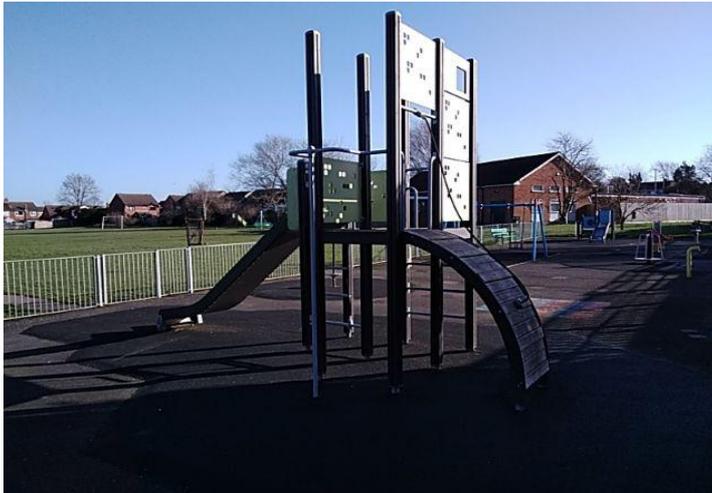
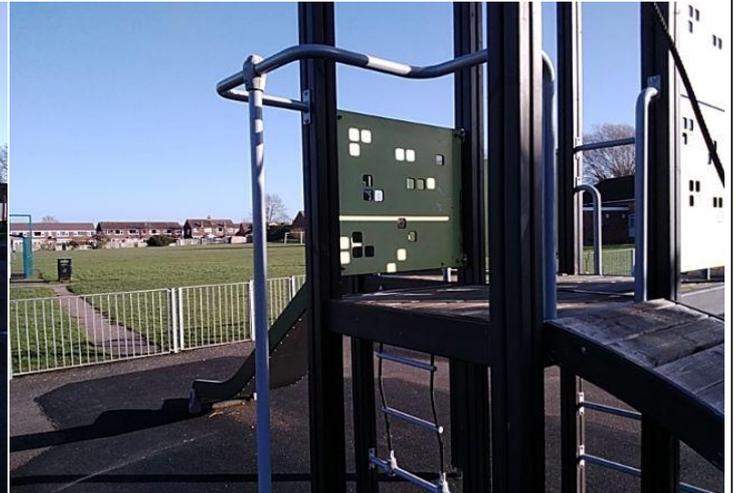
Item: Activity Equipment - Multi Play (Junior)
Manufacturer: Lappset UK Ltd

Finding: The firemans pole is less than 350mm from the platform and does not meet with the recommendations of BS EN 1176 Part 1

Action: Monitor - No remedial work recommended

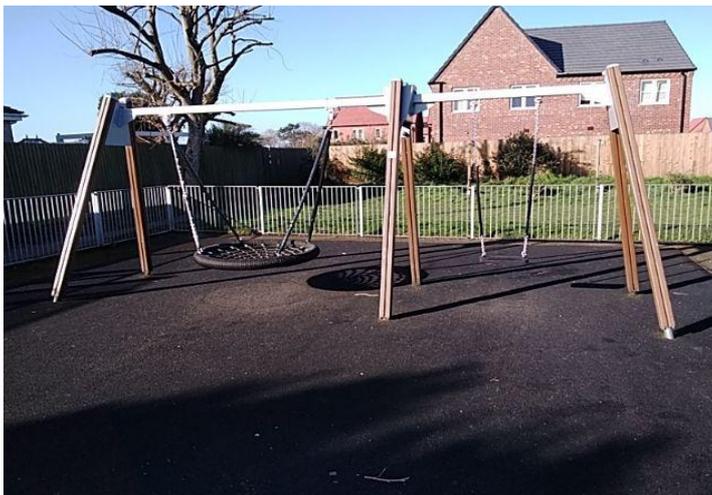
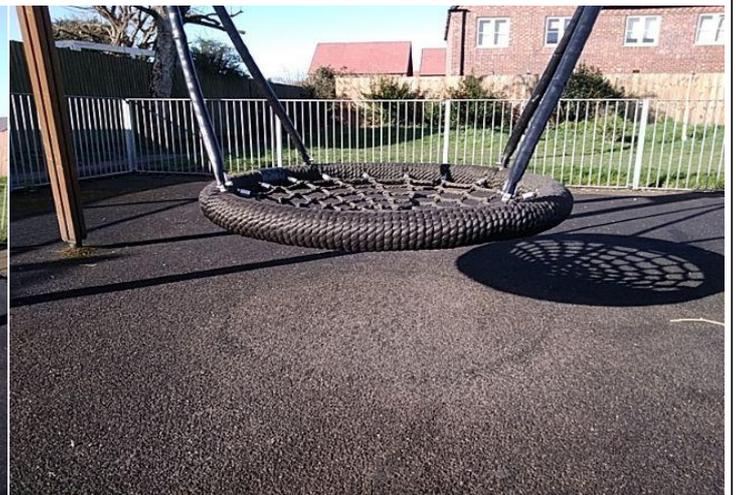
Item: Swings - 2 Bay 1 Flat 1 Basket
Manufacturer: Lappset UK Ltd

Finding: The seat clearance from finished surface level to the underside of the seat is too low when measured in its most onerous position and does not meet the requirements of BS EN 1176 Part 2

Action: Install seats to a minimum height of 400mm for Group Swing Seats

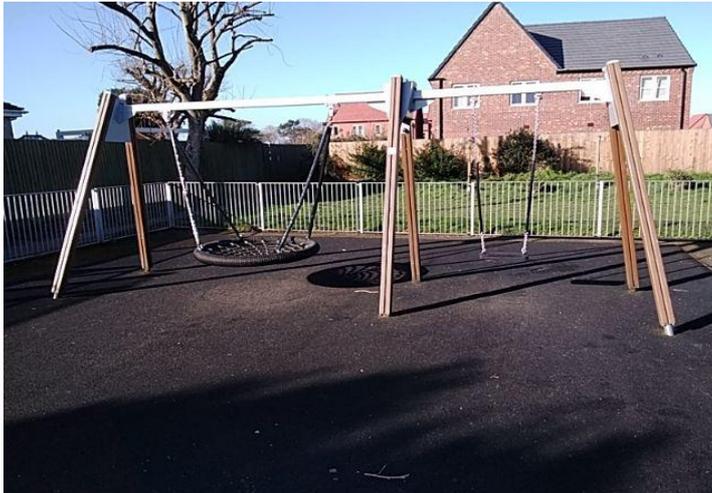
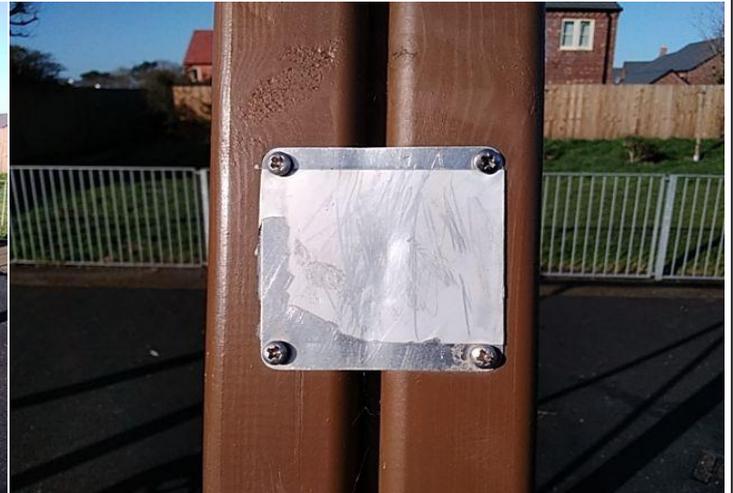
Item: Swings - 2 Bay 1 Flat 1 Basket
Manufacturer: Lappset UK Ltd

Finding: The identification label affixed to the equipment cannot be read

Action: Monitor

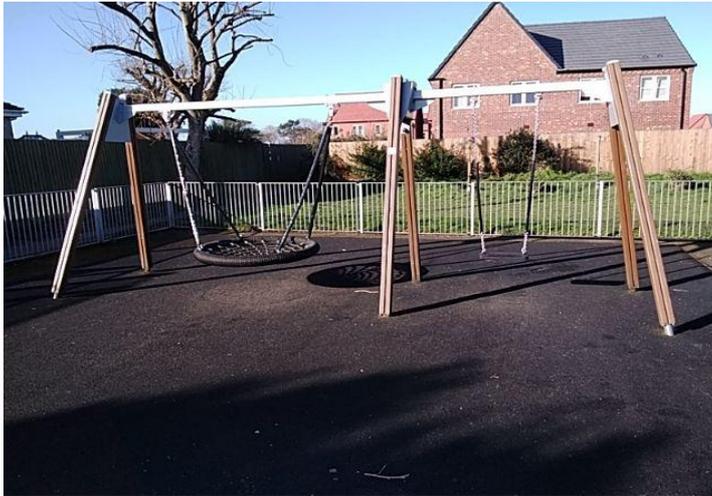
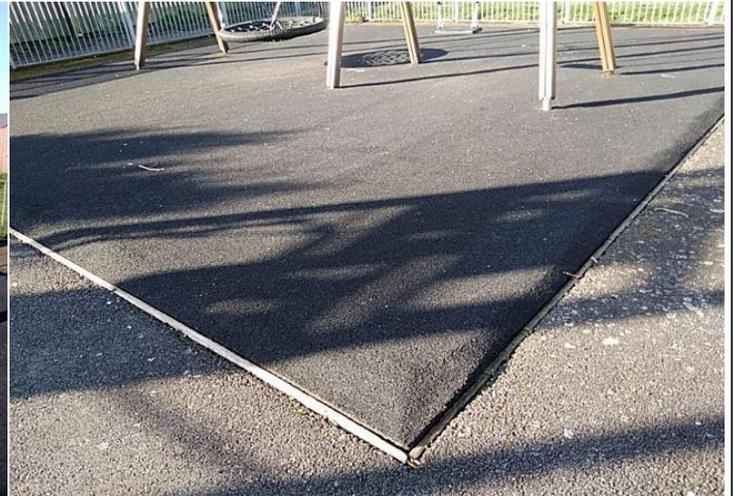
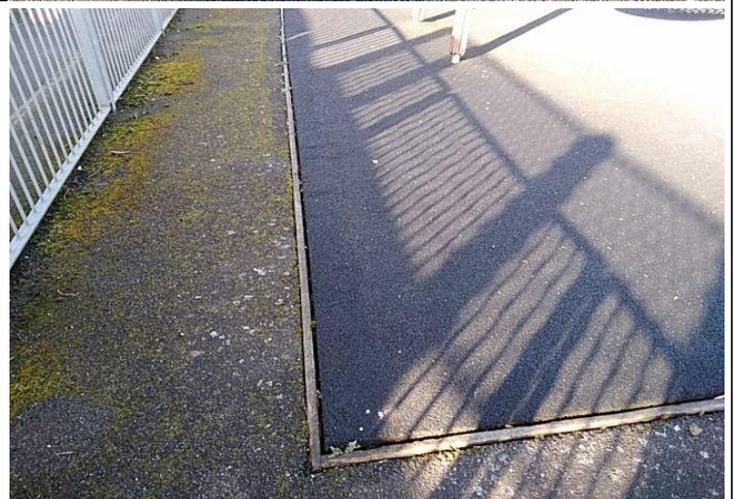
Item: Swings - 2 Bay 1 Flat 1 Basket
Manufacturer: Lappset UK Ltd

Finding: There are gaps opening between the surfacing and the edging surround or between the joints in the surfacing
Action: Monitor for any further deterioration and repair as required

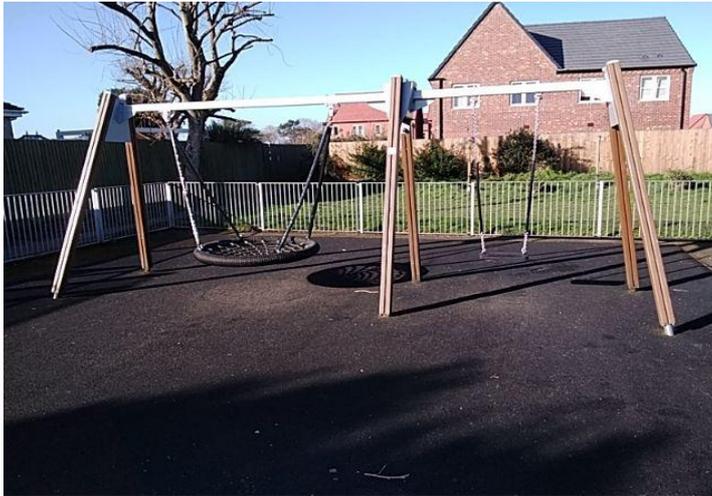
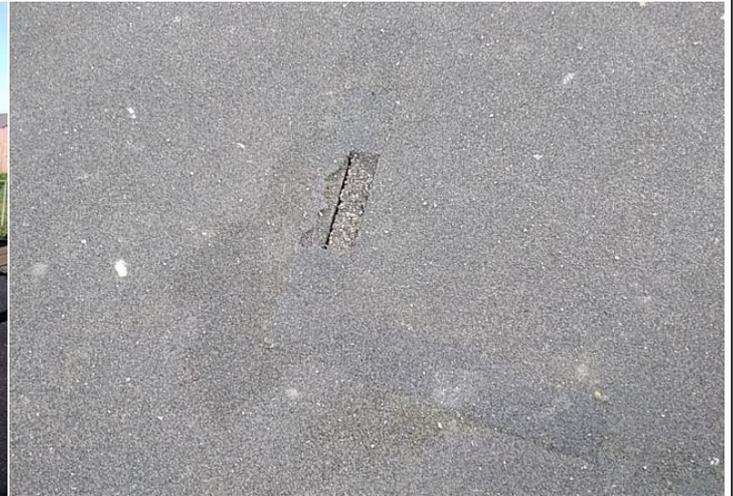
Item: Swings - 2 Bay 1 Flat 1 Basket
Manufacturer: Lappset UK Ltd

Finding: The wetpour playing surface is damaged

Action: Wicksteed are due to repair the surface shortly

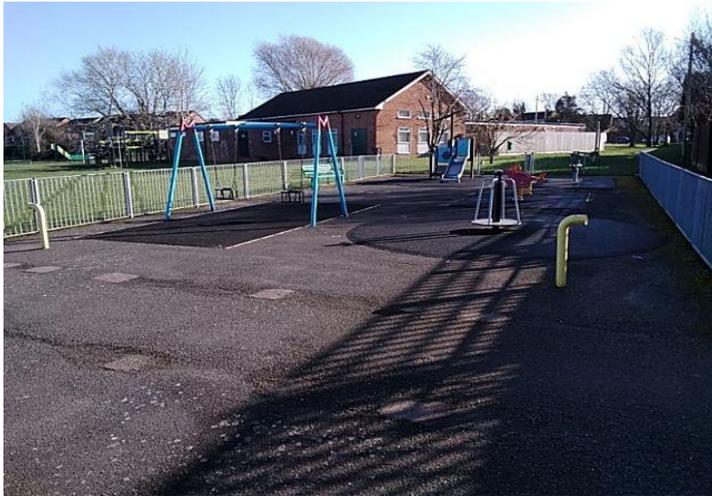
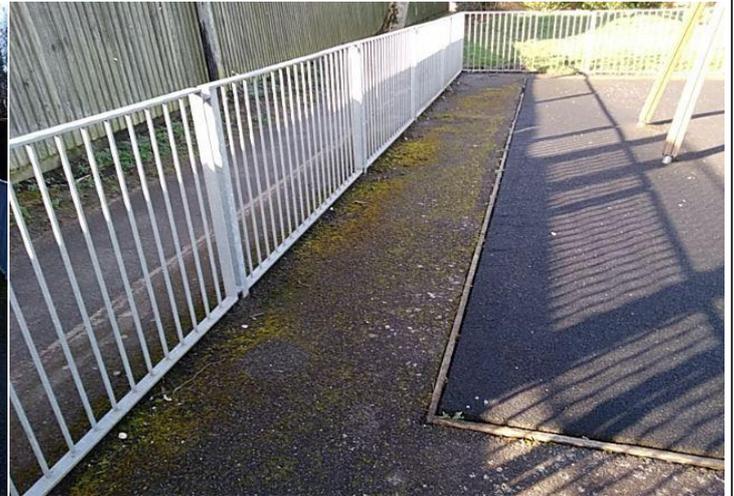
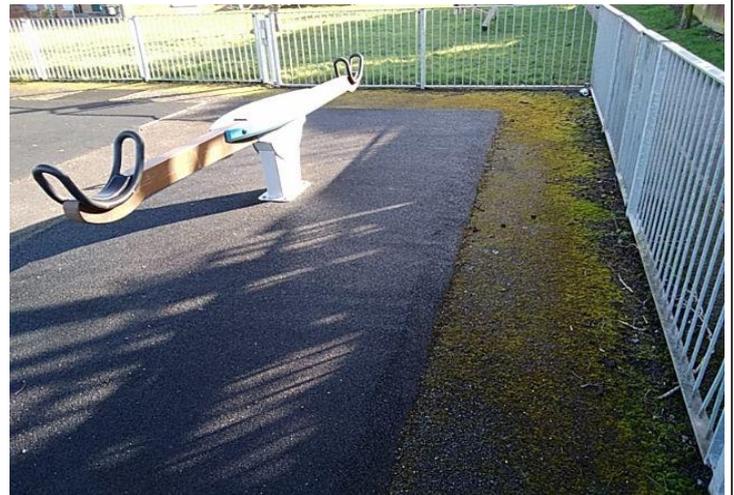
Item: Ancillary Items - Site General
Manufacturer: Unknown

Finding: There is algae or moss growth on the surface resulting in slippery conditions

Action: Clean and treat appropriately

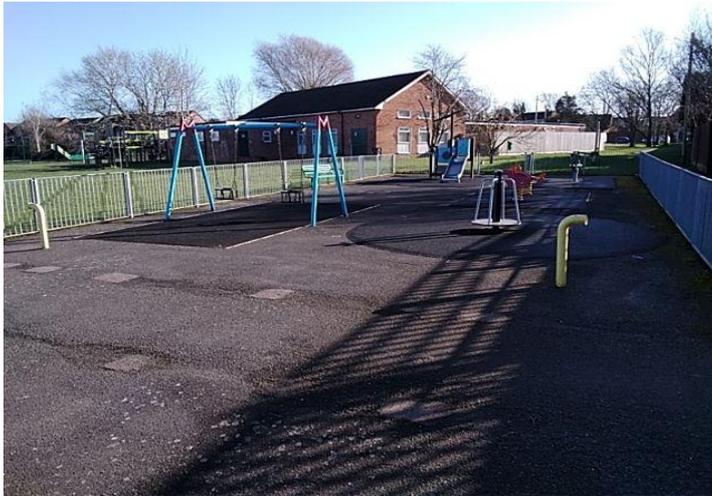
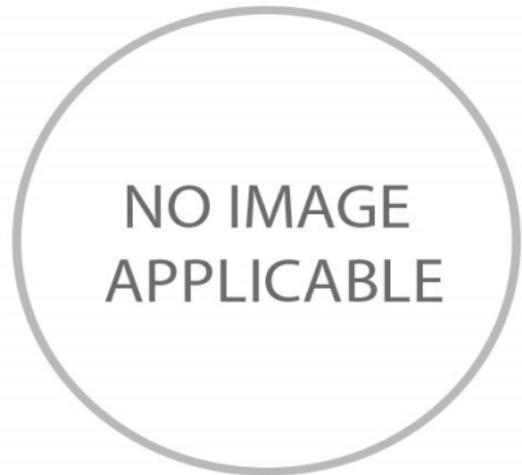
Item: Ancillary Items - Site General
Manufacturer: Unknown

Finding: It is recommended that signage, with information including the site address, contact information for maintenance issues and emergency contact details are provided for the facility

Action: Provide in accordance with the recommendations
