# WALLED KITCHEN GARDEN, WINSTANLEY HALL, WINSTANLEY, WIGAN

# Historic Building Recording

Matrix Archaeology

Report No. 2001-07

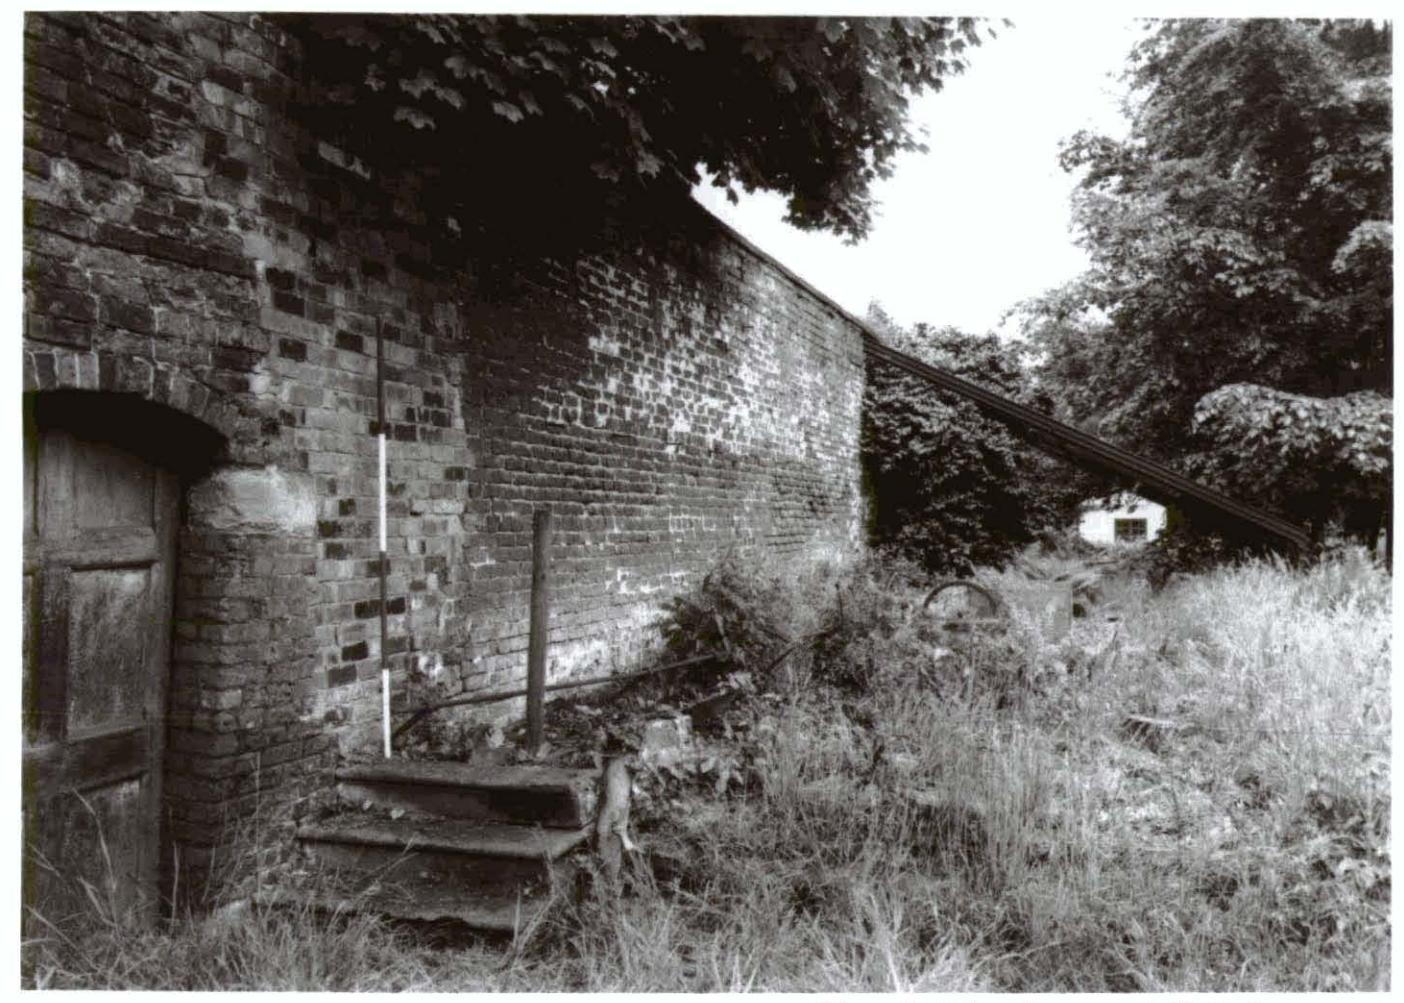
Plate 1. Glasshouses 1 & 2 from west

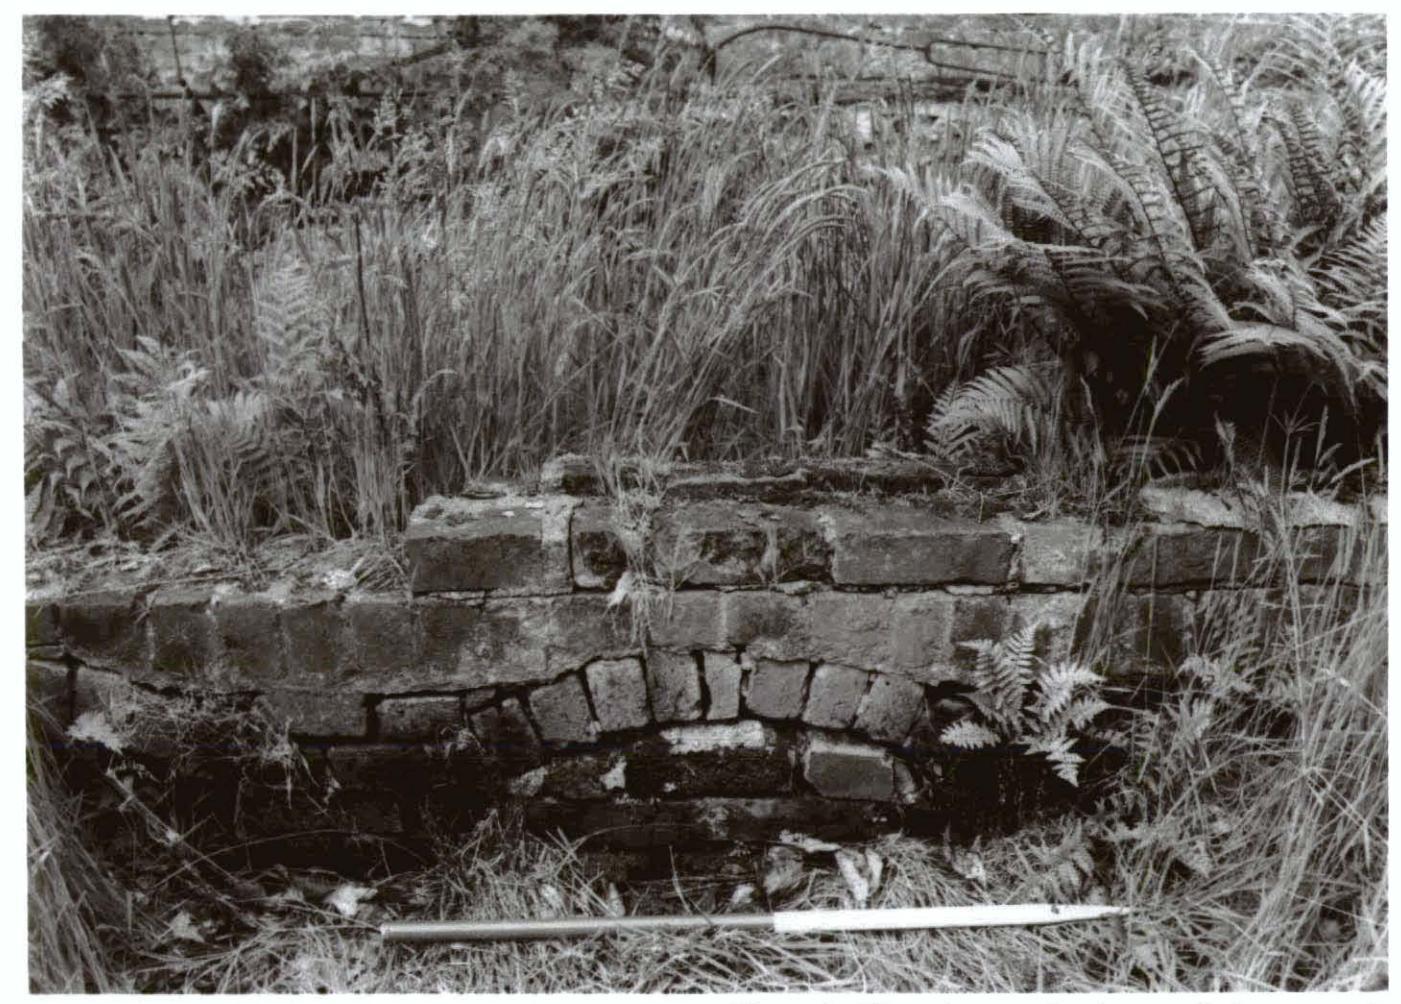
The west and south walls of Building 1 were of handmade brick within a white lime mortar, and the south wall was punctuated by ten segmental brick 'vine arches', which allowed vines growing within the building to be rooted outside (**Plate 2**). The eastern limit of the building was defined by a broad footing of handmade brick with a white lime mortar, which coincided with the westernmost element of the cast-iron frame of Building 2.

Plate 2. Glasshouse 1, vine arch from south

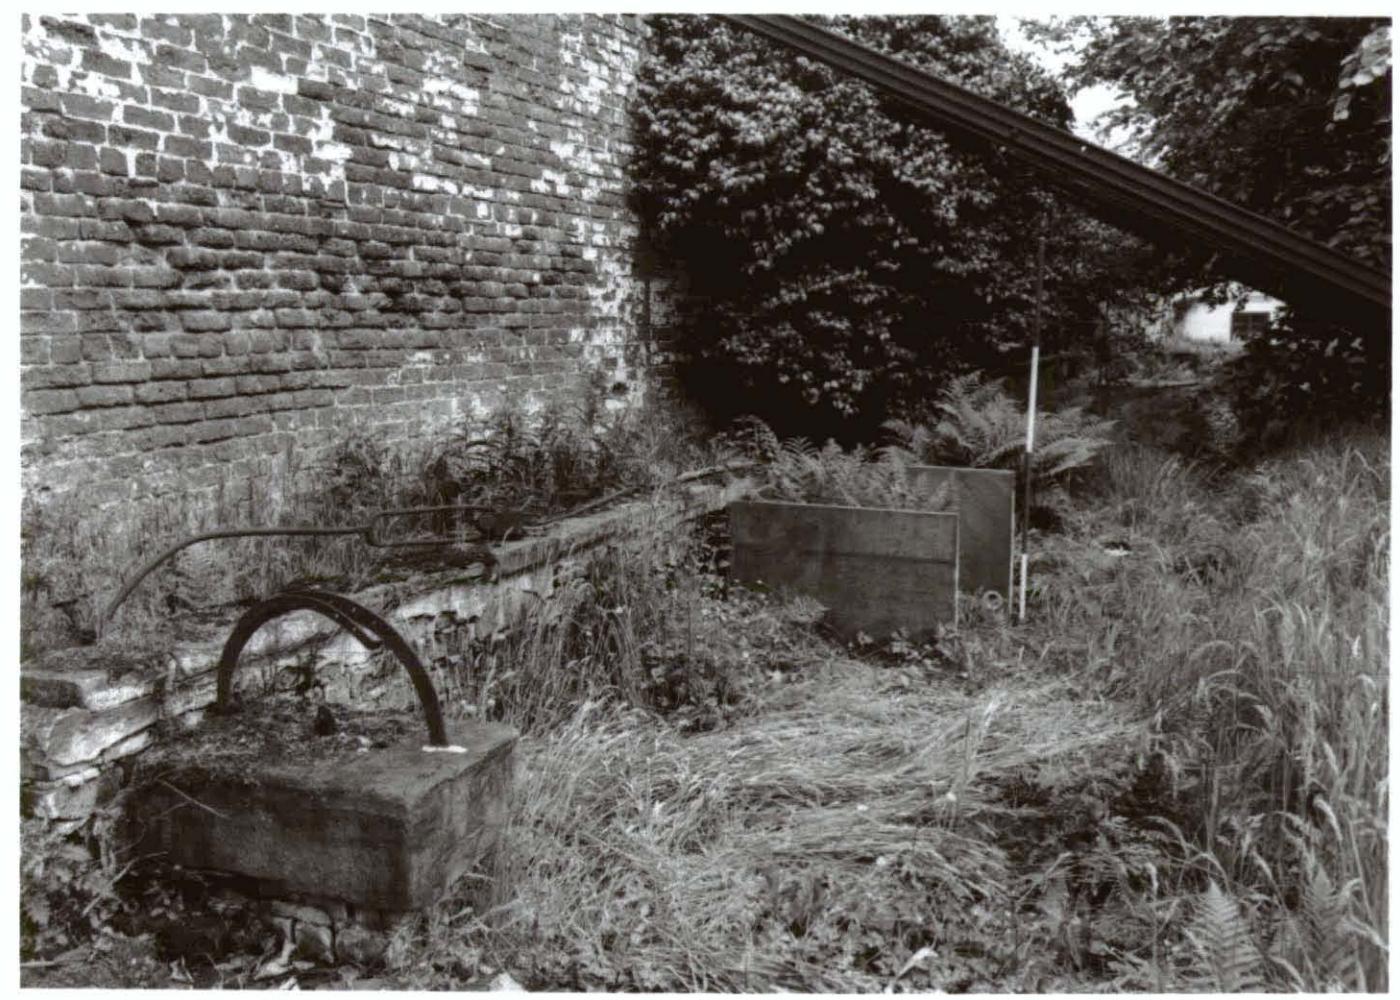
Internal features included a large tank of Welsh slate slabs, and just to the west of this was a gritstone bed on a brick footing, which supported part of a ratchet mechanism presumably used for regulating ventilation of the glasshouse (**Plate 3**). Displaced wrought iron rods, connected to a worm drive and mitred cog mechanism, originally bracketed to a wall, lay on the floor (**Plate 4**). Immediately to the north of these features was a low wall of handmade brick, with a sandstone coping; between this and the heated wall was presumably a passage accessed from the steps at the north-western corner of the building. The only evidence for a roof structure was a row of large joist sockets at a high level in the heated wall, at horizontal intervals of *circa* 2m. There is no evidence to suggest whether the joists or beams were of timber or cast iron, although it is most likely that their pitch matched those of Building 2.

Plate 3. Glasshouse 1, internal features from south-west

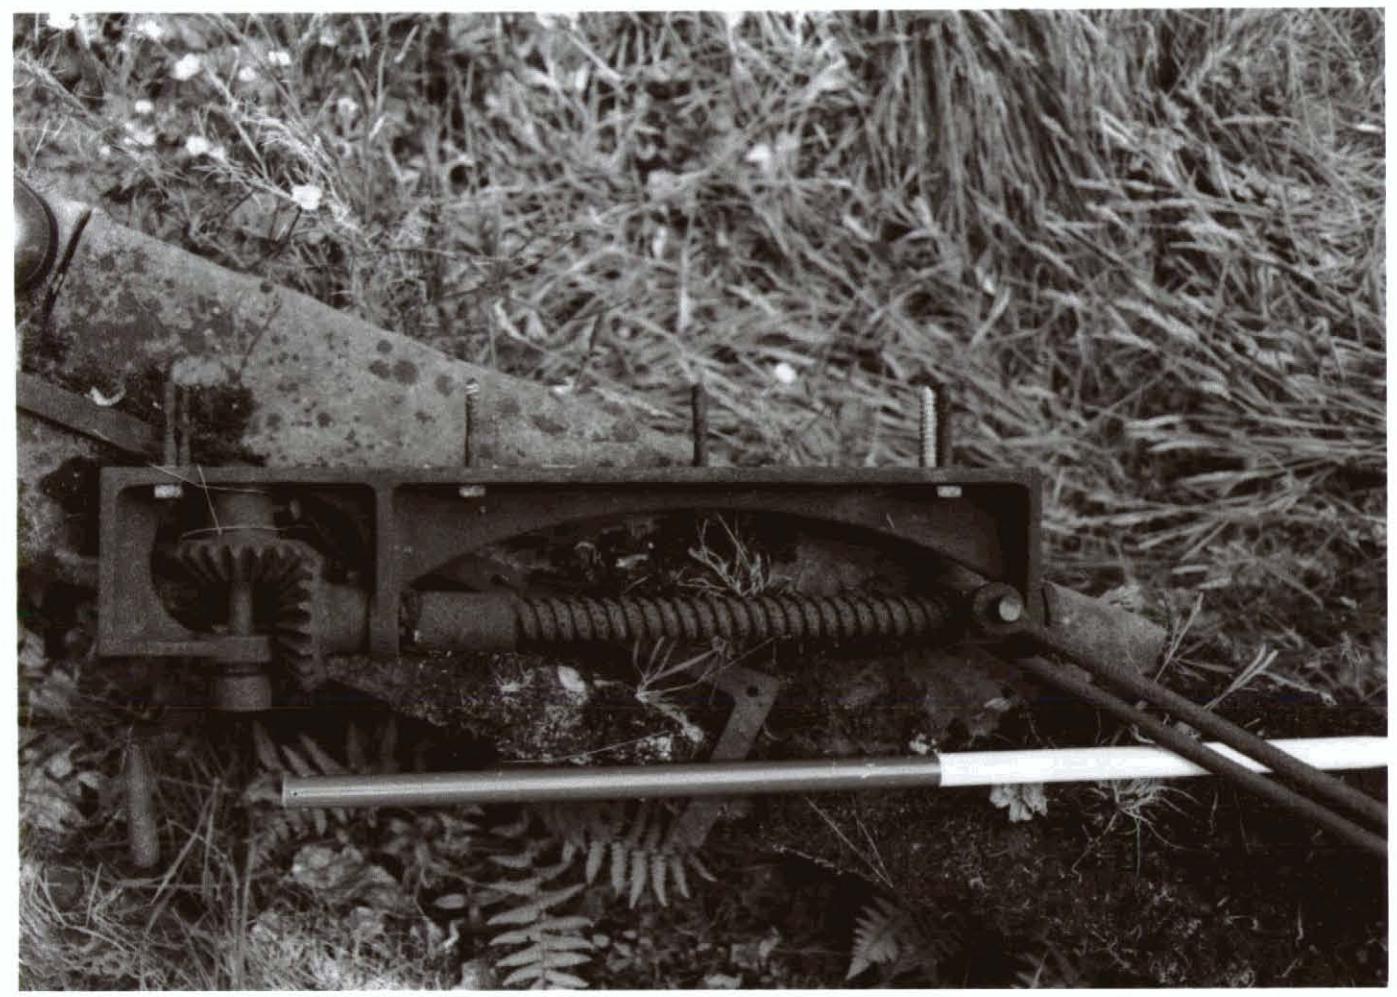
Plate 4. Glasshouse 1, displaced ventilation mechanism

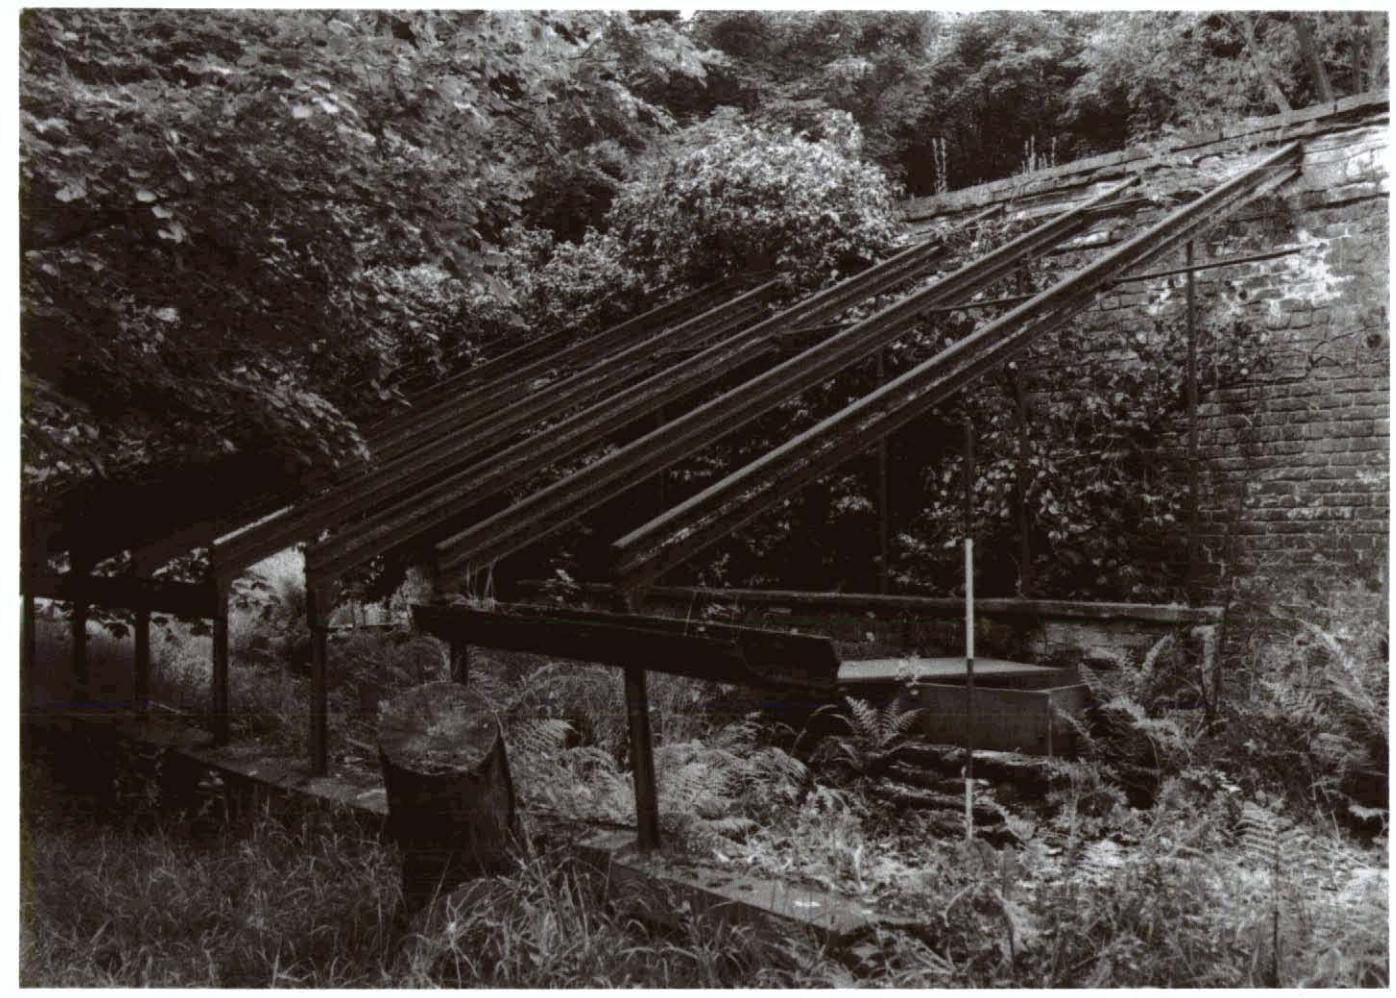
The cast-iron framework of this structure was the most impressive survival of the whole walled garden, and it was located centrally to the south face of the north wall. It was contiguous with Buildings 1 and 3, and yet the superstructure had survived, unlike the other two, possibly because it is difficult to reuse cast iron.

Plate 5. Glasshouse 2, from south-east

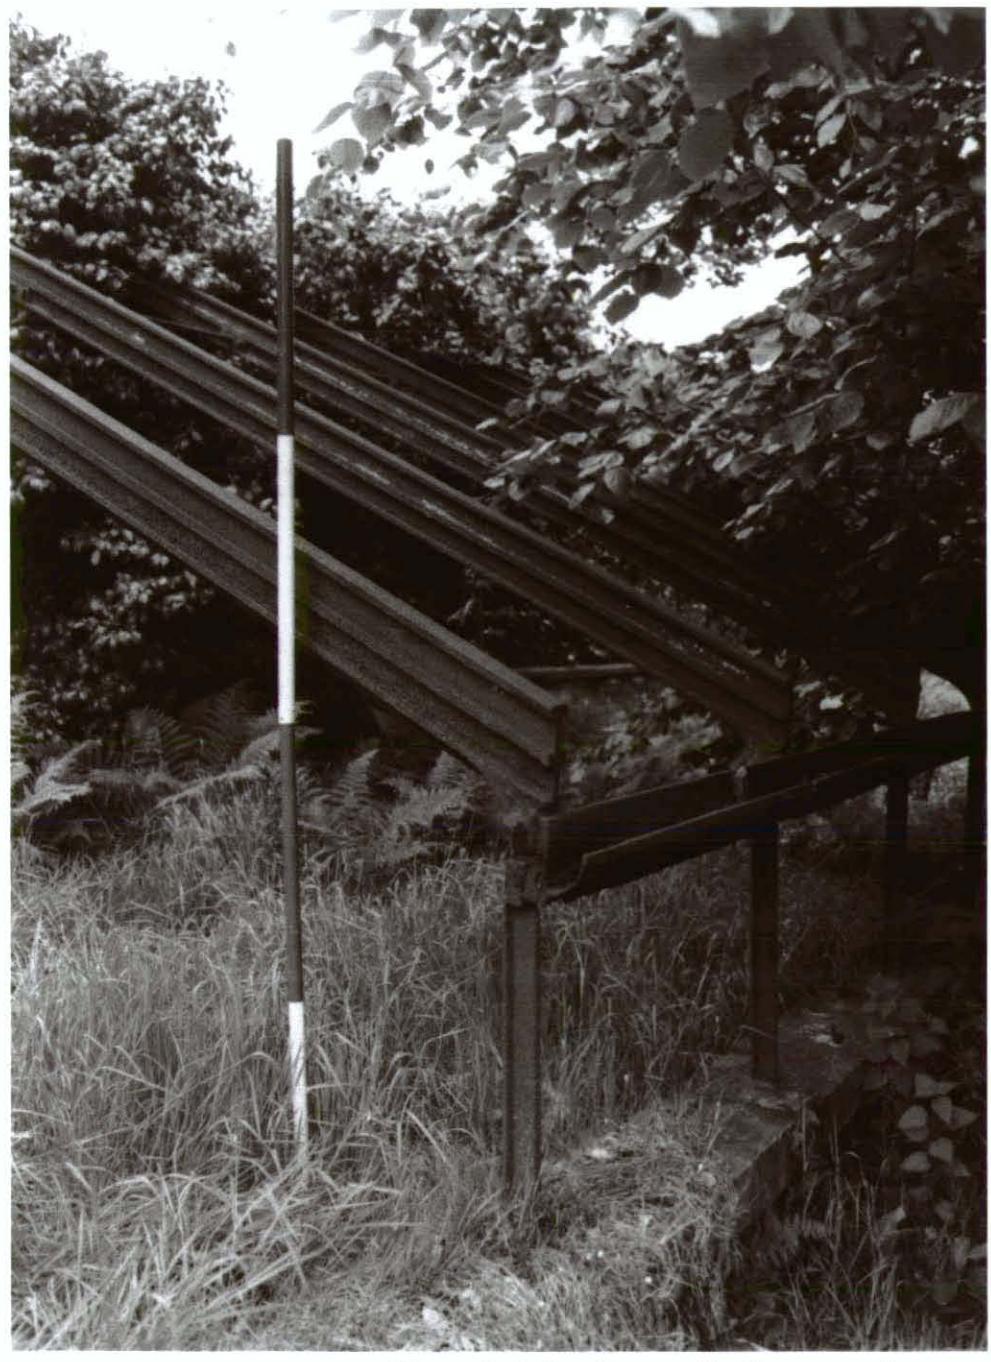
Plate 6. Glasshouse 2, from south-west

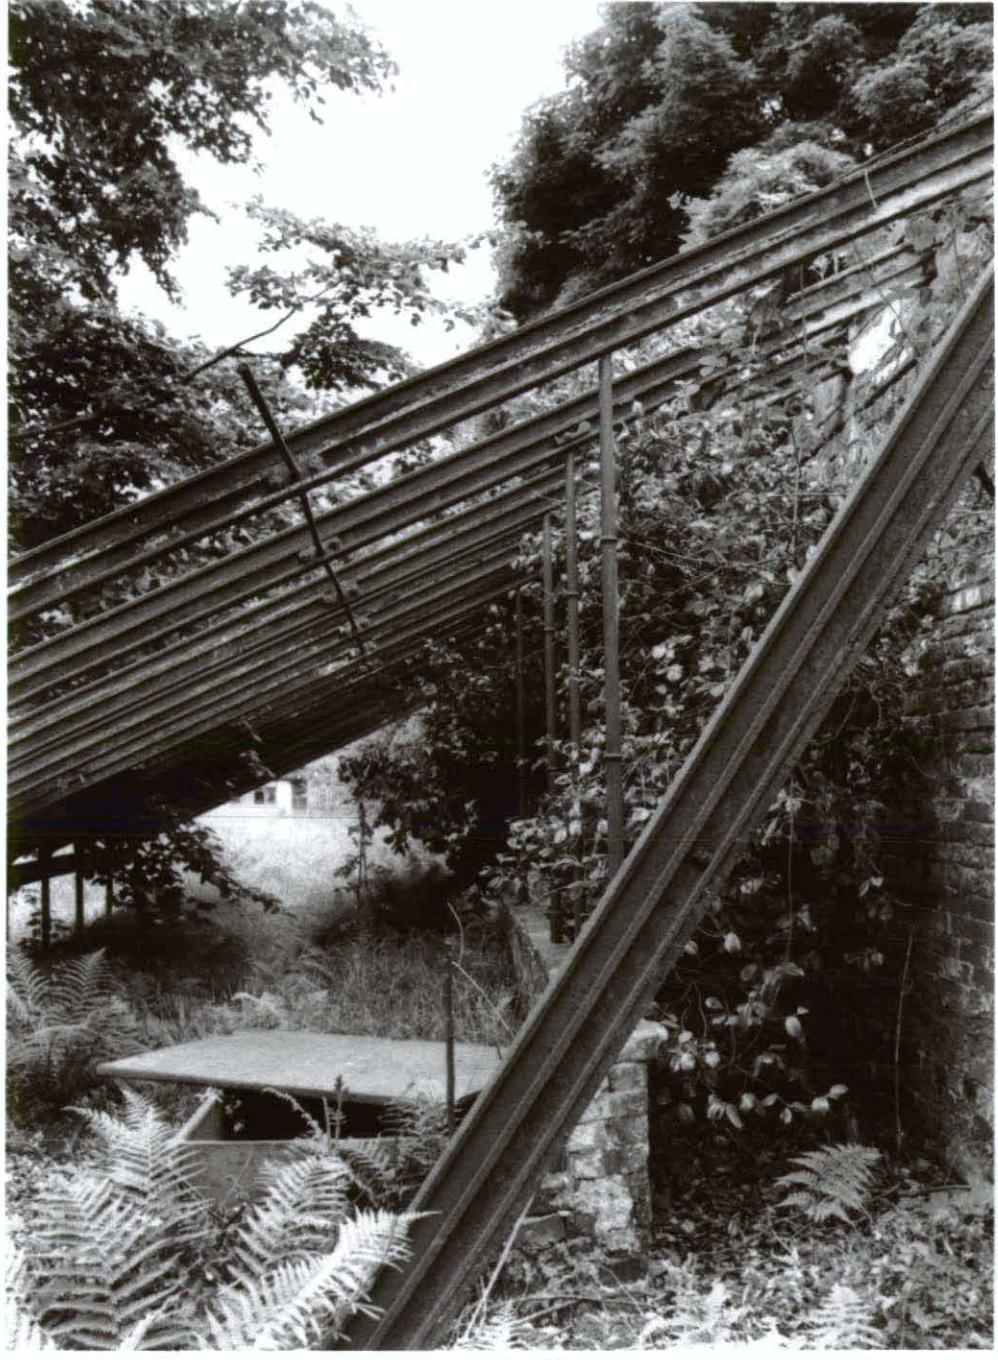
Plate 7. Glasshouse 2, detail from east

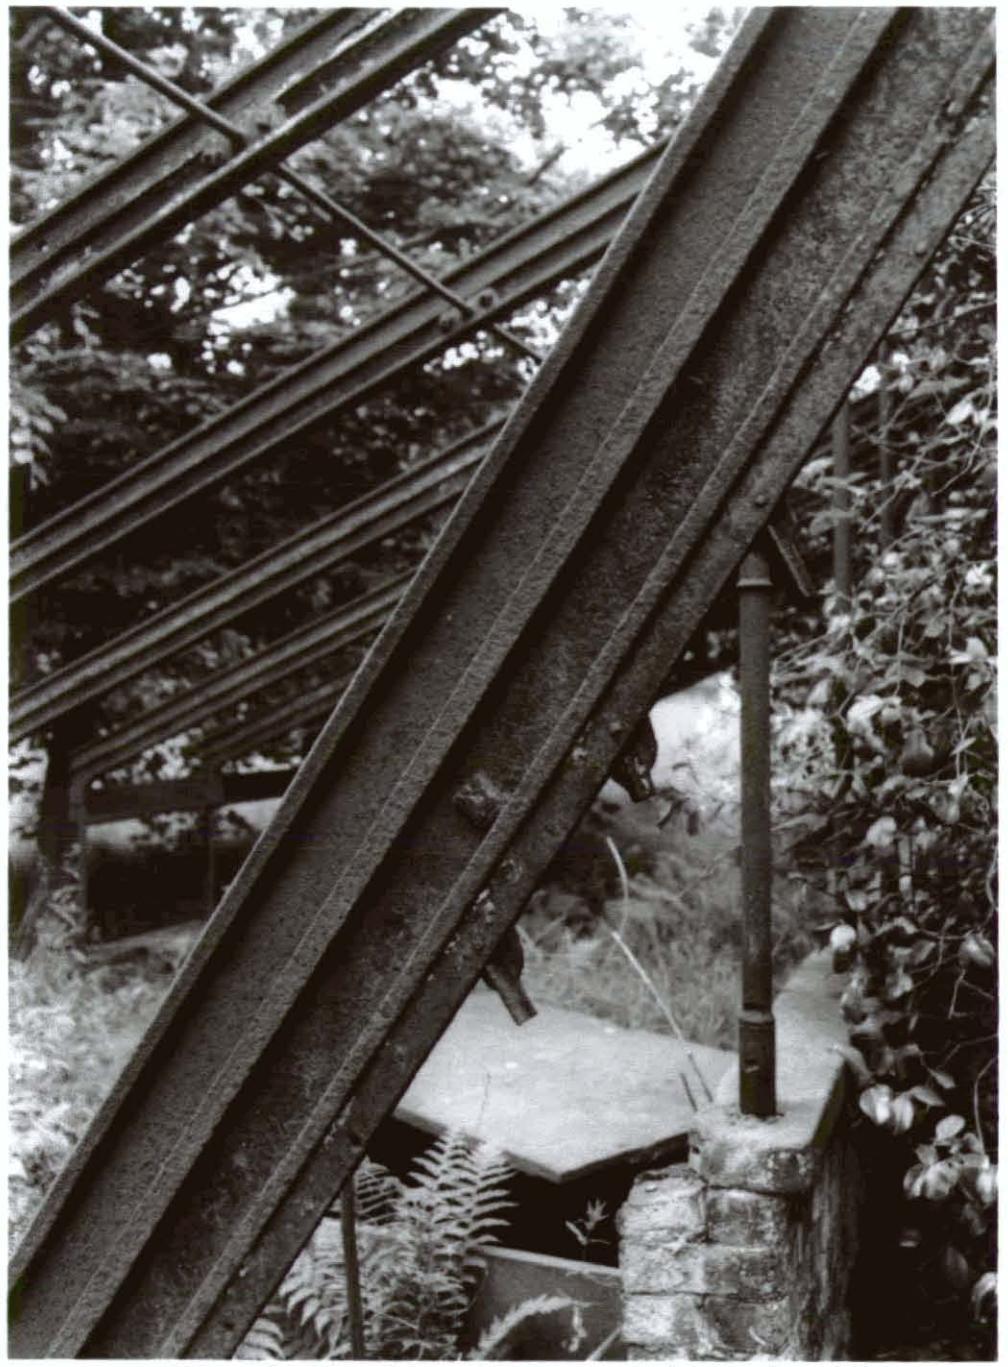
The roof comprised twelve cast iron beams, which spanned between the heated wall and the south wall of the structure. The profile of these beams was that of an I-section, with an additional flange located halfway up the web (elevation D-D1, Figure 16). This latter feature still carried patches of putty, suggesting that it's purpose was to support both the glazing, and the timber glazing bars, one of which still survived *in situ* at a high level. The easternmost beam had evidently been cut towards its south end, and was partially displaced (Plate 7). The section of this was differentiated from the other beams by the addition of a thin web on the eastern (external) portion of the soffit (inset, Figure 16), to which a series of thin cast iron transoms were

Plate 8. Glasshouse 2, cast-iron beam detail from east

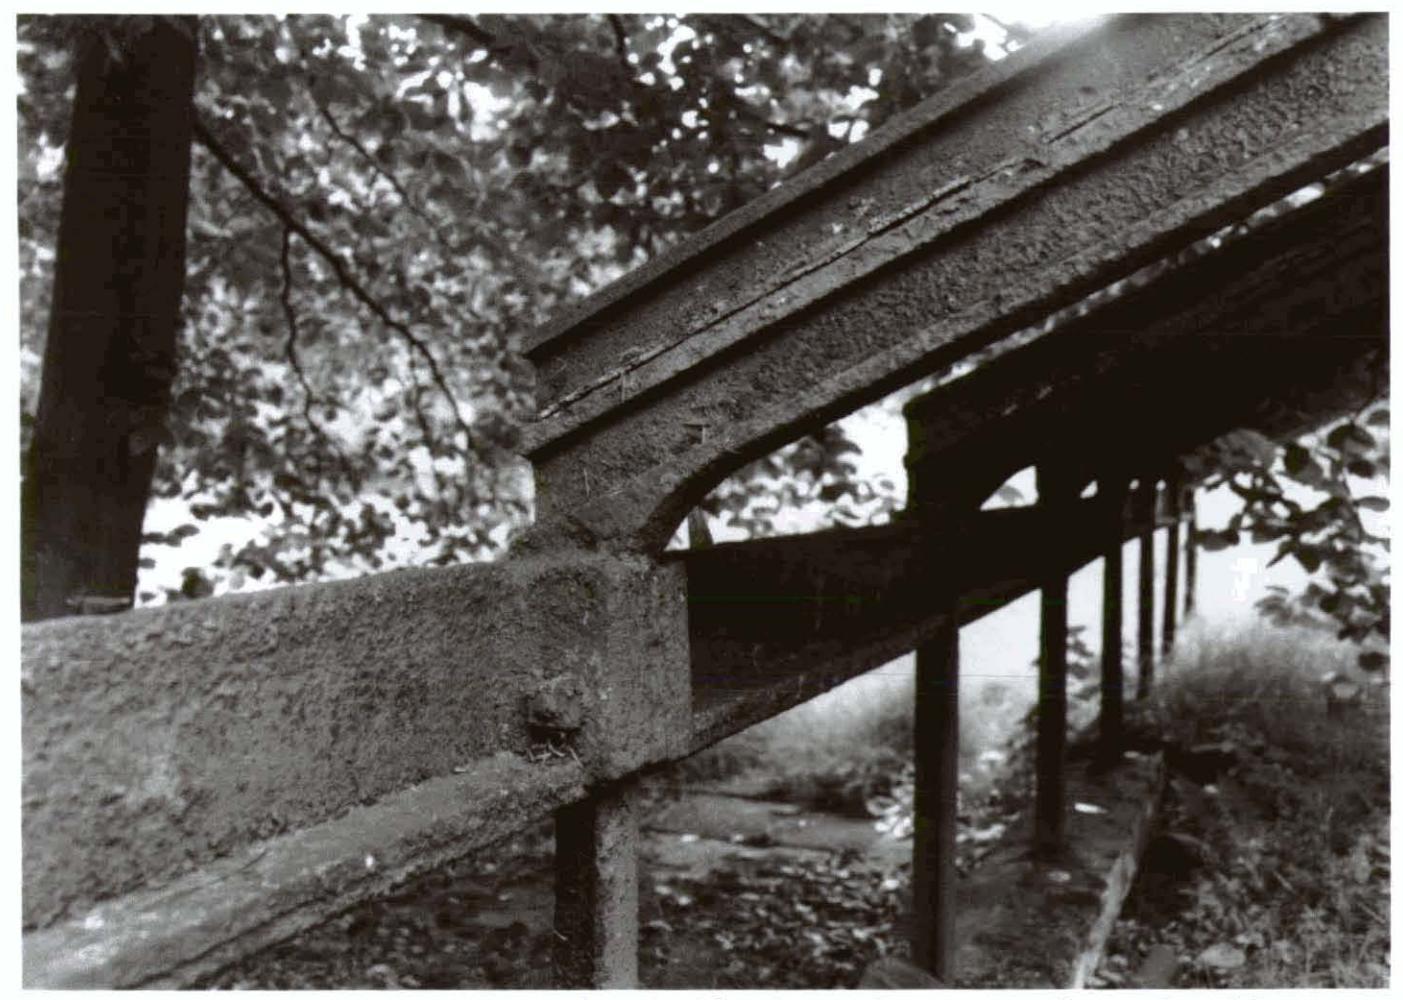
Plate 9. Glasshouse 2, cast-iron frame detail from east

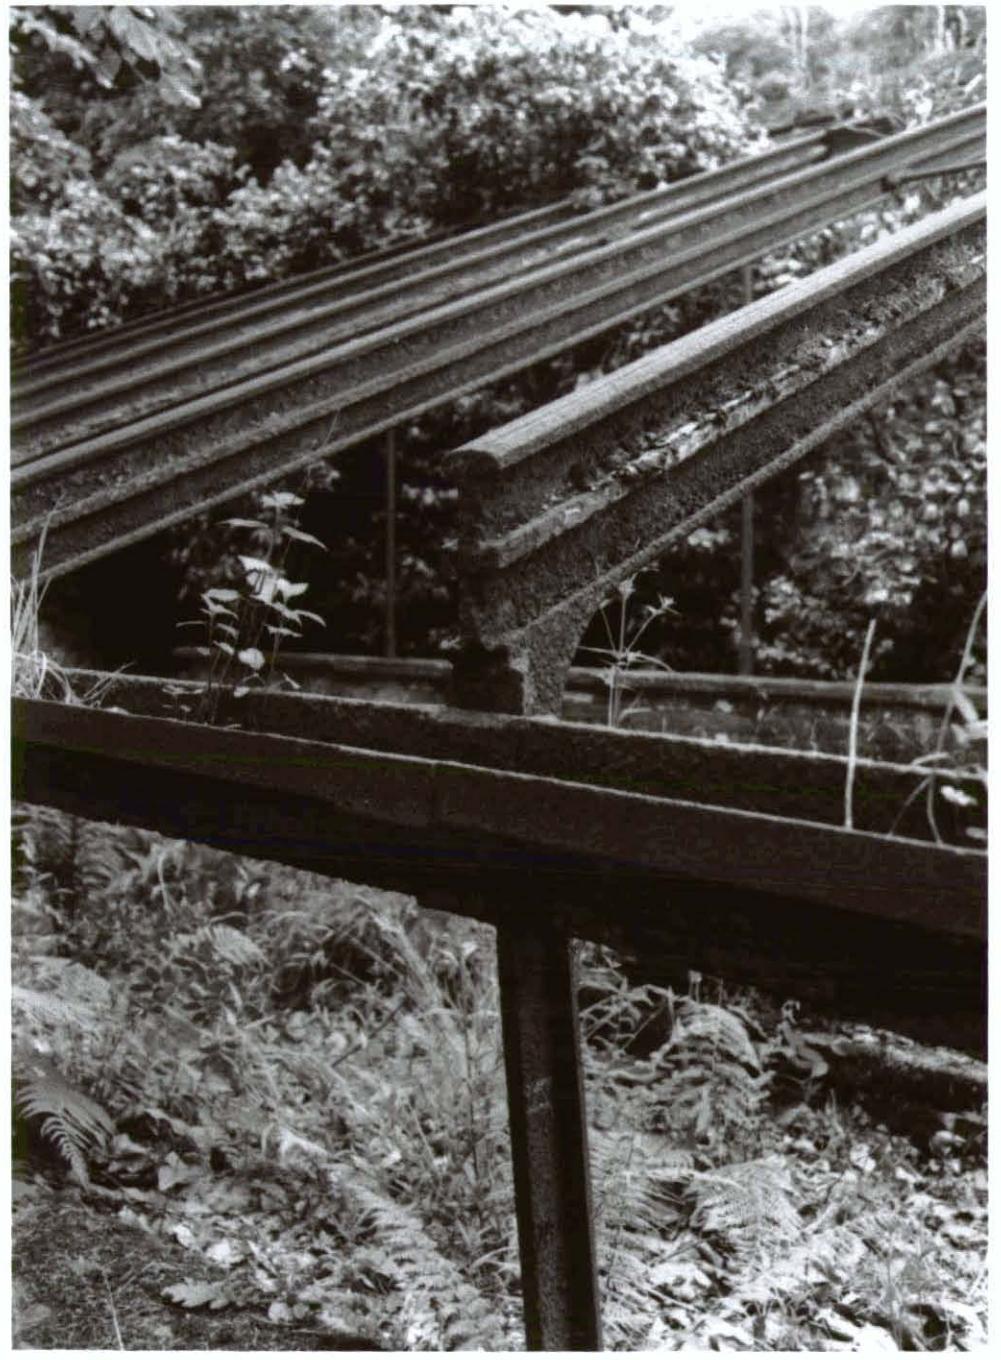
Plate 10. Glasshouse 2, cast-iron frame detail from south

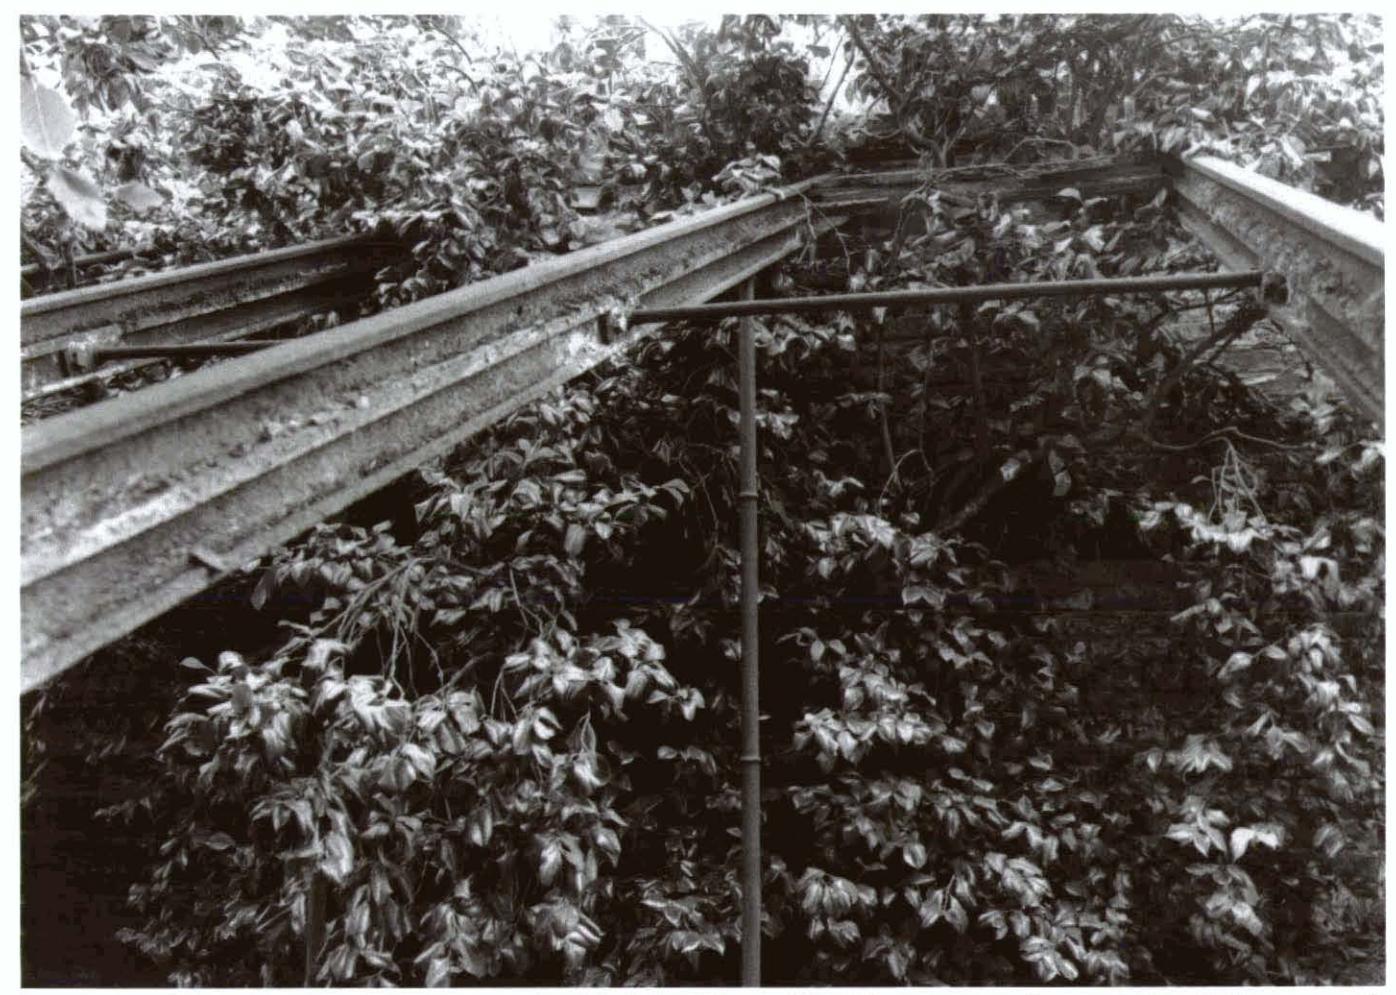
About halfway along the beams were a series of wrought iron tie-rods, which would have prevented any lateral extension, or 'spreading' of the structure (**Plate 11**). Additionally, and standing off the 'passage wall', a series of slender, circular-section cast-iron columns rose to meet the beam soffits (**Plate 7**). These were not substantial enough to retain a structural capacity, and were more likely to be decorative. The upper end of the beams were sat upon a continuous series of sandstone ashlar bearing blocks, whilst the lower beam ends were carried upon vertical cast iron T-sections which were themselves set within a sandstone coping which capped off the southern wall of the building (**Plate 9**). At eaves level, the flanged and bolted ends of a cast iron L-section was affixed between the T-sections, and this carried a cast iron gutter on the exterior (**Plate 10**). The southern wall was comprised of handmade brickwork piers, 0.35m in width, between which were rectangular apertures, which must have functioned as the 'vine arches' described within Building 1.

Plate 11. Glasshouse 2, roof detail from south

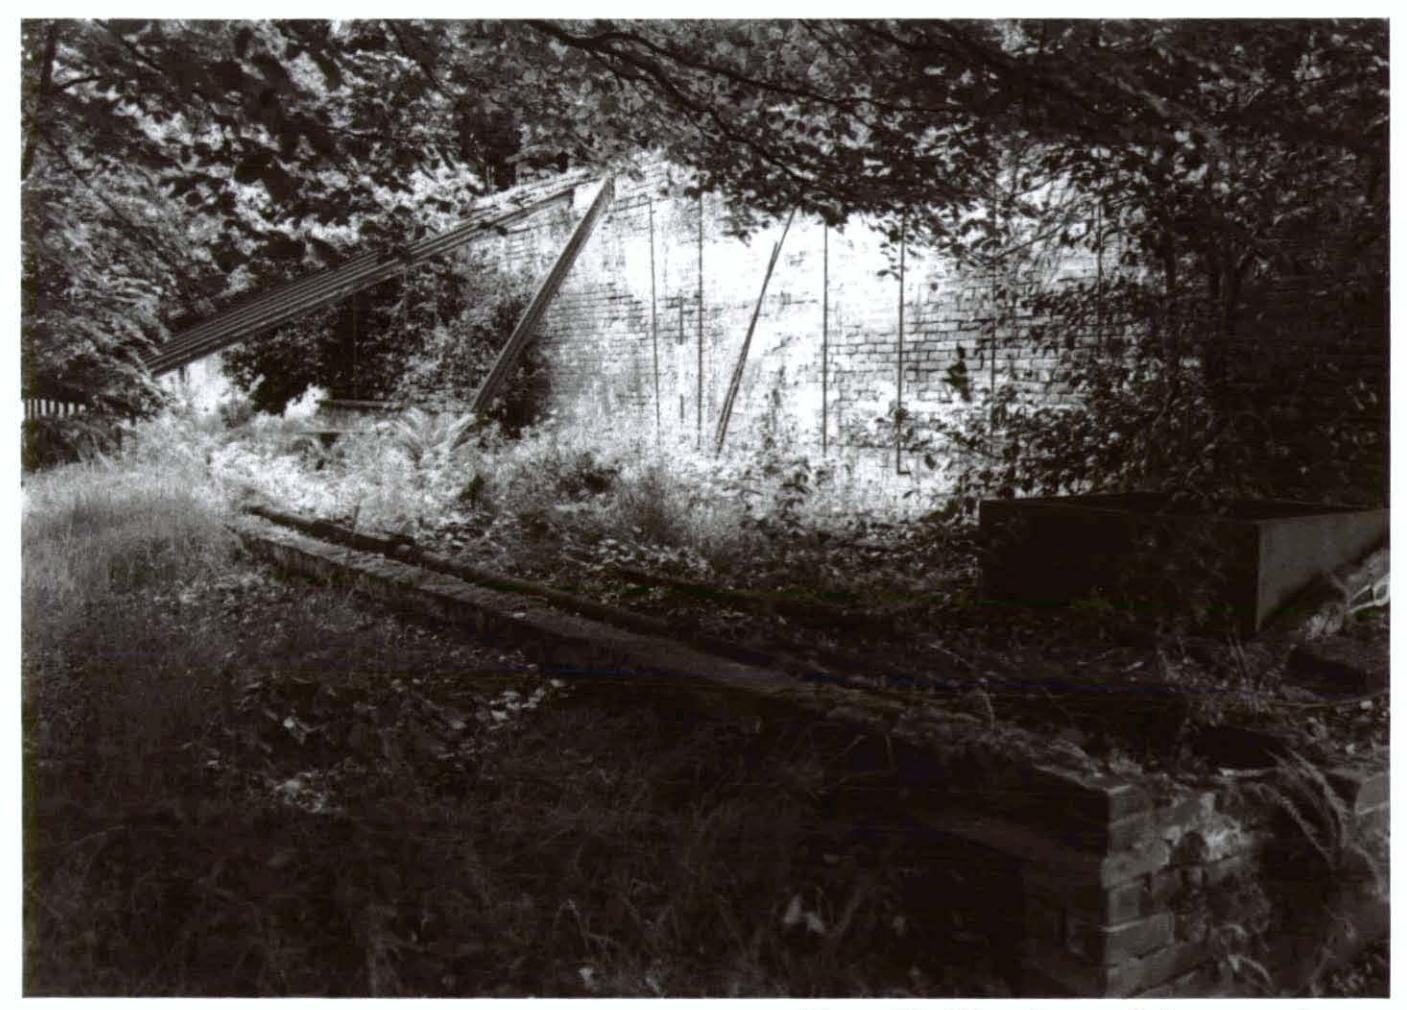
This building comprised the easternmost component of the earliest glasshouse and, as for Building 1, the roof structure did not survive. The south and east walls were of machine-made brick, with rectangular cavities in the south wall to provide for the 'vine arch' function as described above (**Plate 12**). At the east end of the building, a slate tank survived intact, contained within the remains of a handmade brickwork 'frame' structure (**Figure 15**). The tank measured internally 1.37m (4ft 6in), by 1.06m (3ft 6in), with a depth in excess of 0.85m. The shorter sides were tenoned with cement into trenches cut into the longer sides, and it was evident that the tanks were prefabricated offsite because the joints were matched by duplicating numbers of small holes drilled into the upper edges of the slabs, similar to the carpenters' marks which have been recorded for assembly of roof trusses. The slabs were bound together by wrought iron tie-rods, bolted between the longer faces. On the east face of the tank, at a depth of 0.65m, was a circular outlet hole, which could only be seen on the inside.

Plate 12. Glasshouse 3 from south-east

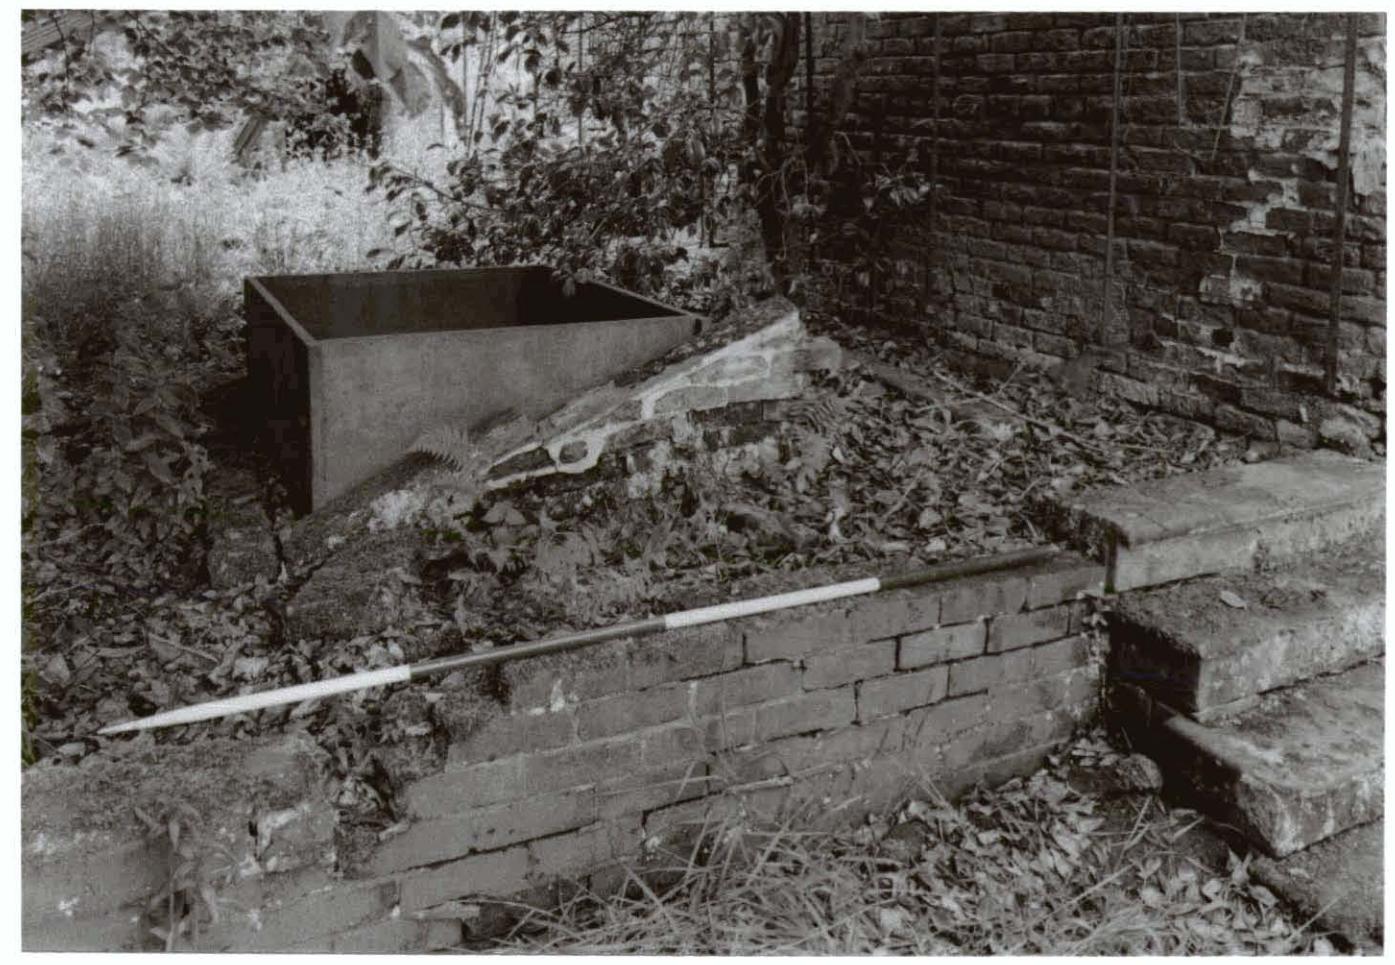
As mentioned above, a 100mm cast-iron pipe extended along the inside of the south wall, this carried two rectangular 'evaporating pans', although the pipe was fractured at both ends, and it was not possible to determine where the water supply had originated. The heated wall face within this building still held cast iron brackets for fixing of wires along the wall face at 0.2m vertical intervals, presumably for training of fruit trees. As drawn wire was a mid. nineteenth century development, these features must post-date that period.

Plate 13. Glasshouse 3, detail from south-east

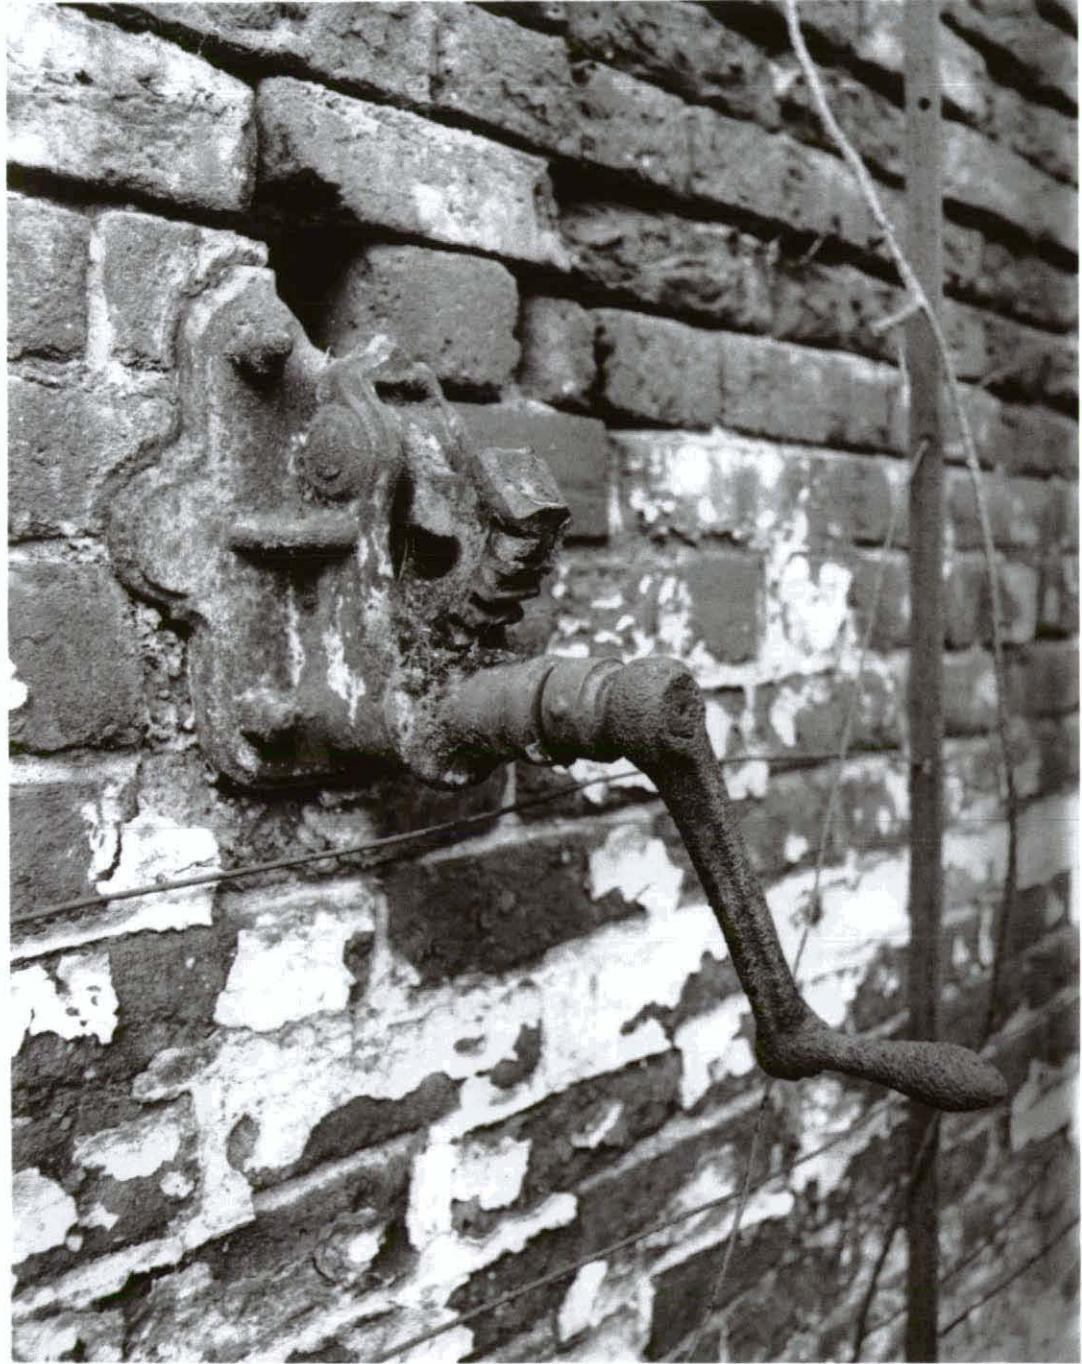
With regard to evidence for the roof structure, only a single beam socket could be identified in the heated wall, presumably the remainder being obscured. This beam-end had been mortared in place, and following demolition of the roof, the profile of the east face of the beam end was retained as an imprint in the mortar within the socket (inset, Figure 15). This suggested that it comprised a cast-iron T-section, with an extravagantly moulded fillet integral to the angle between web and flange. Such a form was certainly of early 19th century date, and was very different from the 'functional' profile of the roof beams recorded in Building 2. Also related to the roof was a cast iron mechanism which had been bolted to the heated wall, comprising a winding handle which turned a worm drive, which itself engaged and rotated a segment of a cogged wheel, which in turn must have created a reciprocal motion on a rod which activated ventilation of roof panels (Plate 14).

Plate 14. Glasshouse 3, worm drive for ventilation

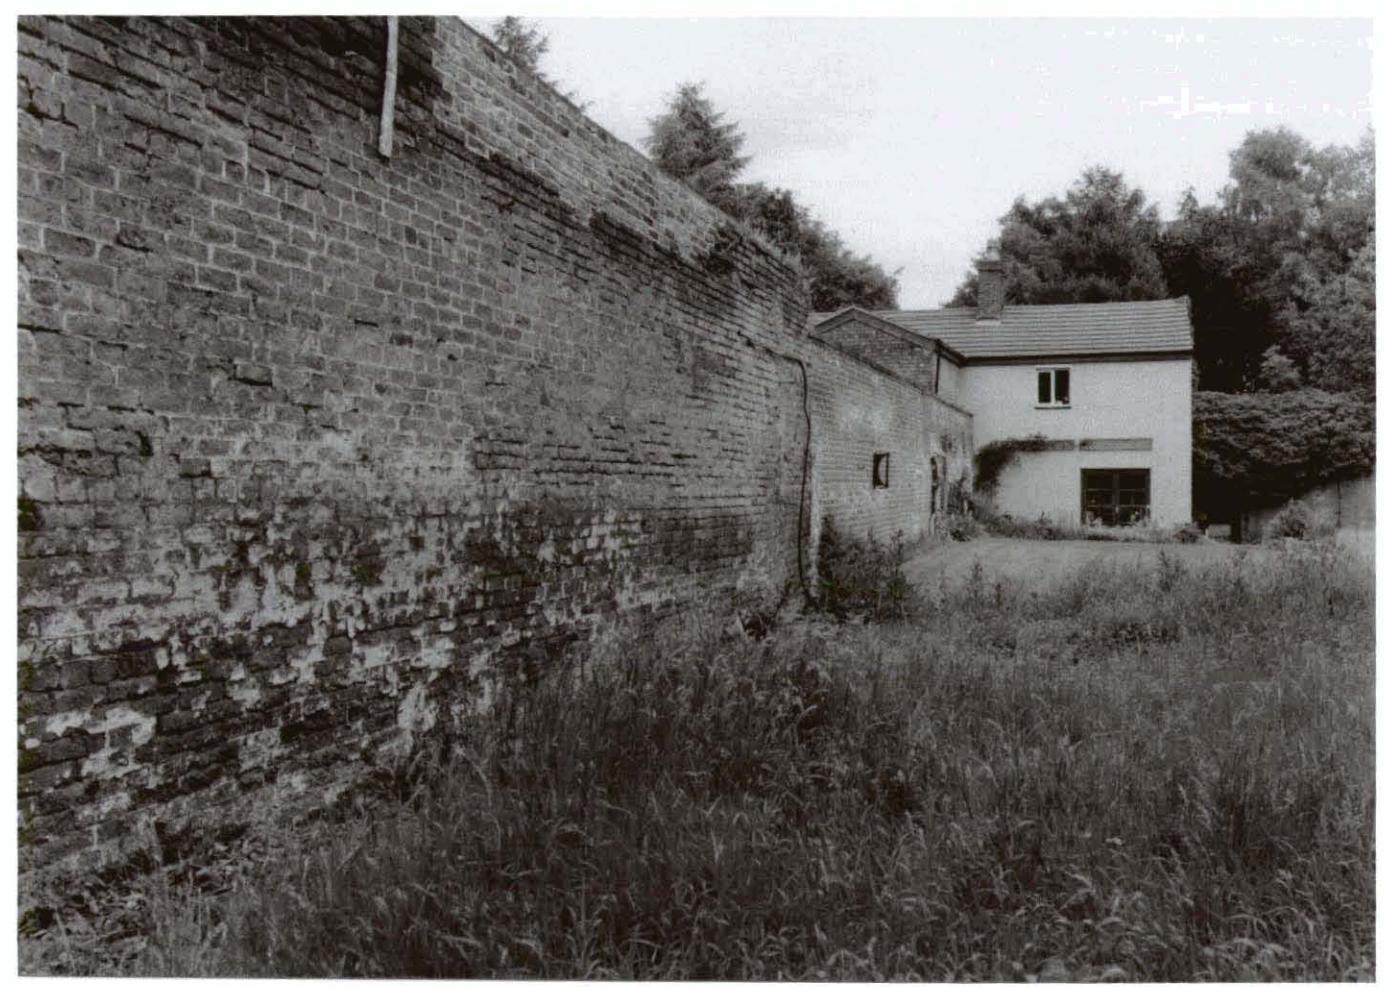
This building was probably in existence before 1820, and formed part of a group with Buildings 10 and 11. It was demolished sometime between 1928 and 1938, and the only physical evidence for this structure comprises a reduction in height of the heated wall, from 3.75m to 3.0m, at the projected eastern end of the building, and a short section of a masonry footing immediately beneath here. At the north-west corner of the building 'footprint', there were holes cut into the heated wall indicative of where the west wall had been tied in. Also at this corner, at the base of the heated wall, could be seen the segmental brick arch of what appeared to be a cleaning hole (Type A?), or alternatively a furnace. The low level, and occurrence on the south face of the wall, may suggest the latter explanation.

Plate 15. Site of glasshouses 9 & 15, and head gardener's house
