# WALLED KITCHEN GARDEN, WINSTANLEY HALL, WINSTANLEY, WIGAN

# Historic Building Recording

Matrix Archaeology

Report No. 2001-07

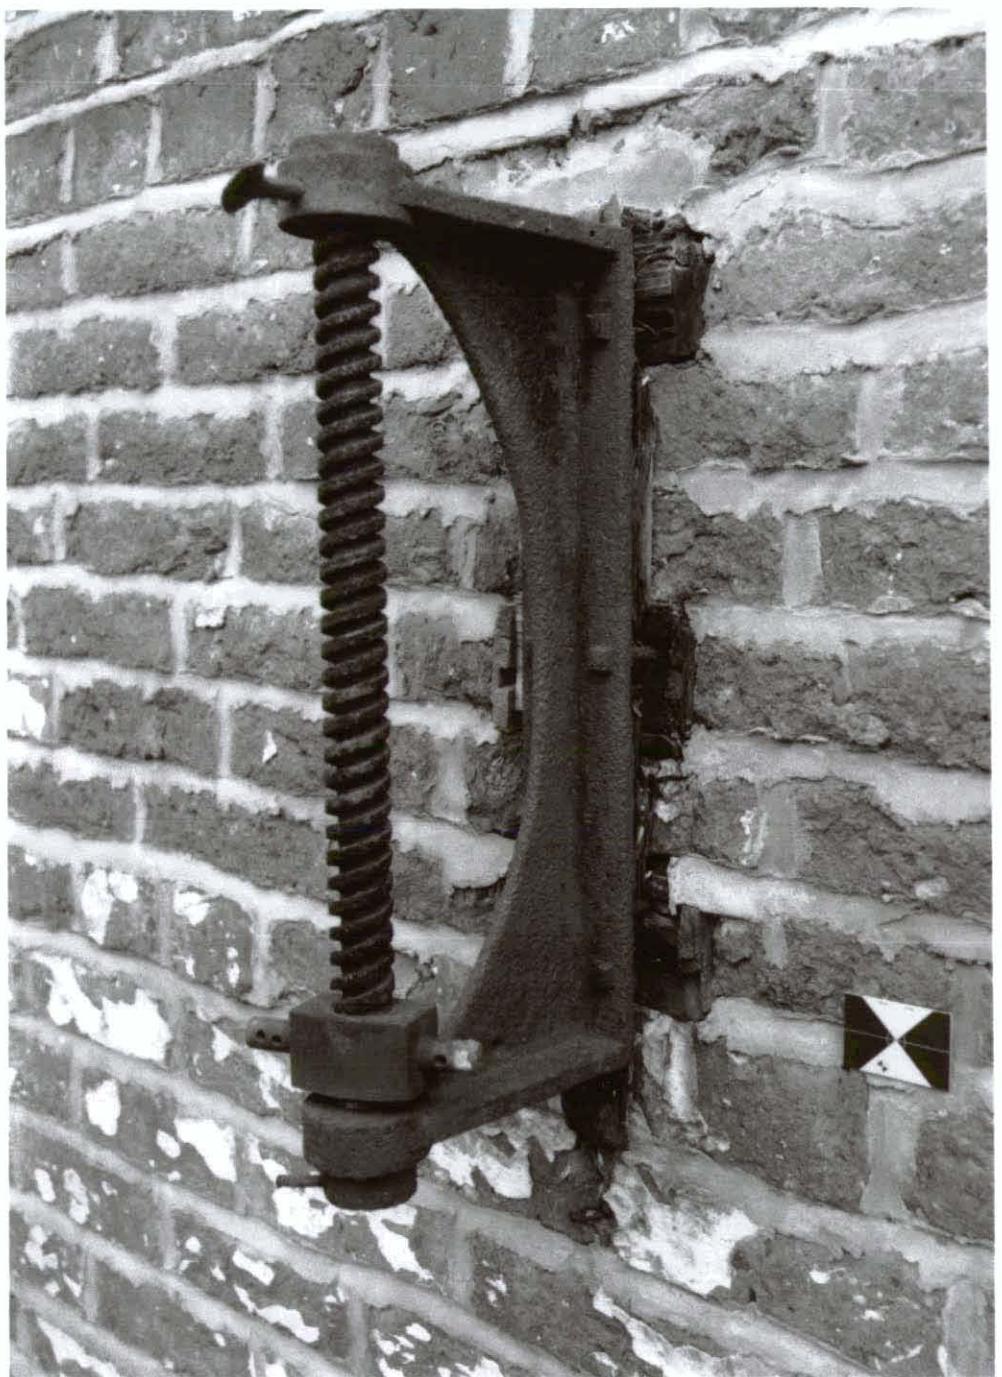
This building was located against the heated wall, contiguous with the head gardener's house. It was constructed between 1849 and 1893, and the section closest to the house was demolished between 1908 and 1928; with the remainder being demolished after 1960. The only surviving evidence for a glasshouse here was a cast iron bracket in situ on the heated wall, which contained a worm drive, presumably to operate a ventilation system (Plate 16).

Plate 16. Glasshouse 15, worm drive for ventilation

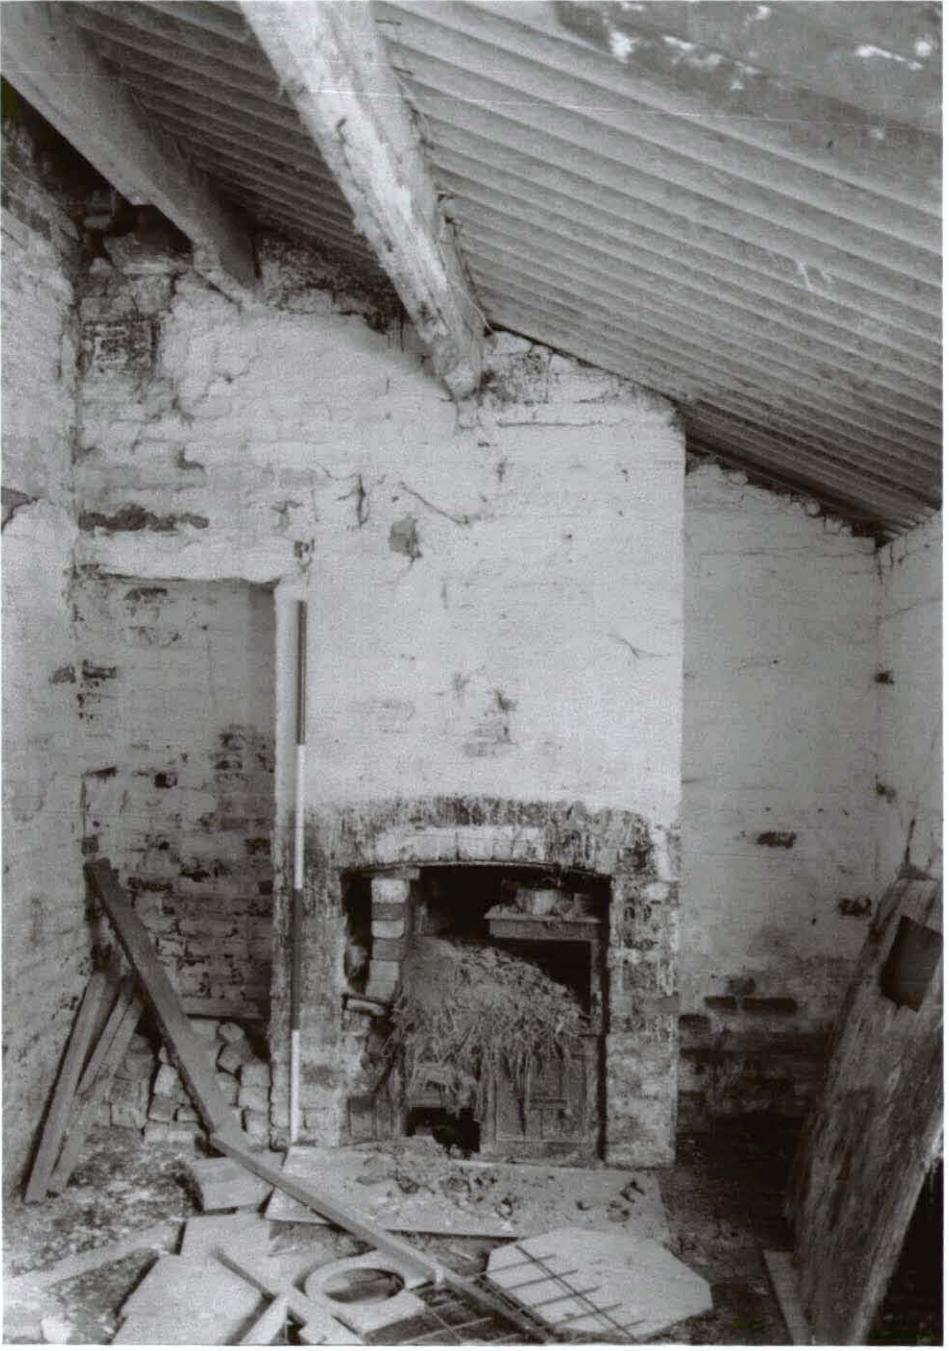
Buildings 6 and 7 appeared to form a single, interconnected unit. Building 6 had a fireplace with an *in situ* cast iron range (Figure 16; Plate 17). This would suggest that this building had functioned as the head gardener's office. The adjacent Building 7 had no access other than through Building 6, and the only window was an inserted one, probably of 20th century date. This would suggest that this was either a fruit store, or a forcing shed, with no natural lighting. Building 6 had a single set of 'Type A' bricked-up cleaning holes, arranged vertically within the heated wall.

Plate 17. Outbuilding 6, west internal elevation

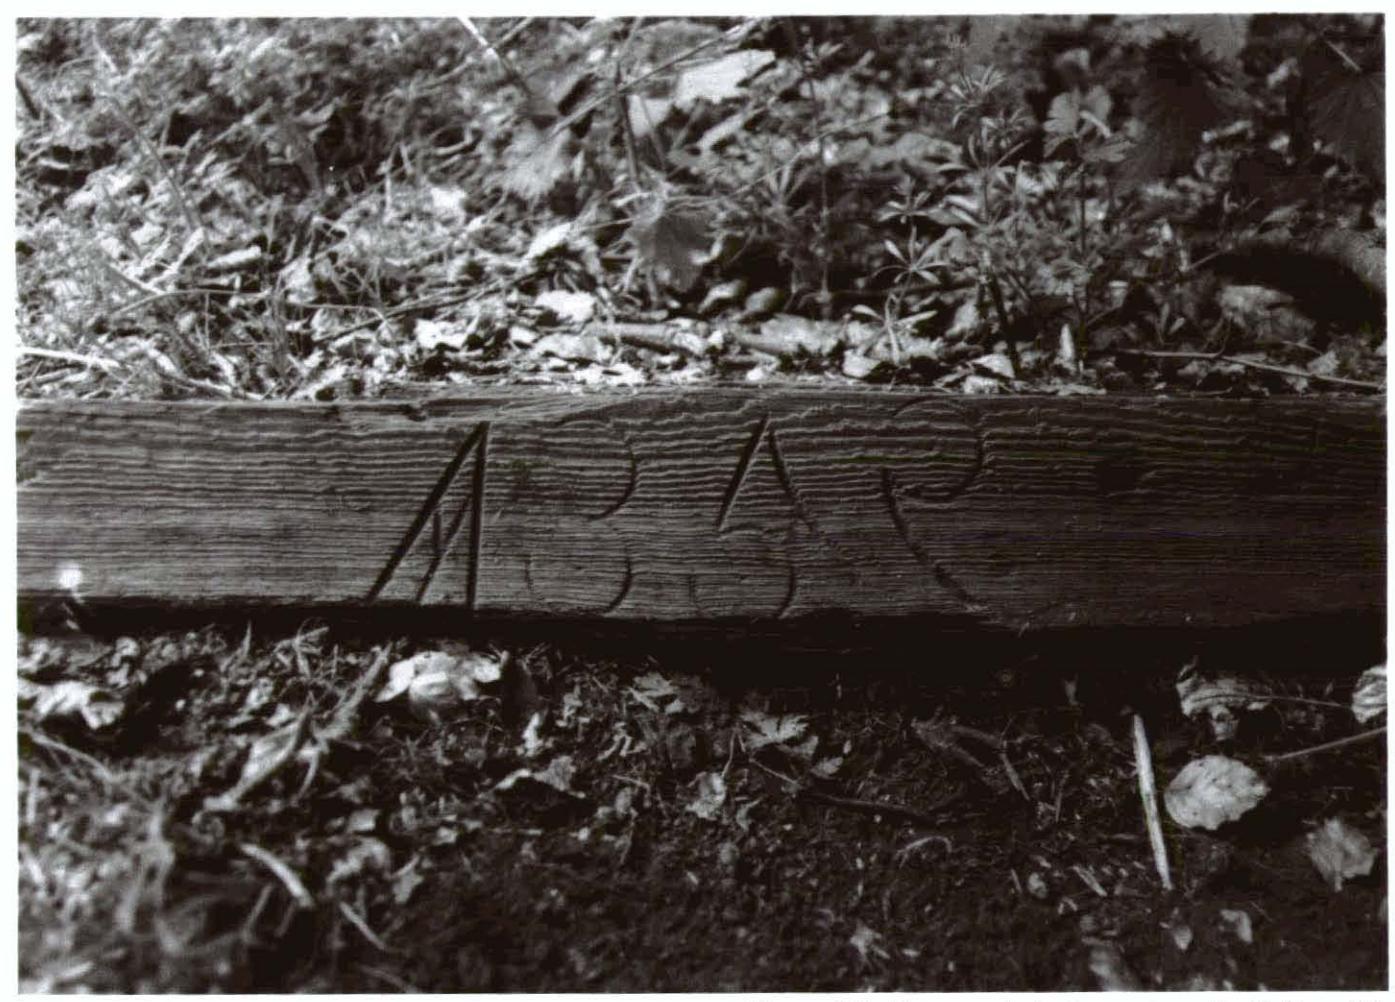
Plate 18. Re-used timber at outbuilding 12
