LAMINATE VENEER RESTORATION USING KATANA™ Zirconia STML PROSTHESES

WITH PANA VIA™ Veneer LC (Clear)

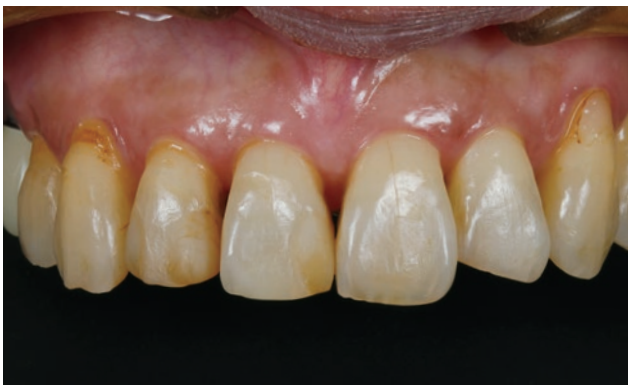
Fig. 1

The patient was referred to our hospital by an orthodontist. The chief complaints were improper esthetics of the teeth due to black triangles at the edges of the gaps between the teeth and occlusal wear of the teeth.

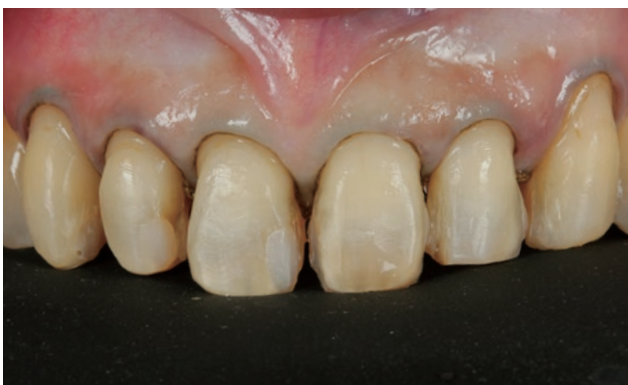
Fig. 2

On the basis of the pre-treatment diagnosis using a mockup, the abutments were prepared without anesthesia, keeping in mind that the enamel should be preserved to the extent possible.

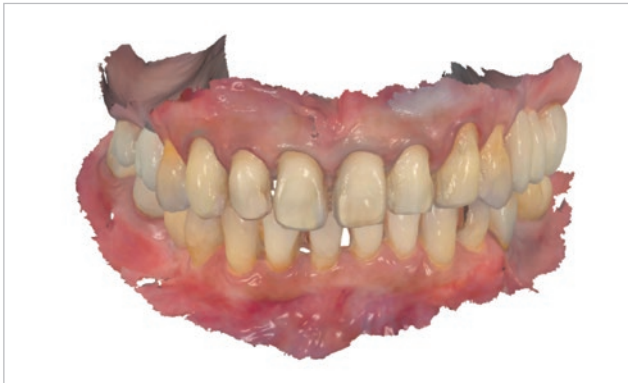
Fig. 3

Since a fixation retainer was installed on the palate side, it was difficult to take impressions using silicone. Therefore, an intraoral scanner for impression taking was used.

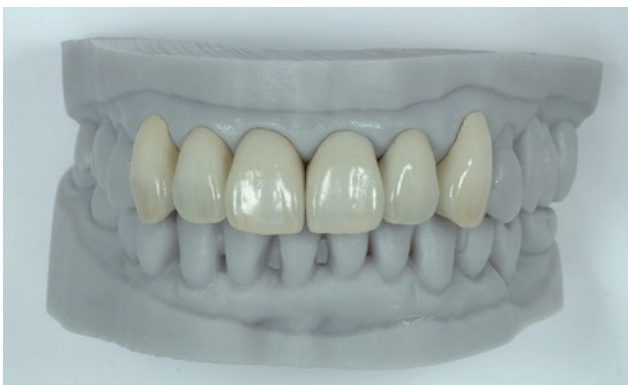
Fig. 4

A layer of porcelain on each of KATANA™ Zirconia STML substrates was applied to complete the laminate veneer restorations. The inner surface of each restoration was sandblasted, being careful to prevent chipping.

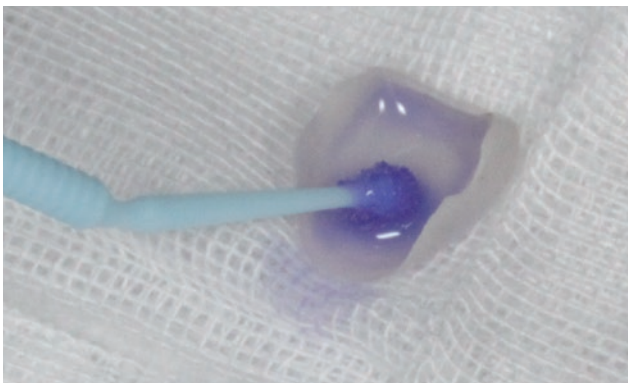
Fig. 5

After trial fitting, bonding inhibiting substances as blood and saliva were removed using KATANA™ Cleaner.

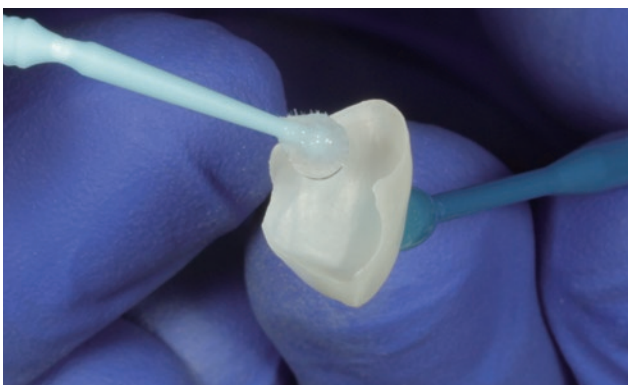
Fig. 6 Milling

CLEARFIL™ CERAMIC PRIMER PLUS, which contains the phosphoric ester monomer MDP, was applied and dried using compressed air.

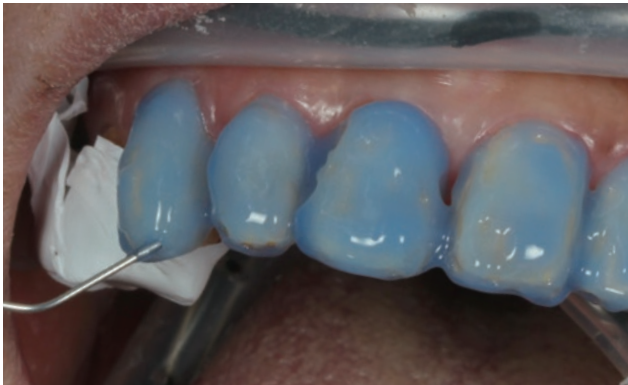
Fig. 7

The surface of each tooth was cleaned and treated with K-ETCHANT Syringe for 10 seconds before washing it away with water and compressed air-dried the area.

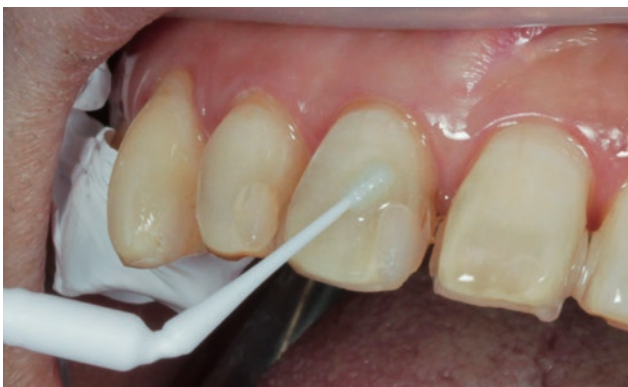
Fig. 8

PANAVIA™ V5 Tooth Primer was applied and left it for 20 seconds, then compressed air-dried it.

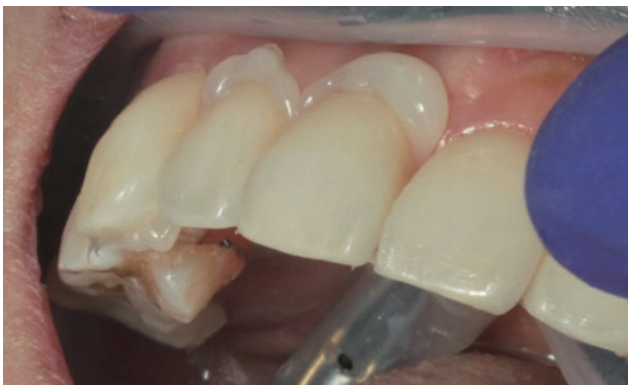
Fig. 9

PANAVIA™ Veneer LC Paste was applied and the laminate veneer was seated. For this case, we treated six teeth during one session.

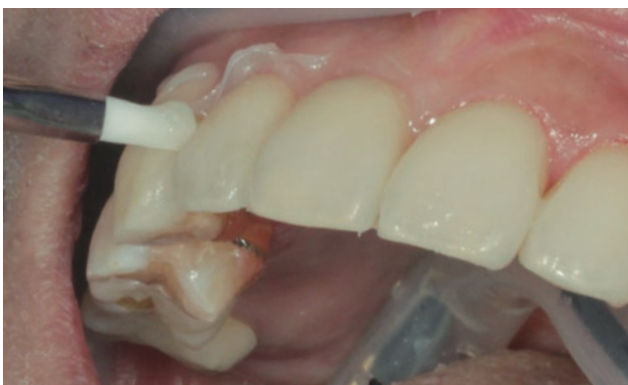
Fig. 10

The unpolymerized excess paste was removed with a brush. PANAVIA™ Veneer LC Paste is a light-cured type, which was designed to provide sufficient working time.

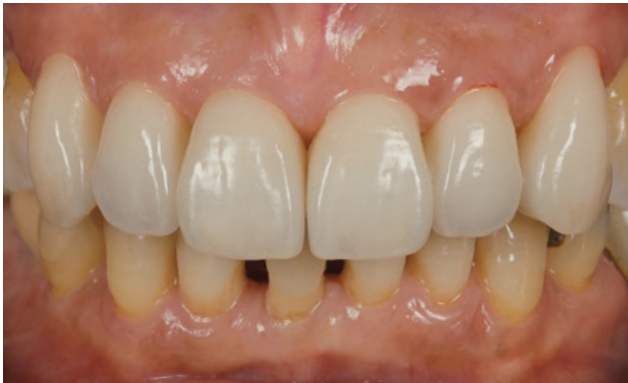
Fig. 11

This photo shows the results after the final light curing. Since the excess cement was easily removed, there were almost no cement residues.

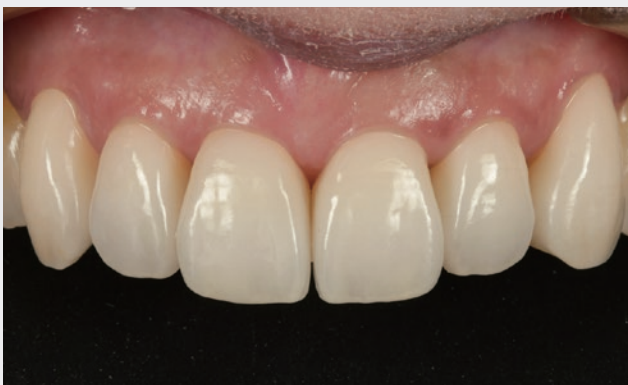
Fig. 12

The photo shows the inside of the oral cavity one month after the fitting of the laminate veneer restorations. It can also be noted that the teeth's marginal gingiva has been improved, thanks to the good fit of the laminate veneer restorations.
