**WINSTANLEY HALL
WIGAN, GREATER MANCHESTER
CONSERVATION MANAGEMENT PLAN**

April 2008

**Prepared by:
Kathryn Sather & Associates
Heritage Conservation Consultants
87 Oldfield Road
ALTRINCHAM
WA14 4BL**

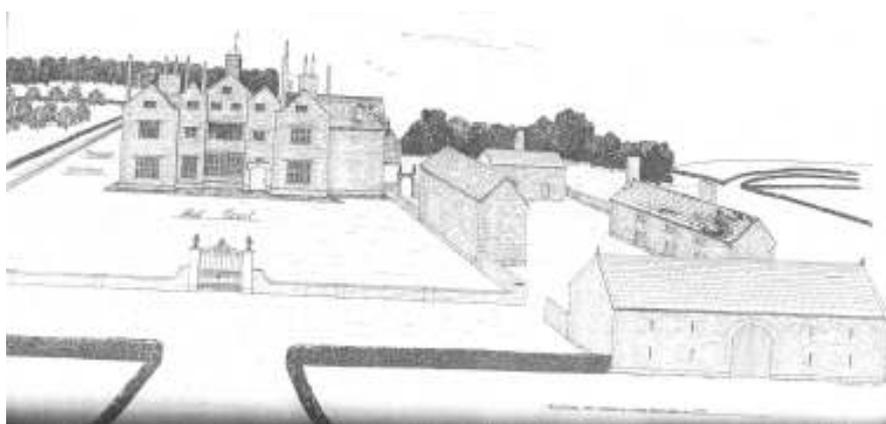
**Conjectural Drawing of Winstanley in 1770, Based on Estate Plan
(Bankes, 1973)**

The 1770 plan (drawn in elevation) shows a ground and low first floor extension to the North-east. This can be seen on the 1779 plan as an L-shaped building and the Wyatt plans show a pre-existing plan for the ground floor. This indicates that the house was extended to the north sometime between the 1600s and 1770. As the hall was built to be symmetrical, this extension is likely to have been added later. However, records do not show the use for which it was built.

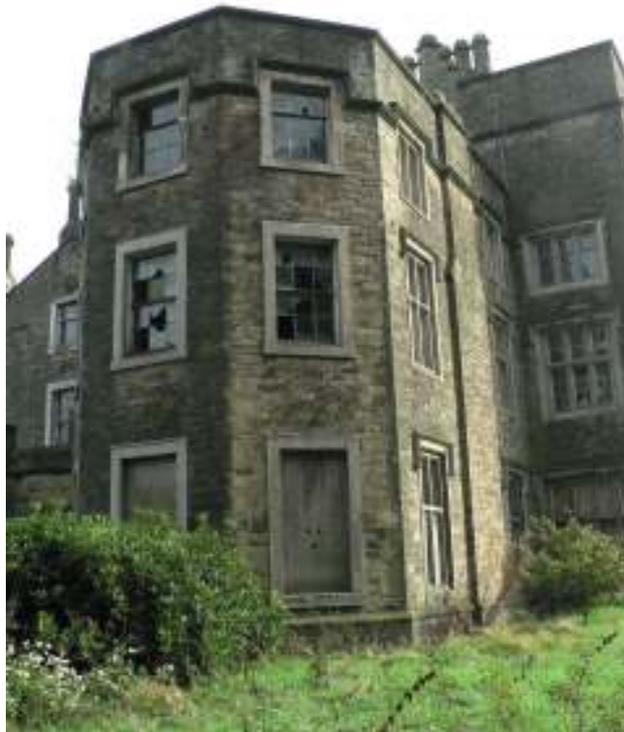
Breakfast Parlour on North-west Front

Bankes married Mary Ann Bunney in 1779 and he may have been keen to improve the house to incorporate recent fashions. Two letters exist from 1780 describing progress on the 'new room' and an octagonal breakfast parlour, while Bankes was on an extensive tour of England. The 'new room' was probably the great hall which had a new ceiling and fireplace. The breakfast parlour is built of stone, canted and fitted with large sash windows. Letters also show that he took pains over the construction of an iron safe in the panelling of his study or bedroom and complained over the quality of the work: 'the shelves don't fit well and the drawers remarkably ill'.

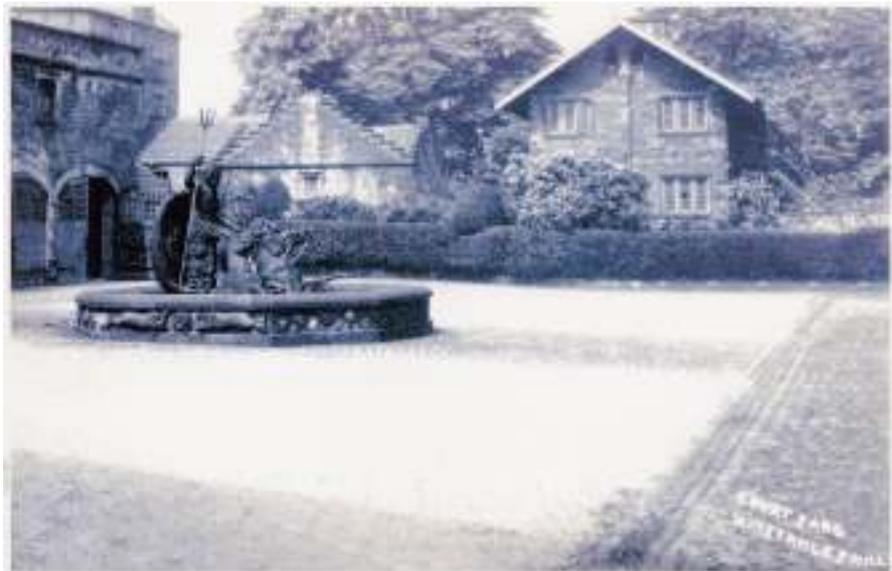
The Upper Courtyard c1900, Showing the Neptune Fountain, Estate Office and Malt House

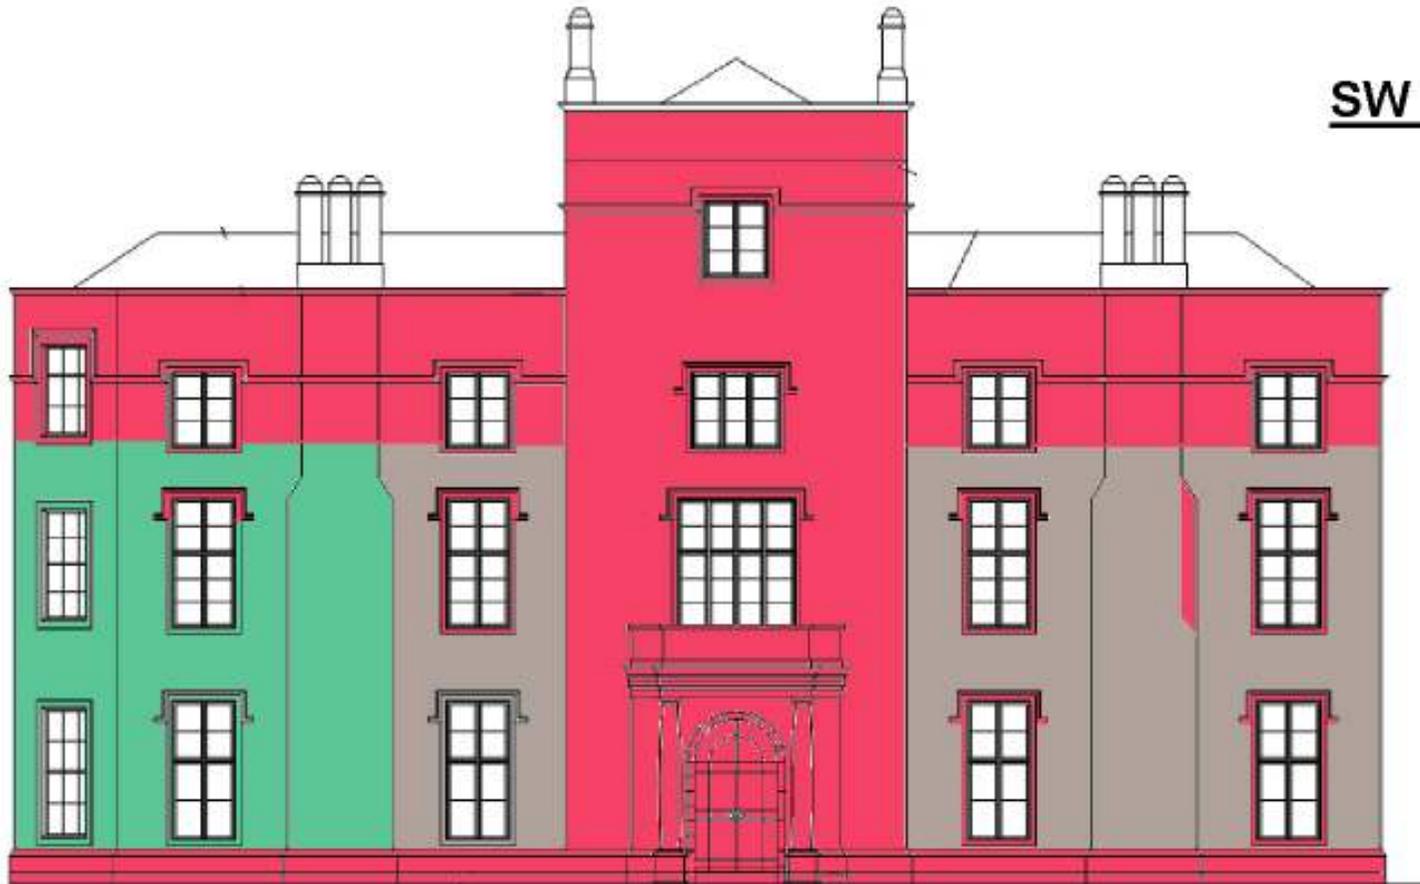
SW Elevation Phasing

Grey	Late 1590
Orange	c 1600 - 1770
Green	1780
Yellow	Pre-1819
Red	1819
Brown	1820 - 50 (1843?)
Dark Grey	1888/9
Blue	Early 20th Cent
Light Orange	Mid 20th Cent
Yellow	Unknown

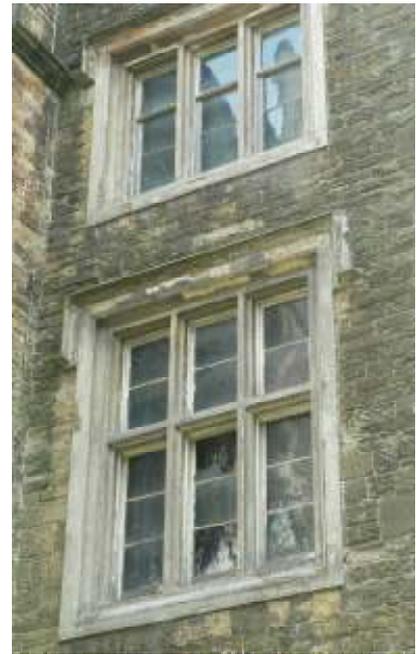
Mullioned and Transomed Windows

elsewhere in his work such as Tatton and Hackwood. At Winstanley, Lewis's work is characterized by panelled window bays, plaster cornice work, nine inch skirting boards and plaster roundels. Externally, Lewis redesigned the southern façade creating five bays to replace the pre-existing gables. The central bay consists of a four storey projecting entrance bay or tower, complete with stone parapet and ashlar dressings. This is typical of Wyatt's work at this time, echoes of which can be seen in Cuerden Hall in Lancashire (1815), with its high parapets concealing the roof. At Cranage Hall (1829), Wyatt also uses Doric columns at the entrance, a stone parapet to span its eight bays and mullion and transom windows; the use of these elements is very similar at Winstanley.

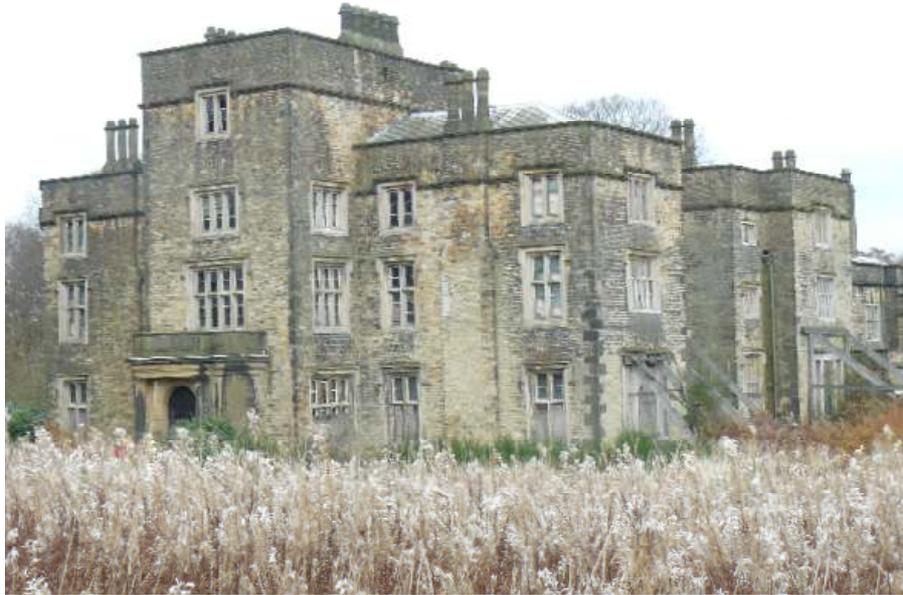
The 1819 South Façade Wyatt Extension in Perspective

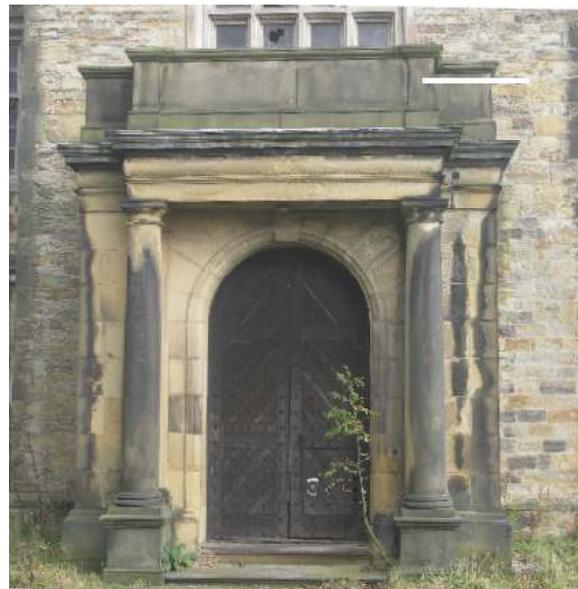
Doric Columns at Entrance to South Facade
