Chris Sharples B.Sc. (Hons), Ph.D.
Consultant Geoscientist

A Geomorphic Investigation of Shoreline Change at Garden Island Sands, Southern Tasmania

Chris Sharples
7th February 2023

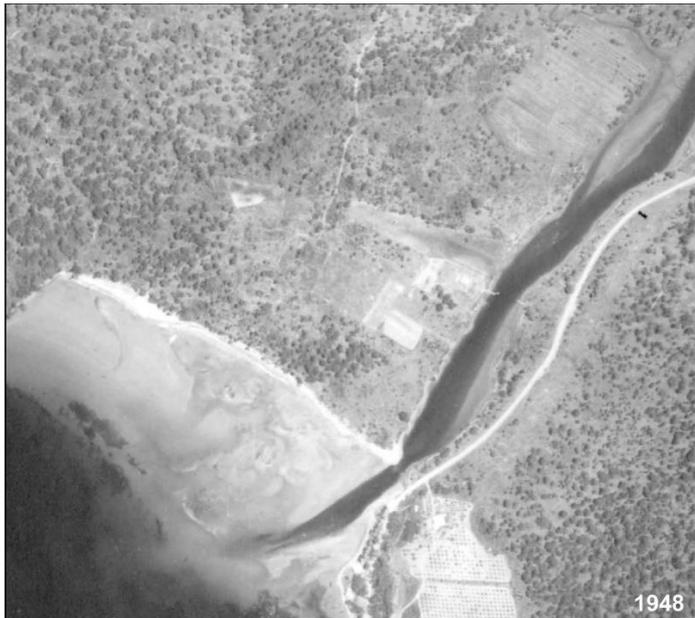
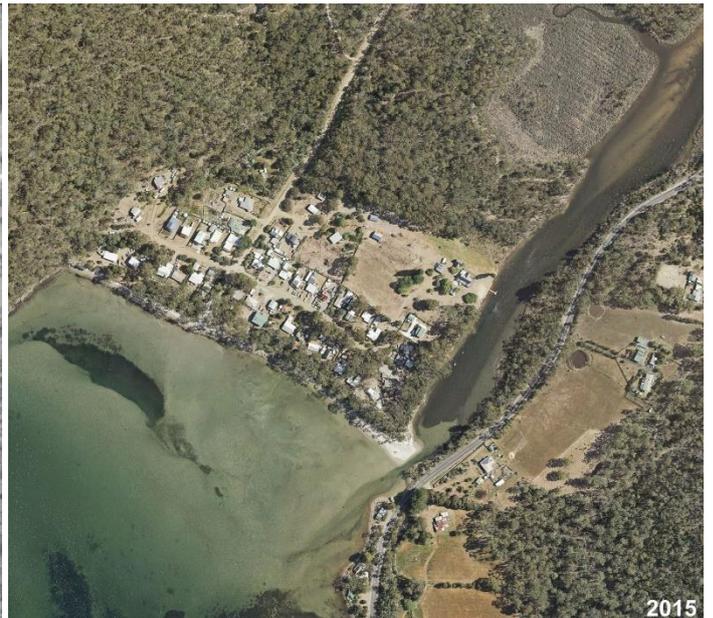
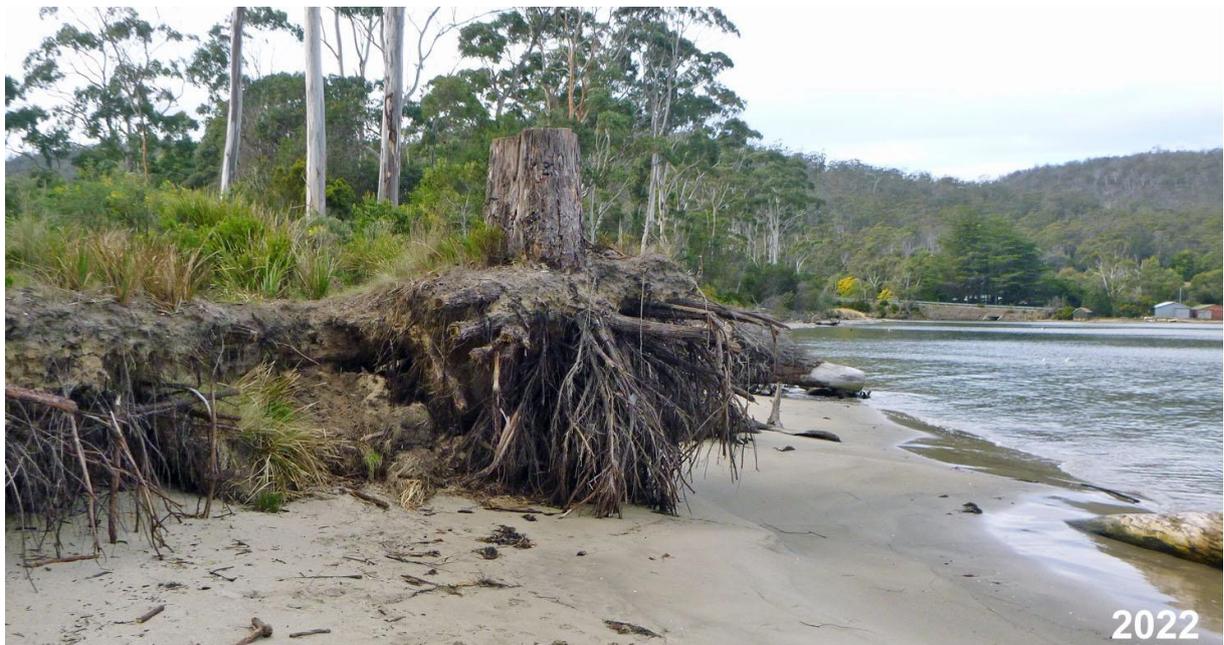
Front Cover: Top: Aerial photographs of Garden Island Sands in 1948 (RHS) and 2015 (LHS); **Bottom:** Large mature tree on the foredune at Garden Island Sands, undermined by recent erosion (Photo date 3rd Aug. 2022).

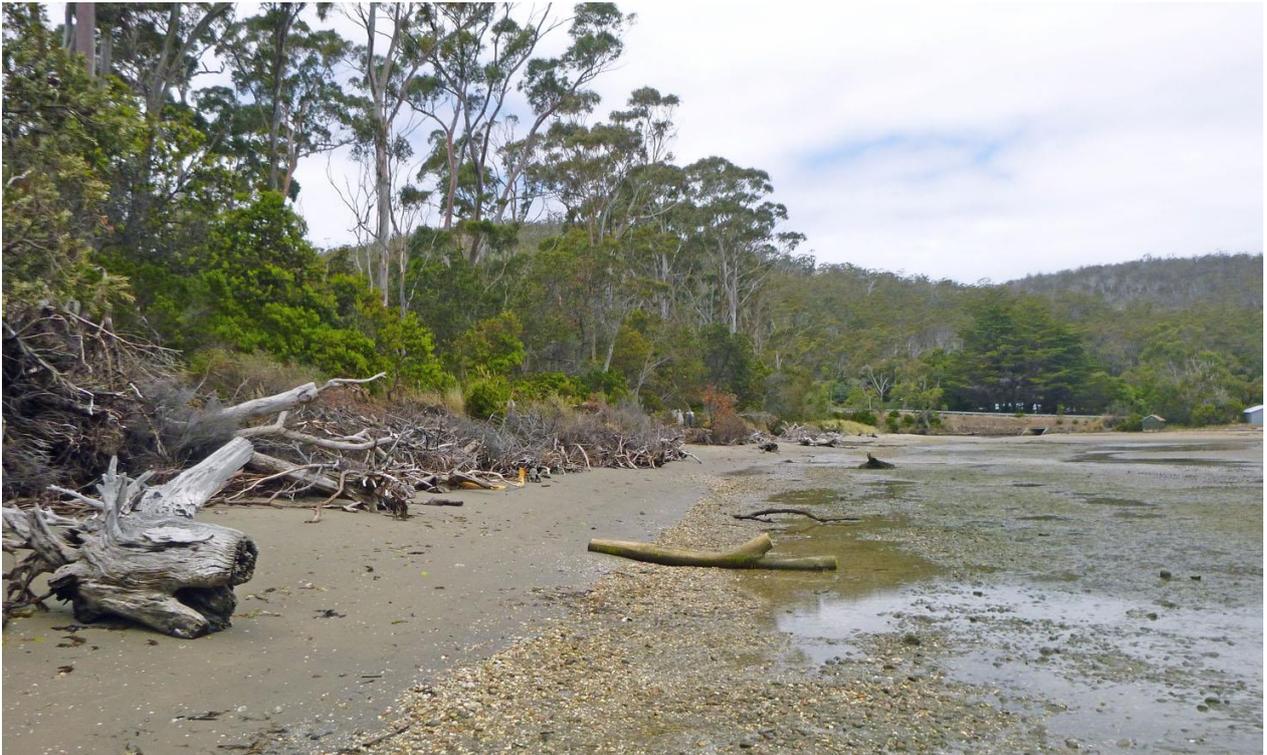
Figure 3: View eastward along the east end of Garden Island Sands Beach at close to low tide (3rd January 2022). This view shows a damp narrow upper sandy beach above the very broad flat wet sandy low tide terrace which here exhibits pebbles and shelly material. The cut woody debris artificially piled against the foredune on the left is covering a very fresh erosion scarp of recent origin (see also Figure 5).

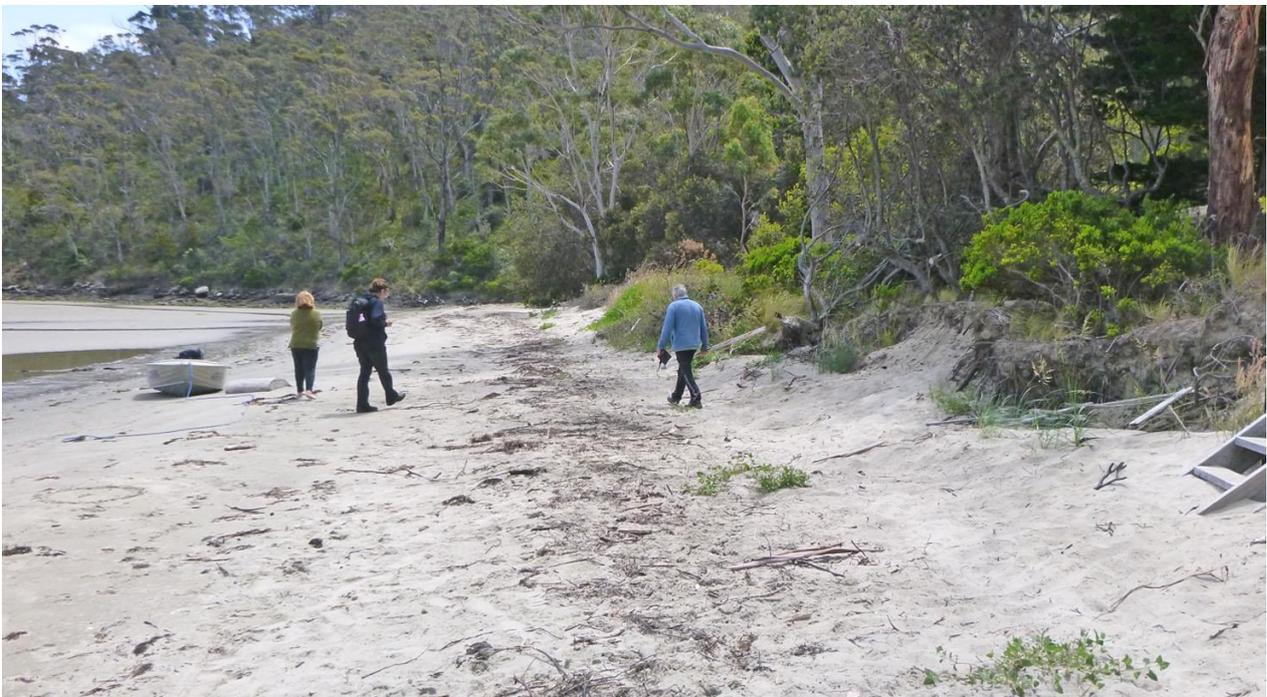
Figure 4: View westwards along the west end of Garden Island Sands Beach at close to low tide (3rd January 2022). Compared to the eastern end of the beach (see Figure 3 above), this view clearly shows a much wider and drier upper beach above the broad flat wet low tide terrace to the left. Although an old erosion scarp is visible in the foredune at the right, it is becoming buried beneath the accreting incipient foredune at its foot, which has grown as sand has been returned to the beach following the last erosion event. This older and more recovered dune scarp contrasts with relatively fresh recent erosion scarping in the central to eastern part of the beach (see Figure 5).

Garden Island Sands Beach is a 470 metres long, south- to south-southwest facing beach of fine-grained yellow-grey sand. Short (2006, p.141) has classified the beach as a steeper “reflective” upper beach (low-energy and wave-dominated) fronted by very broad (~400 metre wide) intertidal to sub-tidal sand flats. At the time of writing (2022), the beach above the low tide terrace is notably narrower (~3-4m) and wetter in its central to south-eastern areas (Figure 3) than it is near its wider (~8-9m) and drier north-west end (Figure 4). This pattern of a wider and drier

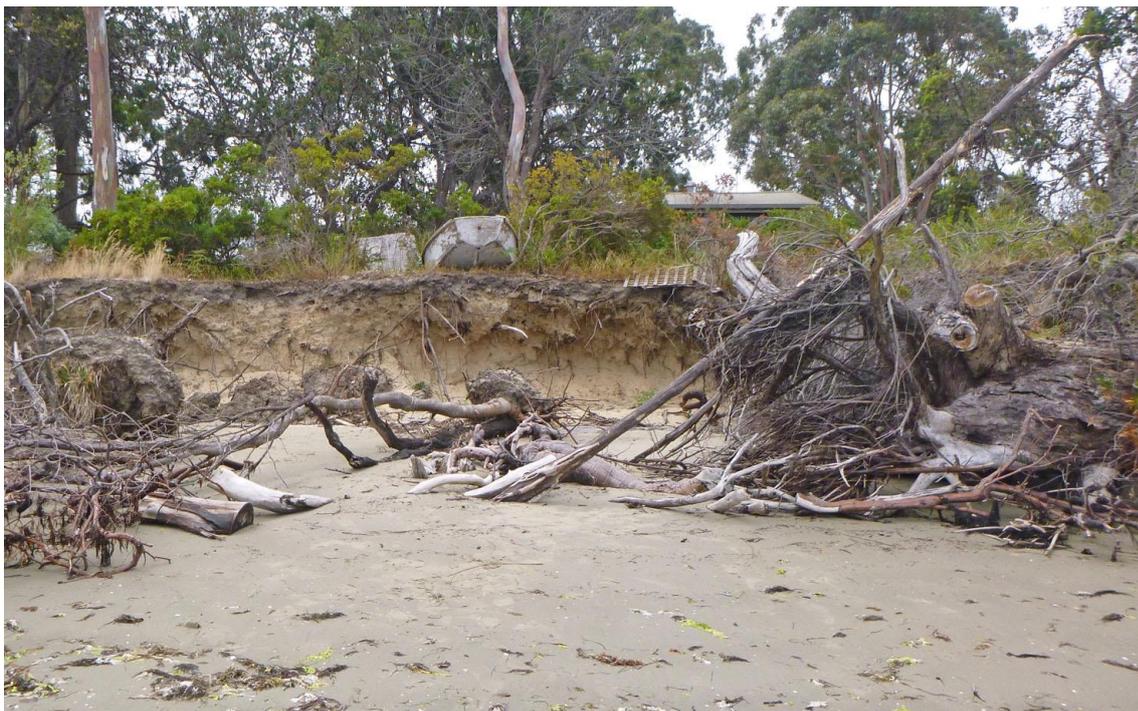
Figure 5: Landwards view of freshly eroded foredune scarp in the central area of the beach at close to low tide (3rd January 2022). This freshly eroded scarp is of similar size, character and freshness to that shown in Figure 3 (above) but has not been covered with cut branches. The woody debris scattered across the beach in this view mainly comprises mature trees formerly growing on the foredune, which have been undermined and toppled by storm wave erosion in recent times (precise storm dates unknown).

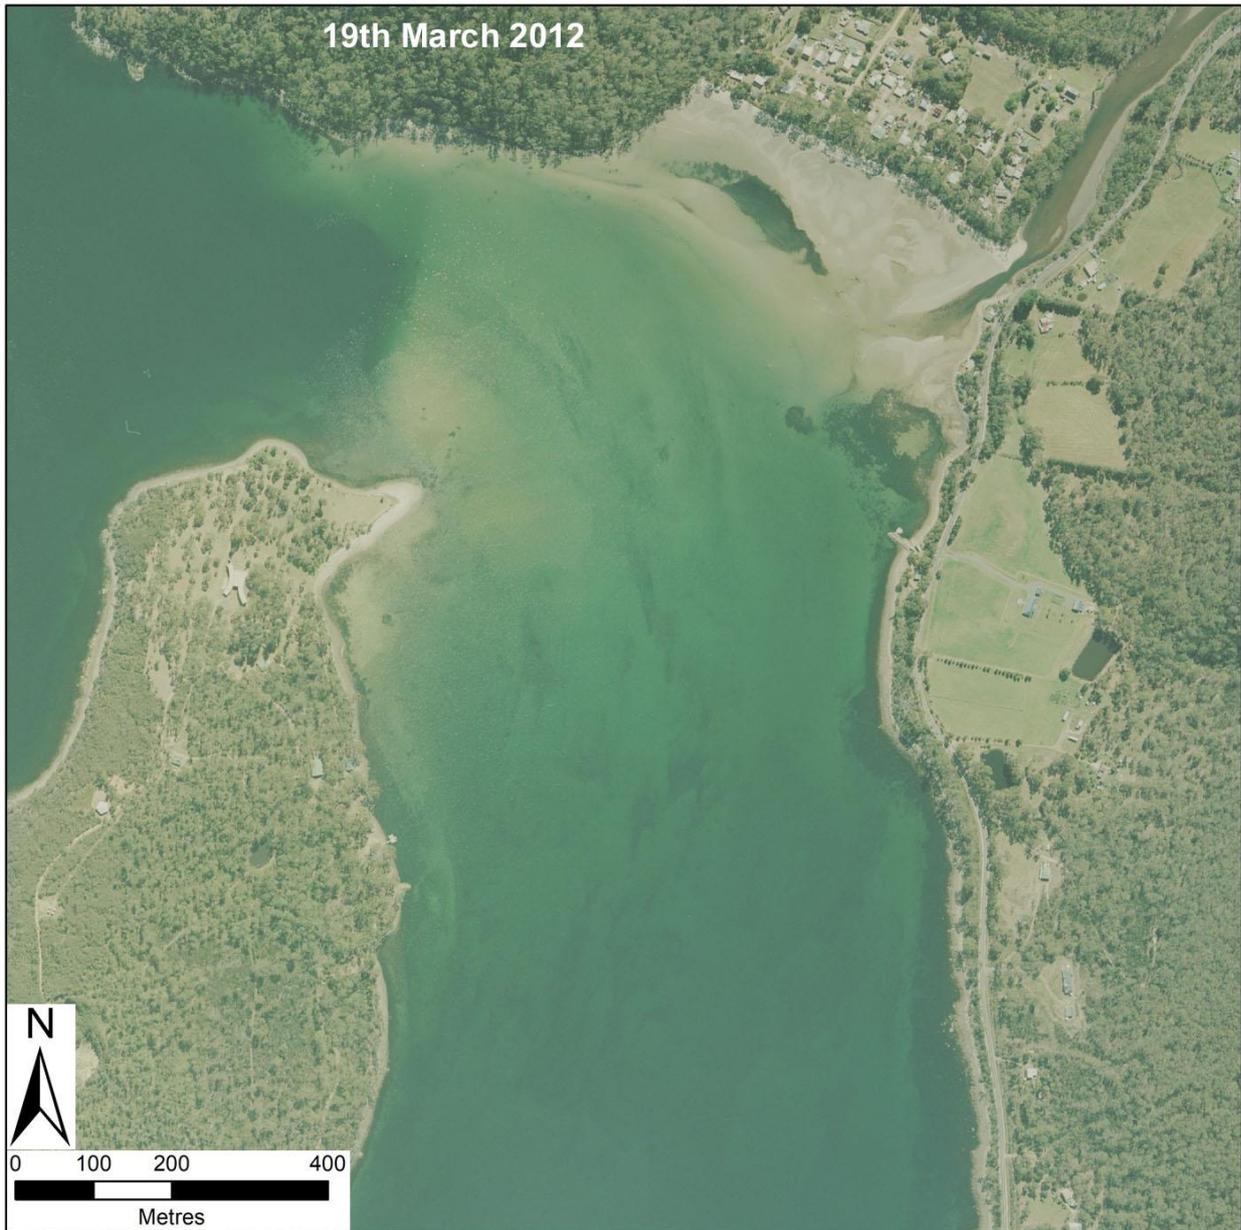
Figure 8: Distribution of shallow sandy seabed in relation to Garden Island and Garden Island Sands Beach. This image is a vertical colour air photo dated 19th March 2012 which provides a particularly clear view of the shallow sandy seabed free of surface water reflections (compare Figure 7). This view demonstrates the “sand trap” nature of the area between Garden Island and the Garden Island Sands Beach embayment. Most of the very ‘bright’ sand close to the vegetated shoreline is submerged in very shallow water but may be partly or wholly exposed at low tide. Dark patches in the sandy seabed are mainly seagrass beds. Air photo © NRE.

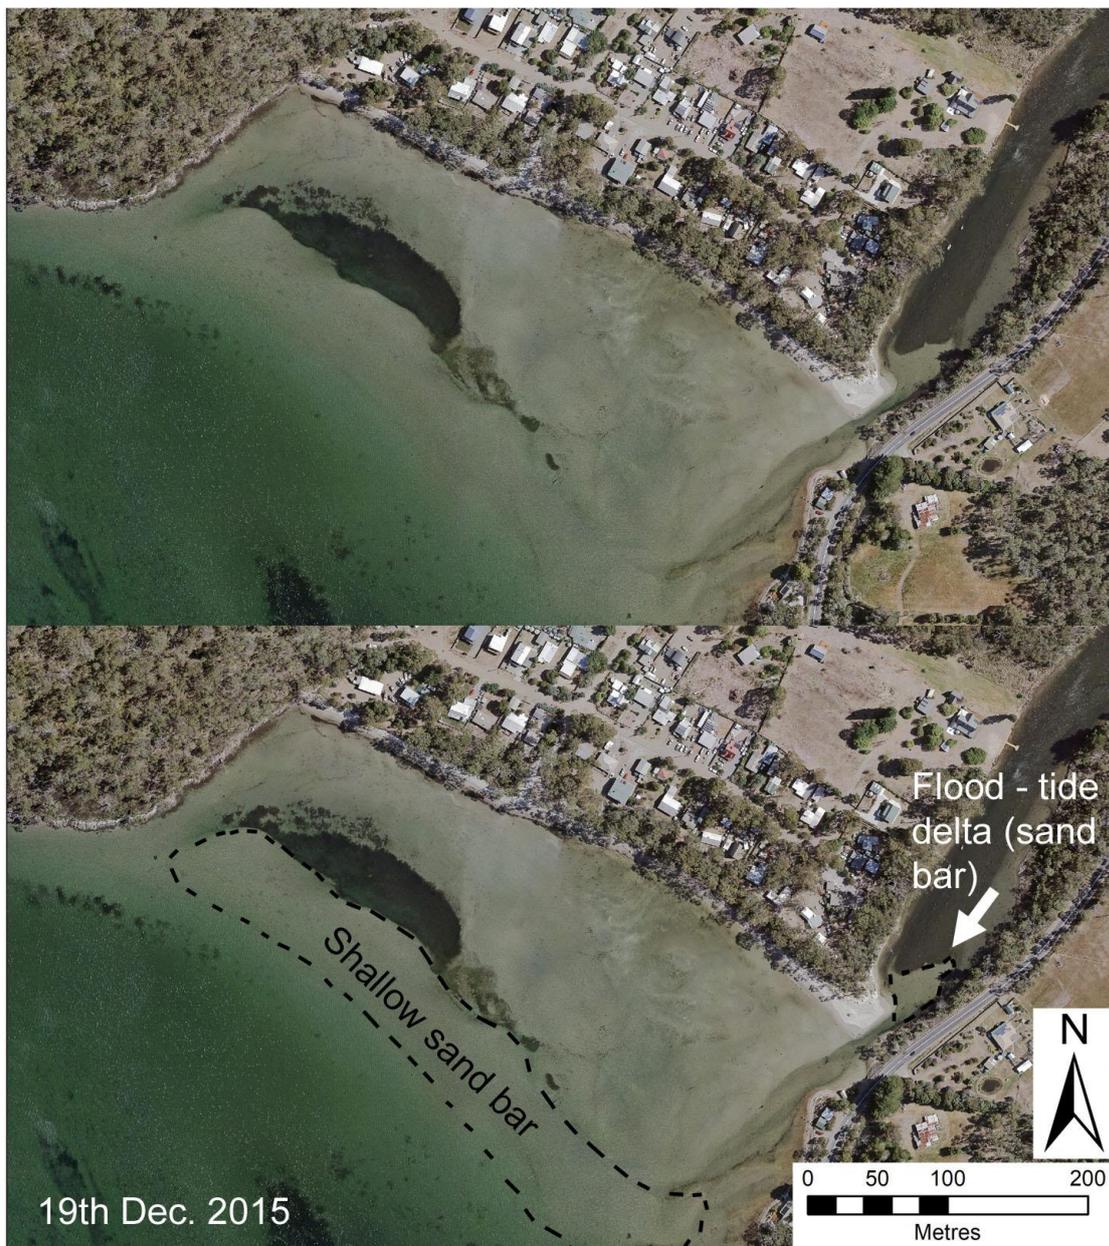
Figure 9: Air photo of Garden Island Sands showing shallow sub-tidal sand bar features. Original photo dated 19th Dec. 2015 (top) and annotated version (bottom) showing ephemeral sandy flood-tide delta in estuarine lagoon and shore-parallel shallow offshore sand bar encroaching landwards over the margins of a large seagrass bed. Air photo © NRE

An important feature of the sand accumulation in the Garden Island Sands area is a prominent sand bar approximately 100 to 200 metres offshore and roughly parallel to Garden Island Sands Beach (see Figure 9). When observed on 14th Sept 2022, the bar was a very shallow discontinuous accumulation of clean fine-grained yellow-brown sand that was partly exposed above water level at mid-tide directly offshore from the Garden Island Creek mouth, and elsewhere was as shallow as only 0.2 m water depth. Low swell waves were breaking across the shallowest point of the bar. The full extent of the bar was not mapped; however, the water is deeper on both the beach and island sides, and seagrass beds on the beach side of the bar appear to be somewhat protected from wave action by the bar. It is likely the sand bar absorbs some of the energy of waves approaching the beach, albeit large storm waves would undoubtedly partly or wholly excavate the bar itself, resulting in increased wave attack on the beach and foredune.
