Annual Inspection

Radford Semele Parish Council

Fenced Play Area

Inspection Ref: 1589724

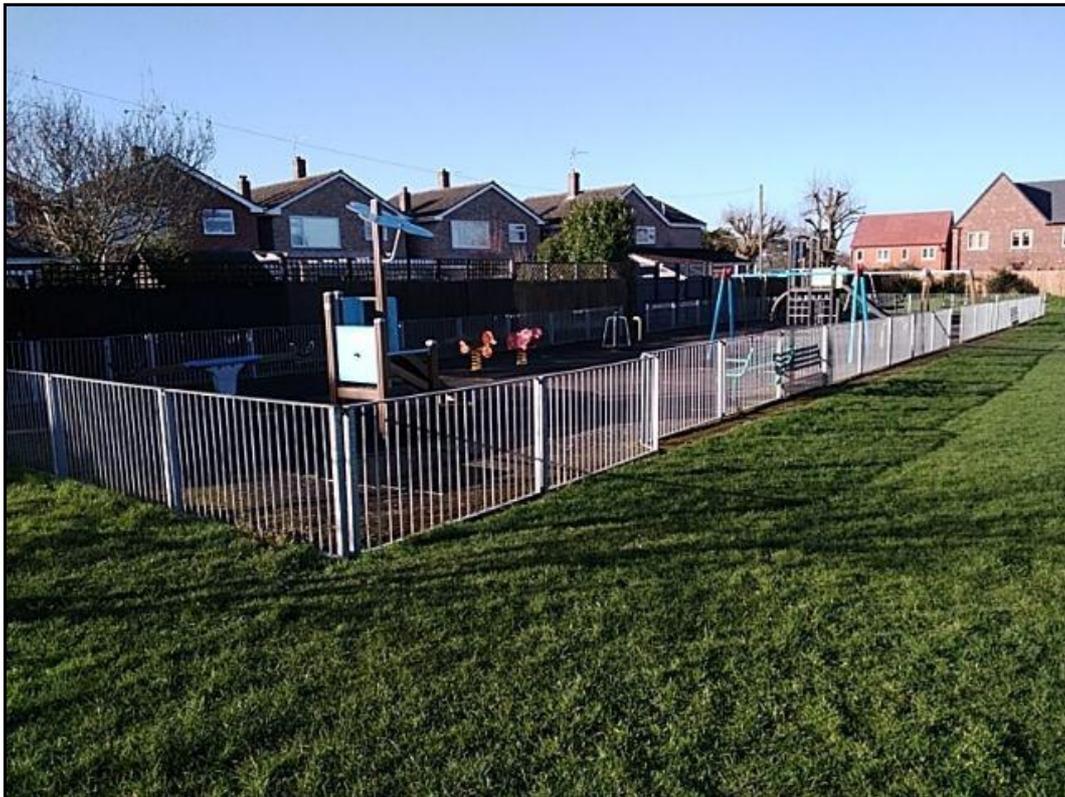
Location:

The site is located in an area of public open space and is overlooked by a number of properties in the local community.
