OCDEA TECHNICAL BULLETIN

A Guide to
Photographic Evidence
for New Homes

A GUIDE TO PHOTOGRAPHIC EVIDENCE FOR NEW HOMES

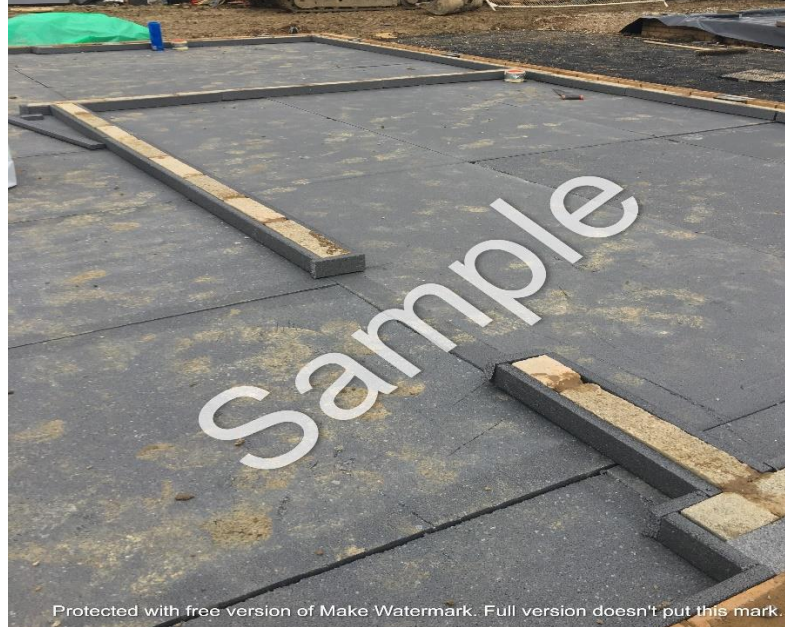
AD L Photo Reference	Direction of Photograph	Typical Example	AD L Guidance
<p>1A – GF perimeter insulation</p> <p>(SAP junction reference E5)</p>

<p>Protected with free version of Make Watermark. Full version doesn't put this mark.</p>	<p>Photograph should show a continuous strip of insulation in contact with the walls around the perimeter of the ground floor.</p>

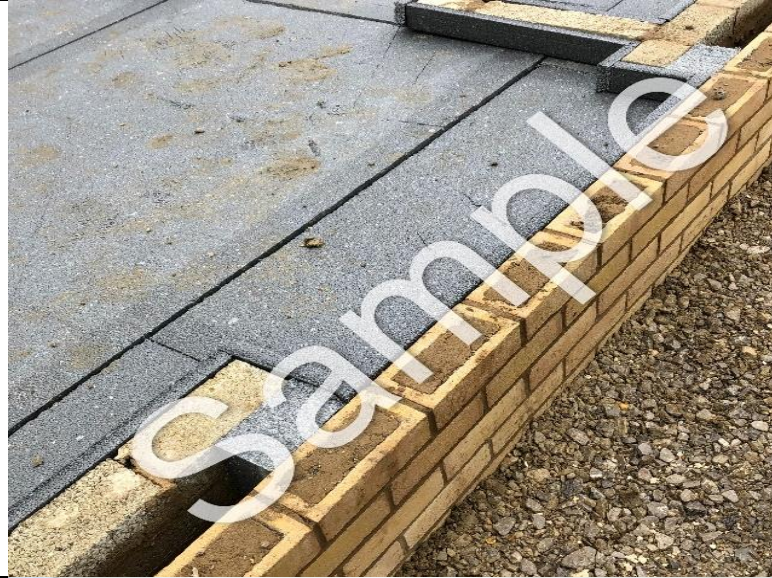
1B – Door threshold

(SAP junction
reference E3)

Photograph should
show a strip of
insulation or insulated
cavity closer in the
threshold zone.

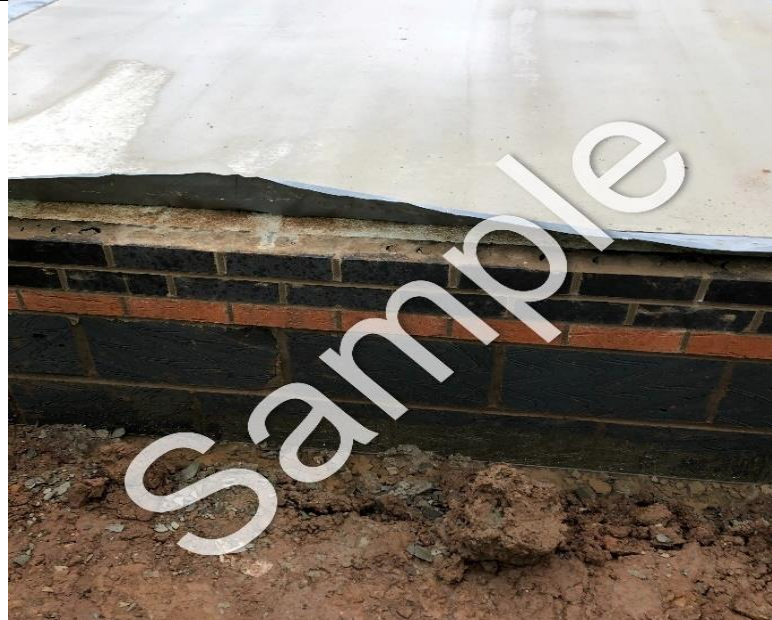
1C – Below DPC on
ext. walls

Moisture-resistant
insulation should be
fitted below damp-
proof course level
and extend to the
foundation
block/structure.

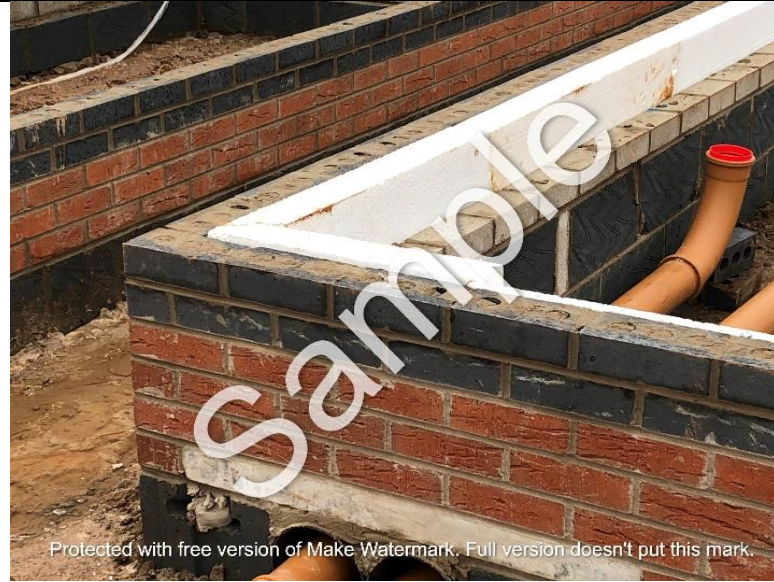
2A – GF to Ext. wall
junction

(SAP junction
reference E5)

External or cavity wall
insulation should
extend below the
dampproof course

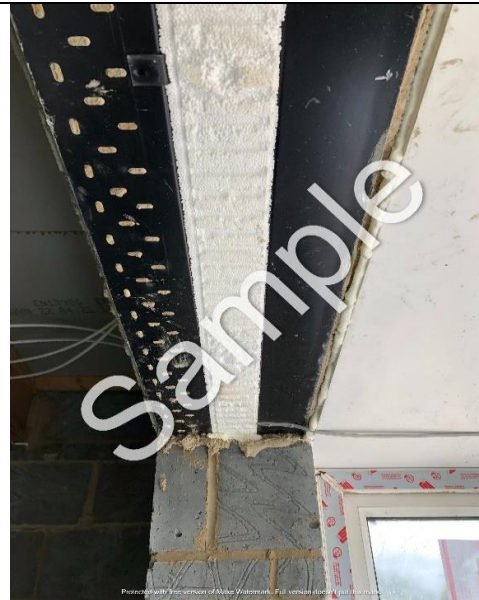
2B – Structural
penetrating elements

(SAP junction
reference E1/2)

There are a number
of items this could
cover but discussions
with stakeholders
suggests this would
usually include lintels,
and one photo is
required per opening
type.

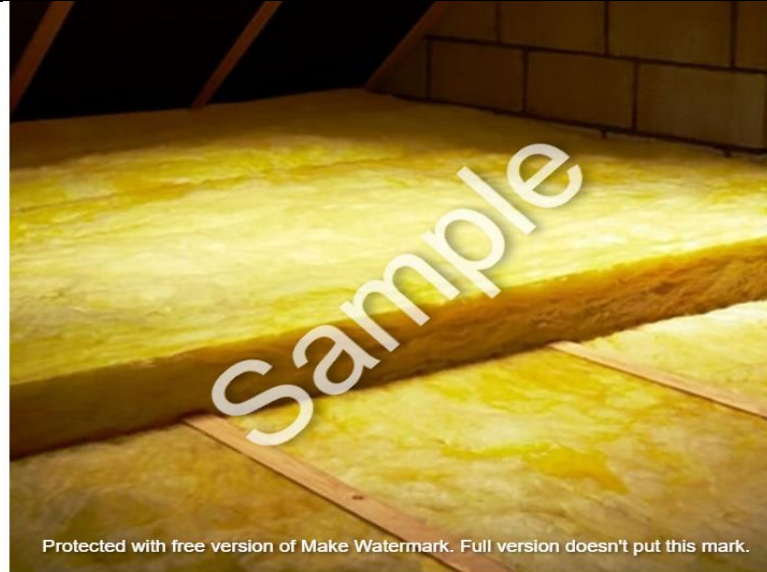
3A – Roof at
joist/rafter level

Insulation should be installed tight to the structure, without air gaps, and should extend to the wall insulation

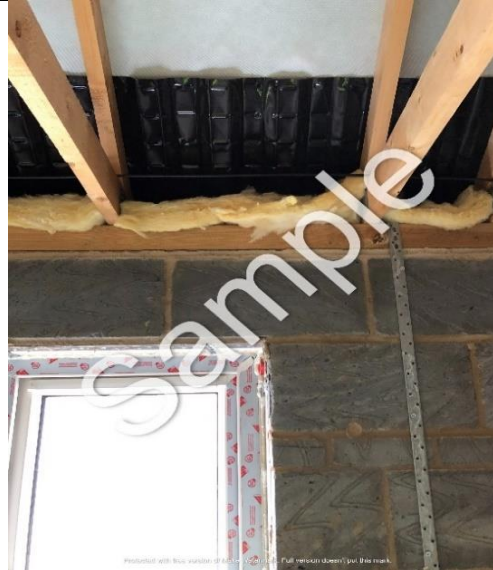
3B – Roof at
eaves/gable edges

(SAP junction
reference E10, E11,
E12, E13)

Eaves photograph
should show loft
insulation extending
beyond the wall
insulation to minimise
cold bridging.

Gable photograph
should show
insulation against the
inner surface of the
external/party walls
to minimise cold
bridging.

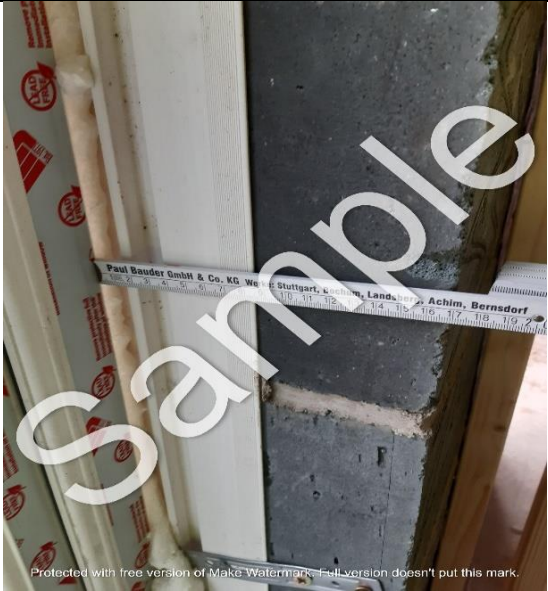
<p>4A/B – Window/door position to cavity closer/insulation line</p> <p>(SAP junction reference E4)</p>

<p>One photo per window/door type is sufficient here.</p> <p>Good practice would be to show a tape measure to check the window/door is in line with the cavity closer/insulation</p>
<p>5 – Airtightness issues</p>			<p>There is little guidance on what is required in this section currently.</p> <p>This could be to show how items that penetrate the air barrier, which are not covered by other photos, are sealed.</p>

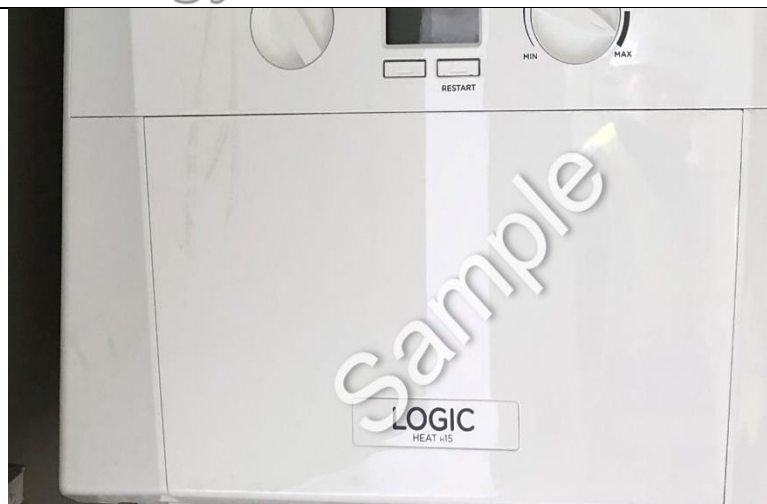
6A - Plant/equipment identification label(s), including make/model and serial number

Photos should show the labels clearly identifying make and model of heating system and hot water cylinder.

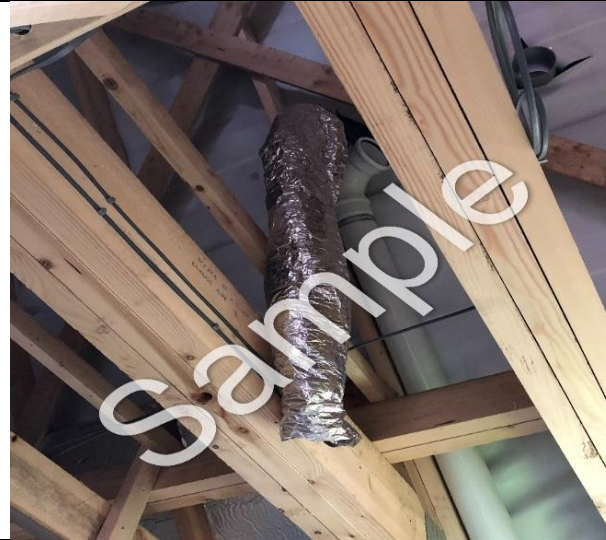
6C- Ventilation
ductwork insulation

Only needed for
ductwork in
unheated spaces
and should show the
insulated ductwork
used.

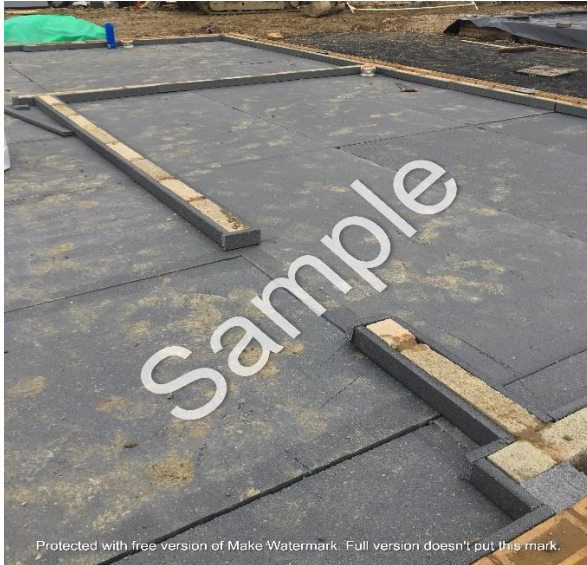
Photo reference; P1/1a
Additional notes;

a. Ground floor perimeter edge insulation (SAP junction reference E5)

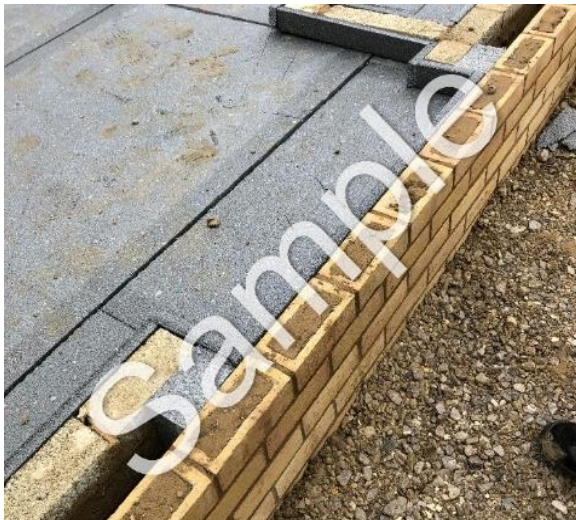
Photo reference; P1/1b
Additional notes;

b. External door threshold (SAP junction reference E3)
