CLIENT: REGION OF MAINLAND GREECE

YEAR: 2018

The object of the study is the Restoration of Boeotian Kephisos' River stone bridge at the site "Neroutsos' Mill" which is located on the upper course of the Boeotian Kifisos as the central arch that bridged the deep bed of N. Kifisos collapsed on February 2 year 2015 due to excavation.

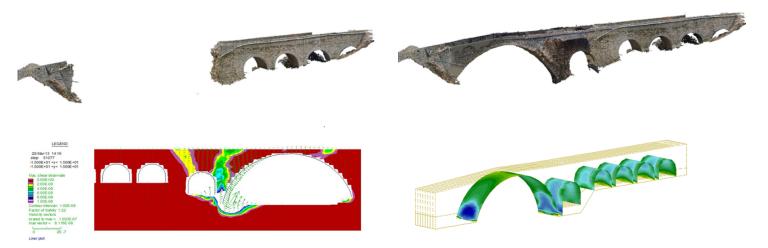
The bridge is approximately 4.00 m wide and consisted of a central opening about 14.00m, one arch of four smaller 2.90m span arches on right bank (S-W) connecting the bridge with the main road (current P.E.O. Athens-Lamia) and a pair of return walls, which form one bridge access ramp from left berth (N-E). Between the central opening and the arch there is nave with relief opening 3.00m. The total length of all sections is approximately 65m.
